# 1973 BUXTON BEACH NOURISHMENT PROJECT

AN ANNOTATED PHOTOGRAPHIC ATLAS

CAPE HATTERAS NATIONAL  
SEASHORE  
NORTH CAROLINA

FEBRUARY 1974

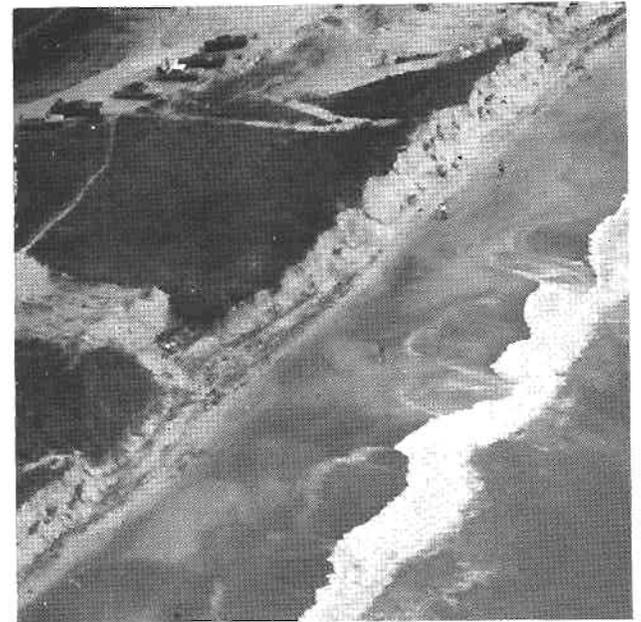
DUNE SCARPING

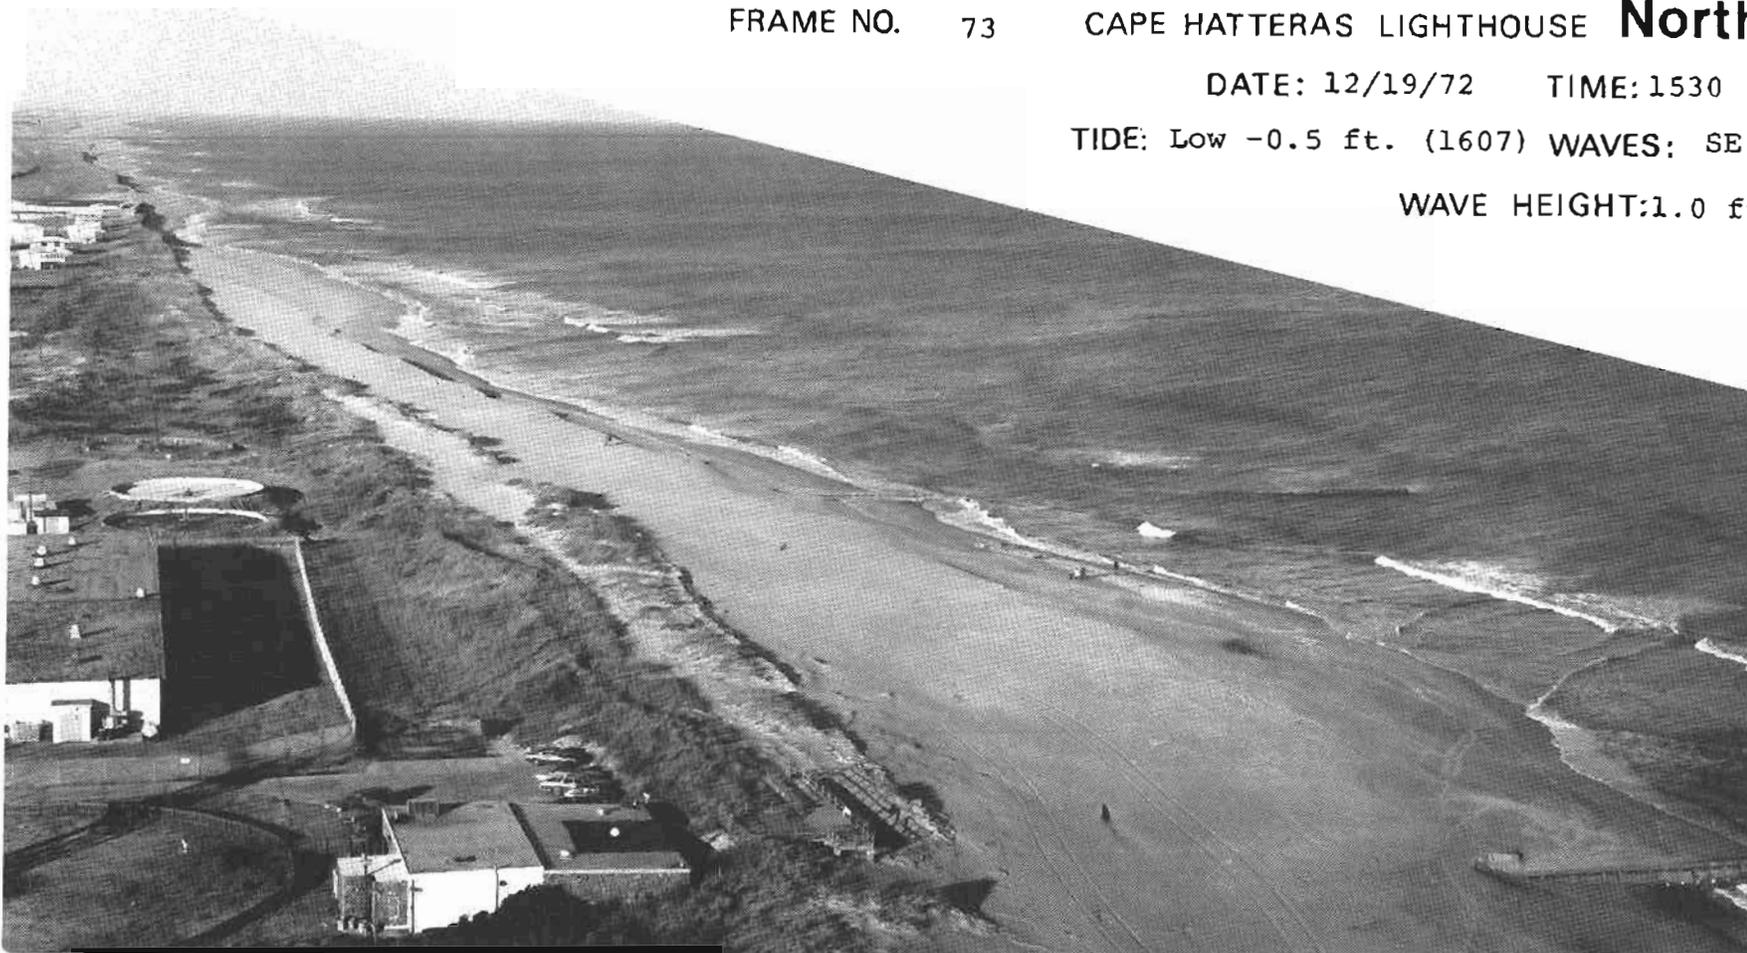
FRAME NO. 73

Prior to the start of the 1973 nourishment project, little evidence of the 1972 nourishment project (250,000 yd.<sup>3</sup>) remained near the motels. Storms during October, 1972, prompted a sandbagging project to protect the motels where 80,000 yds.<sup>3</sup> of beach material were lost. Dune erosion between MP42 and MP41 has continued threatening both private property and North Carolina Route 12. Shadows cast by the dune crests show the height of the dune scarps. MP42 is especially vulnerable at this time because of the bar-trough embayment located offshore. Two of the three Navy groins are seen in these pictures. The prevailing NE waves of winter have created a 40- to 50-foot wider beach on the updrift (north) side of the middle groin. This deposition, characteristic of groins, has not developed around the north groin because the center section of the structure (150 ft.) failed soon after construction.

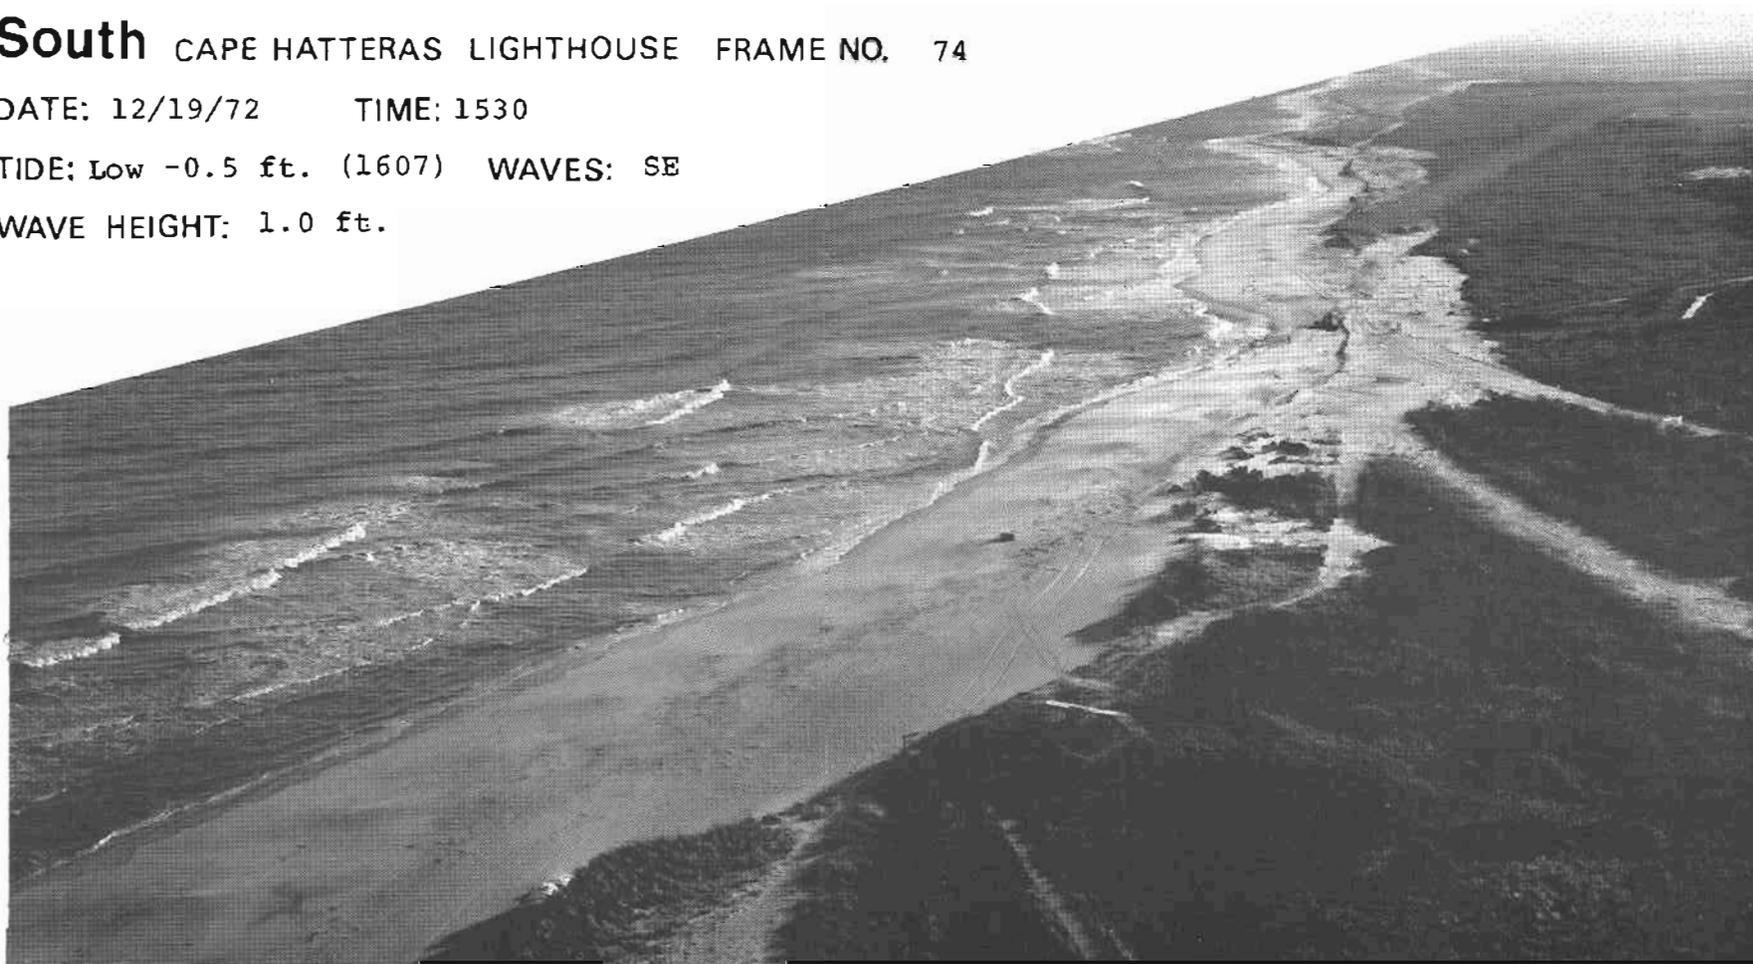
**South** CAPE HATTERAS LIGHTHOUSE FRAME NO. 74

To the south, most of the barrier dune has been lost. The truncated portions of the primary dune and the lower Loran Station dune were eroded during the fall. In duneless areas, overwash fans have been deposited. The shoreline adjacent to the four embayments in this picture is currently receding. Note the lack of offshore breakers seaward of each embayment, indicating a lower inner bar and higher waves at the shore. Scarping of the beach face within the first embayment contrasts with the depositional cusps on either side. Peat and highway pavement are being eroded with the remains littering the beach face.

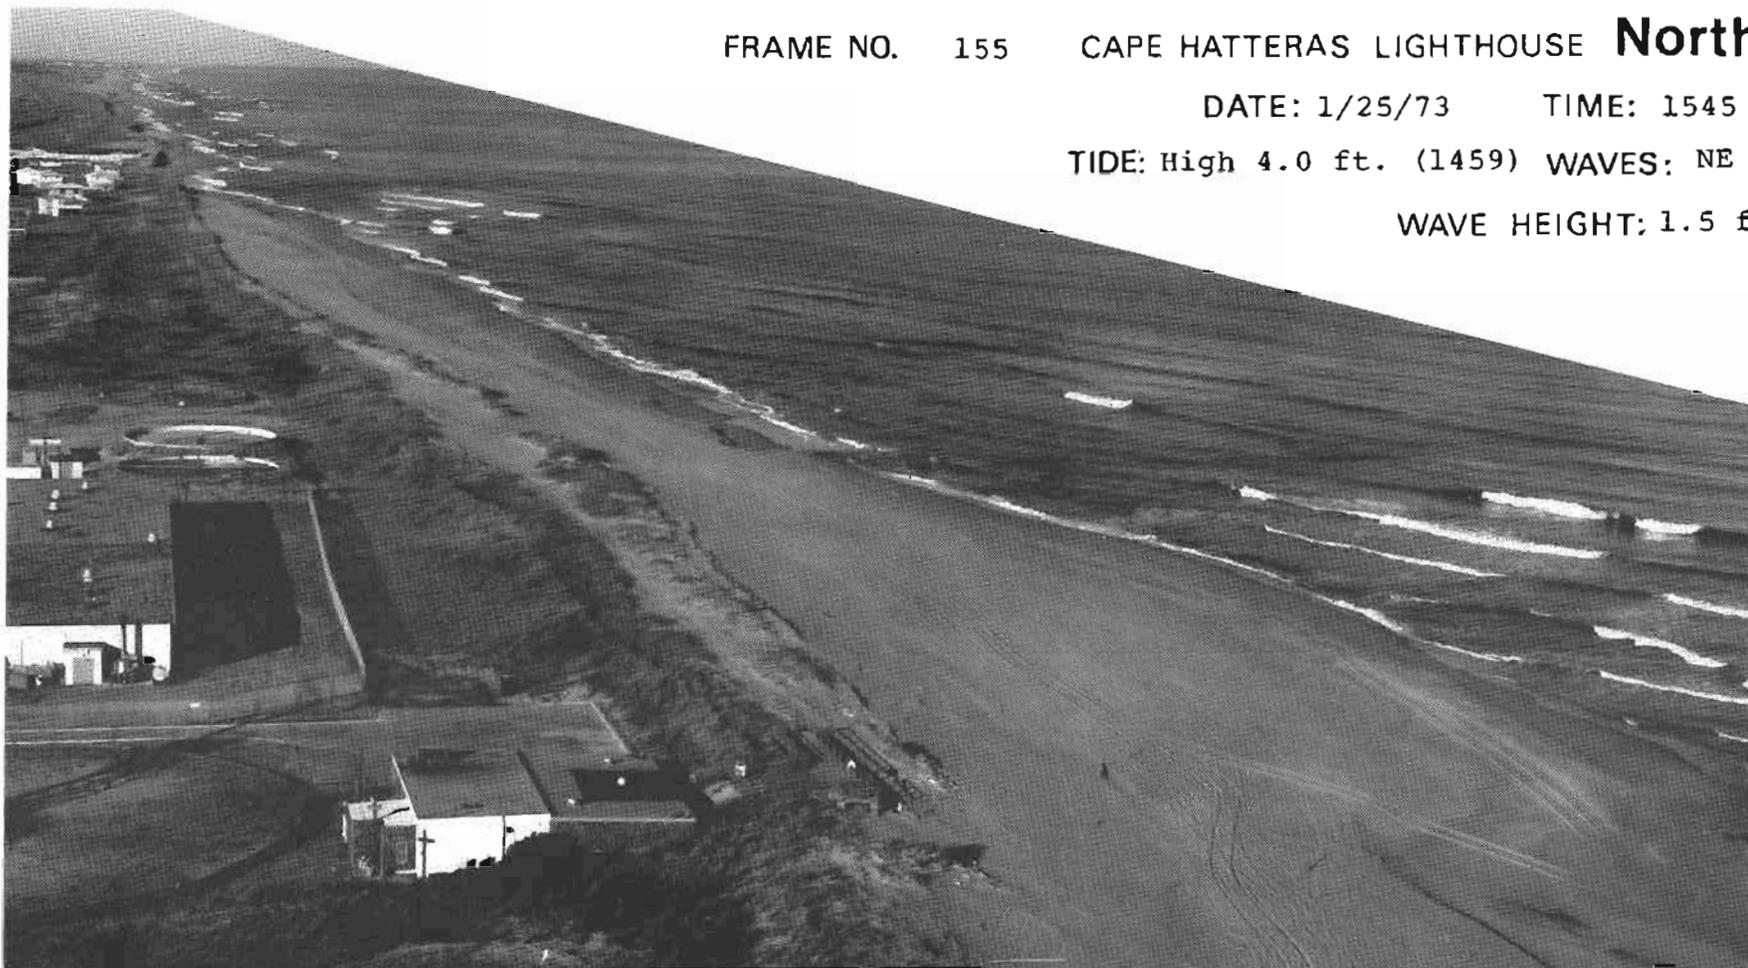
FRAME NO. 155

The 30 to 40 feet of dune left at MP42 was washed away in late December, 1973, leaving the cottages less than 100 feet from the mean sea-level shoreline. Swash from moderate waves reaches the foundations of the cottages and surges up and onto the nylon sandbag seawall. Scarping can be seen beneath the southern end of the seawall. Dune erosion to the north has continued with losses of up to 20 feet; however, these losses have been limited to the beach sections landward of embayments. Other sections of the dunes between MP42 and MP41 have shown no significant recession. The sharp westward curve of the beach near MP41 is still evident with a corresponding curve in the inner bar indicated by the position of the breaker line.

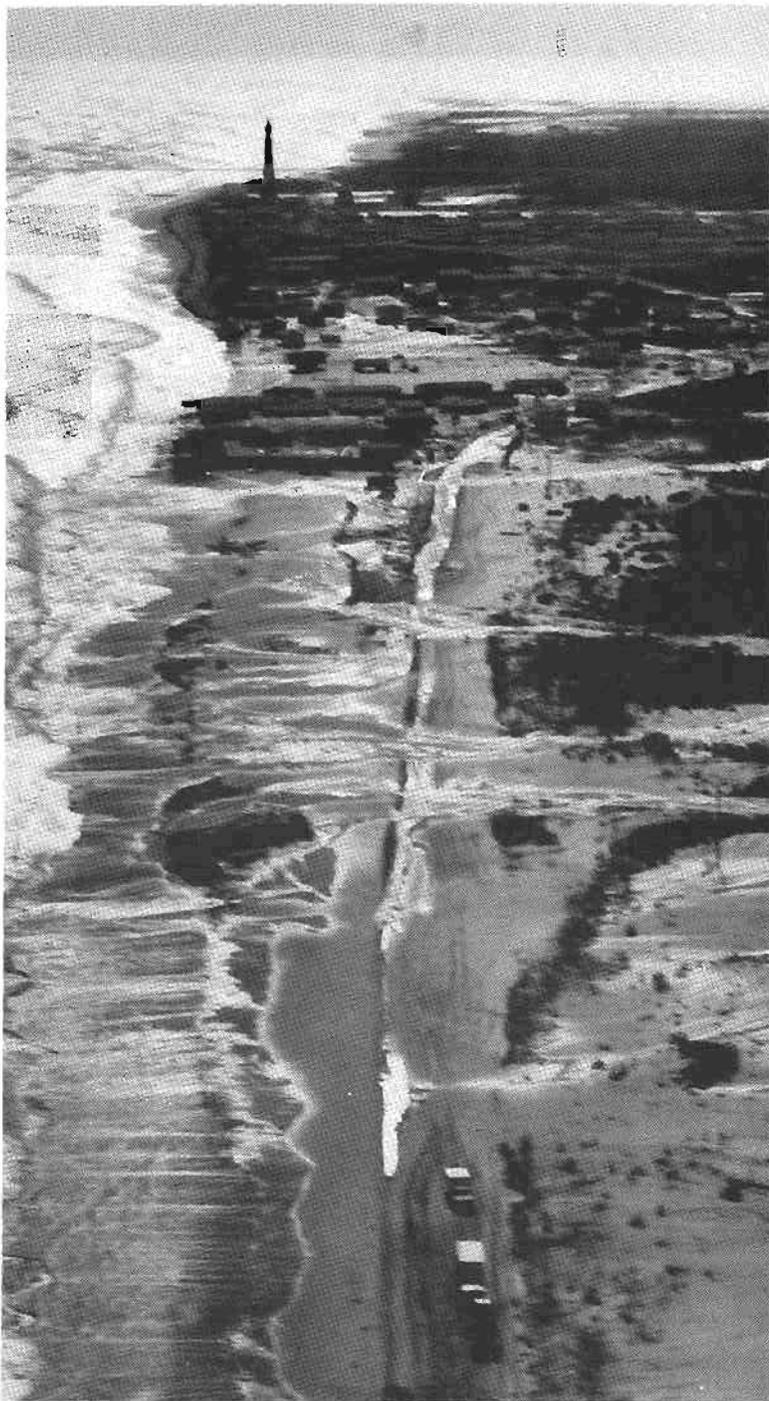
## AERIAL PHOTO OF BUXTON AND CAPE POINT

From February 10 to 13, 1973, the Lincoln's Birthday storm, one of the most severe winter storms on record, generated storm waves and surge onto the beaches of the Outer Banks. From MP42.1 to MP41.2 the barrier dune was completely destroyed, and an extensive overwash fan was deposited across this gap. In the village, the fan was up to 600 feet wide. North of Buxton, sand was carried over the island and into the sound, covering North Carolina Route 12 with up to 4 feet of sand. Approximately one-half mile of the road had to be relocated to the west. Beach loss ranged from 100 to 150 feet.

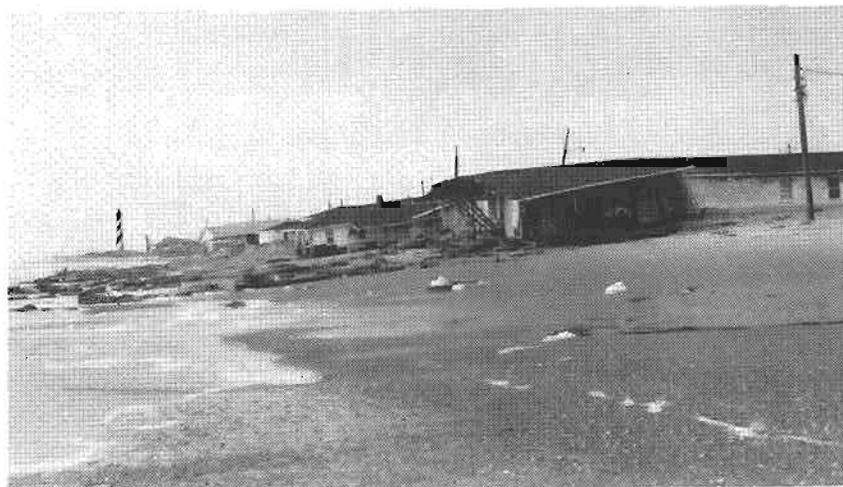
## PROPERTY DAMAGE AT MP42

Two cottages at MP42 were destroyed. A third cottage to the south (see above) was severely damaged while others received extensive wave and water damage. In addition, cottages in the path of the overwash fan had up to 4 feet of sand deposited under and around them.

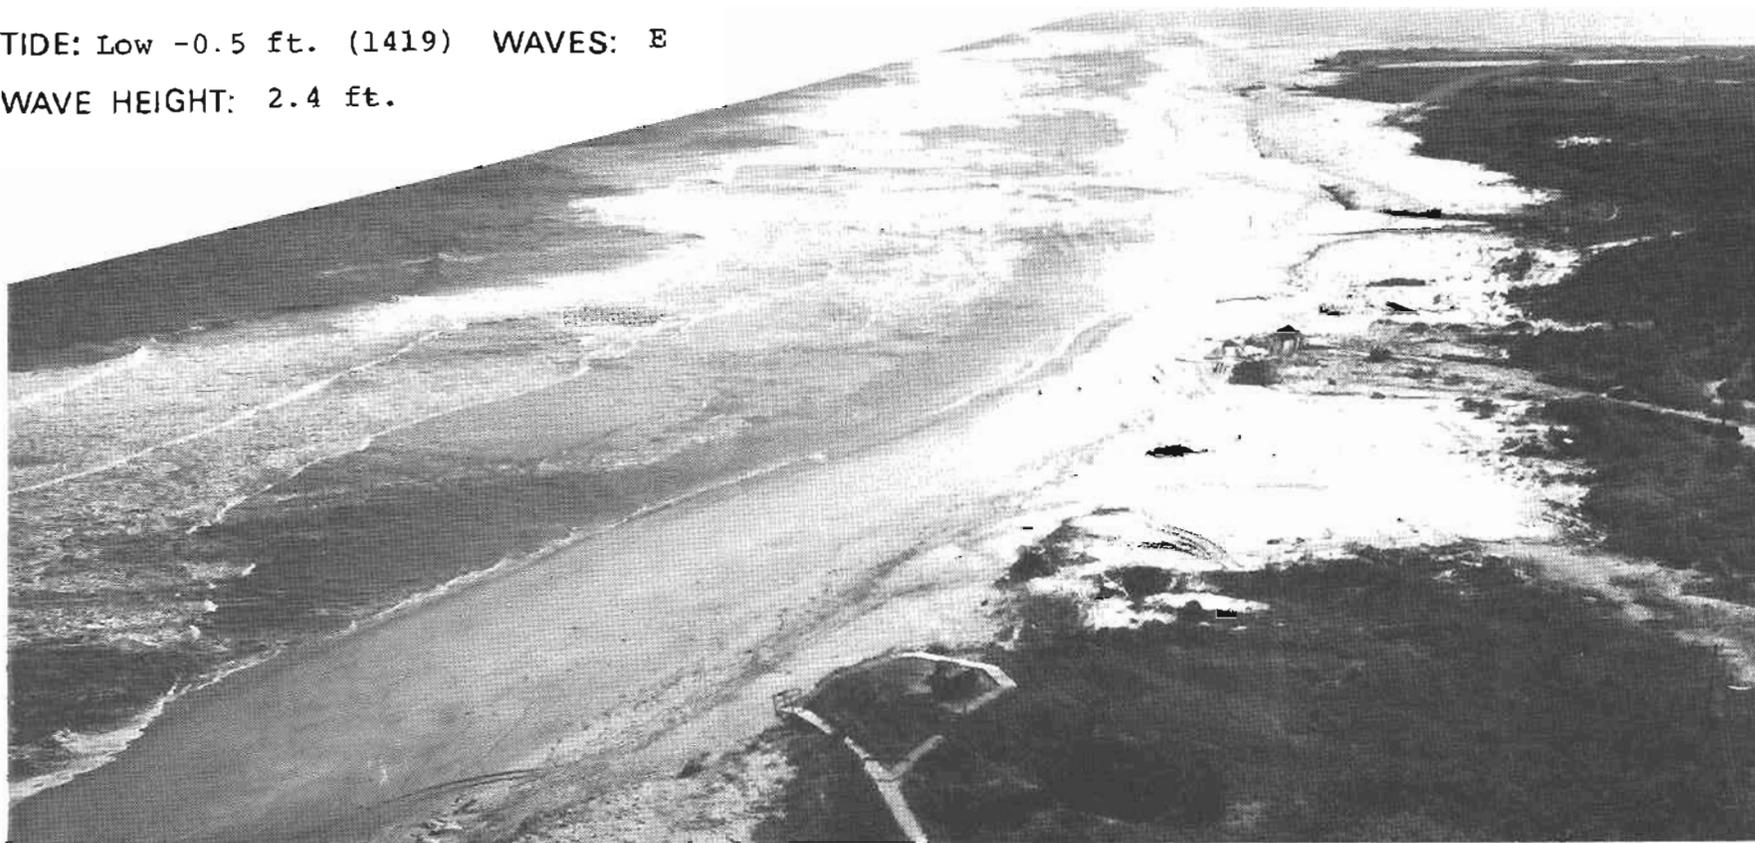
**South** CAPE HATTERAS LIGHTHOUSE FRAME NO. 209

Extensive overwash also occurred south of the old lighthouse. Over 1,000 feet of the Loran Station dune was washed away while another 600 feet of this dune was covered by the overwash deposits. Altogether over 2,000 feet of the barrier dune was destroyed or buried. In the area south of the Lighthouse overwash deposits penetrated up to 400 feet inland along one mile of the beach. A channel between the borrow pit and the ocean was established and remained open for 3 to 4 weeks. This cut occurred in the embayment seaward of the NE corner of the borrow pit.

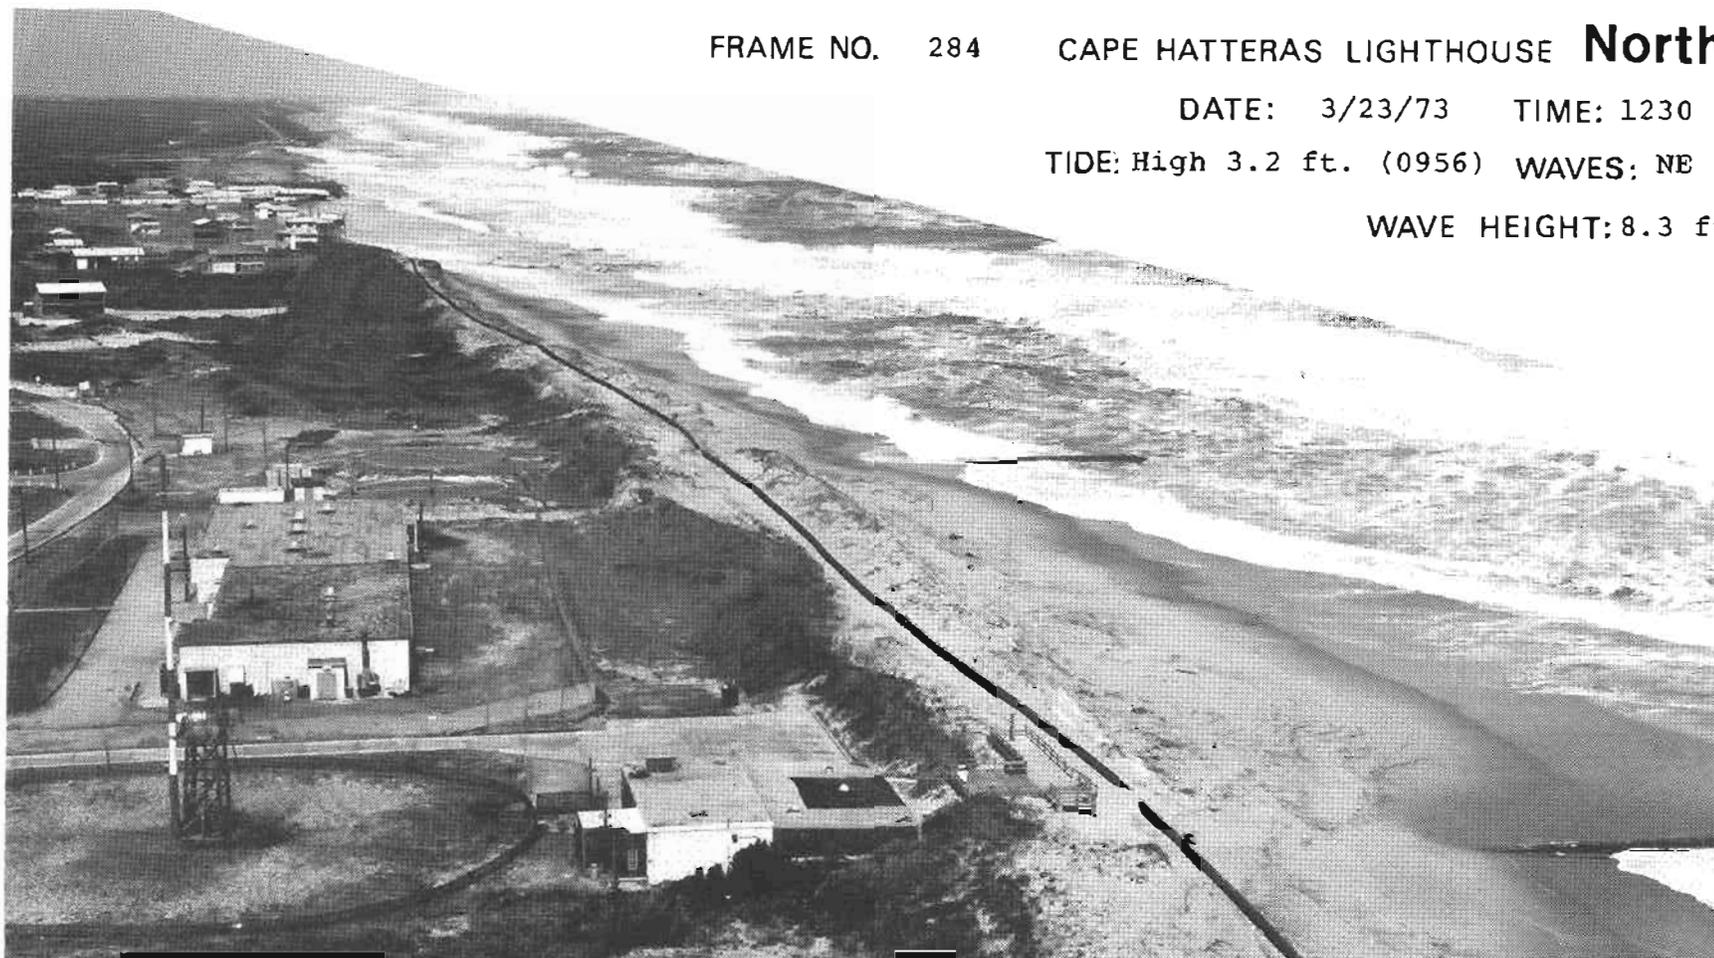
FRAME NO. 284

The northeaster occurring at the time of this photo caused additional overwash and property damage. Relocated North Carolina Route 12 was covered with water and sand, briefly stopping traffic. Additional dune destruction took place south of MP42.1, and one of the cottages damaged in February was destroyed. During high-energy conditions, the position of the outer trough and bar can be seen. Note that the outer trough, indicated by the dark area between the two areas of breaking waves, closely parallels the beach face. Fathometer profiles taken during the summer have shown a deeper trough and lower bar seaward of the areas of overwash than seen here. The extensive overwash and property damage at the north end of Buxton is at least partly a result of this offshore configuration.

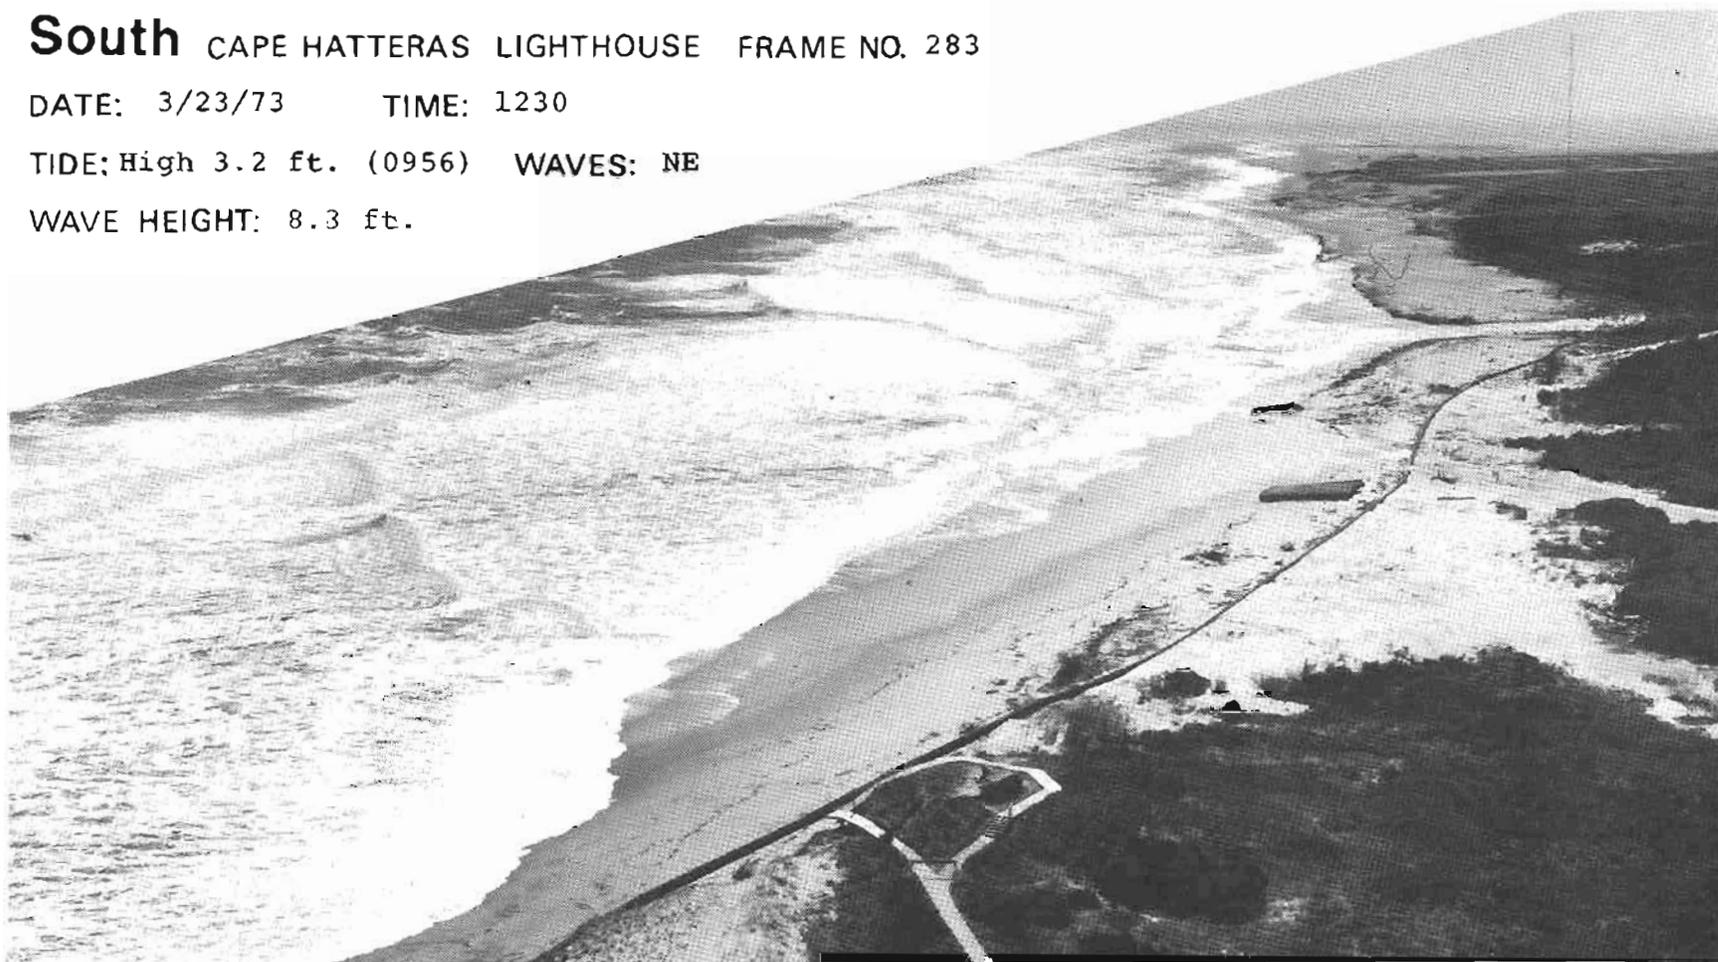
**South** CAPE HATTERAS LIGHTHOUSE FRAME NO. 283

Some of the contractor's equipment, mostly stockpiles of pipe, was scattered and buried during this storm; however the damage caused only minimal delays. Overwash occurred along the southern beach and once again in the northeast corner of the borrow pit. Over 15 feet of sand were deposited in some areas of the borrow pit by the overwash from winter storms.

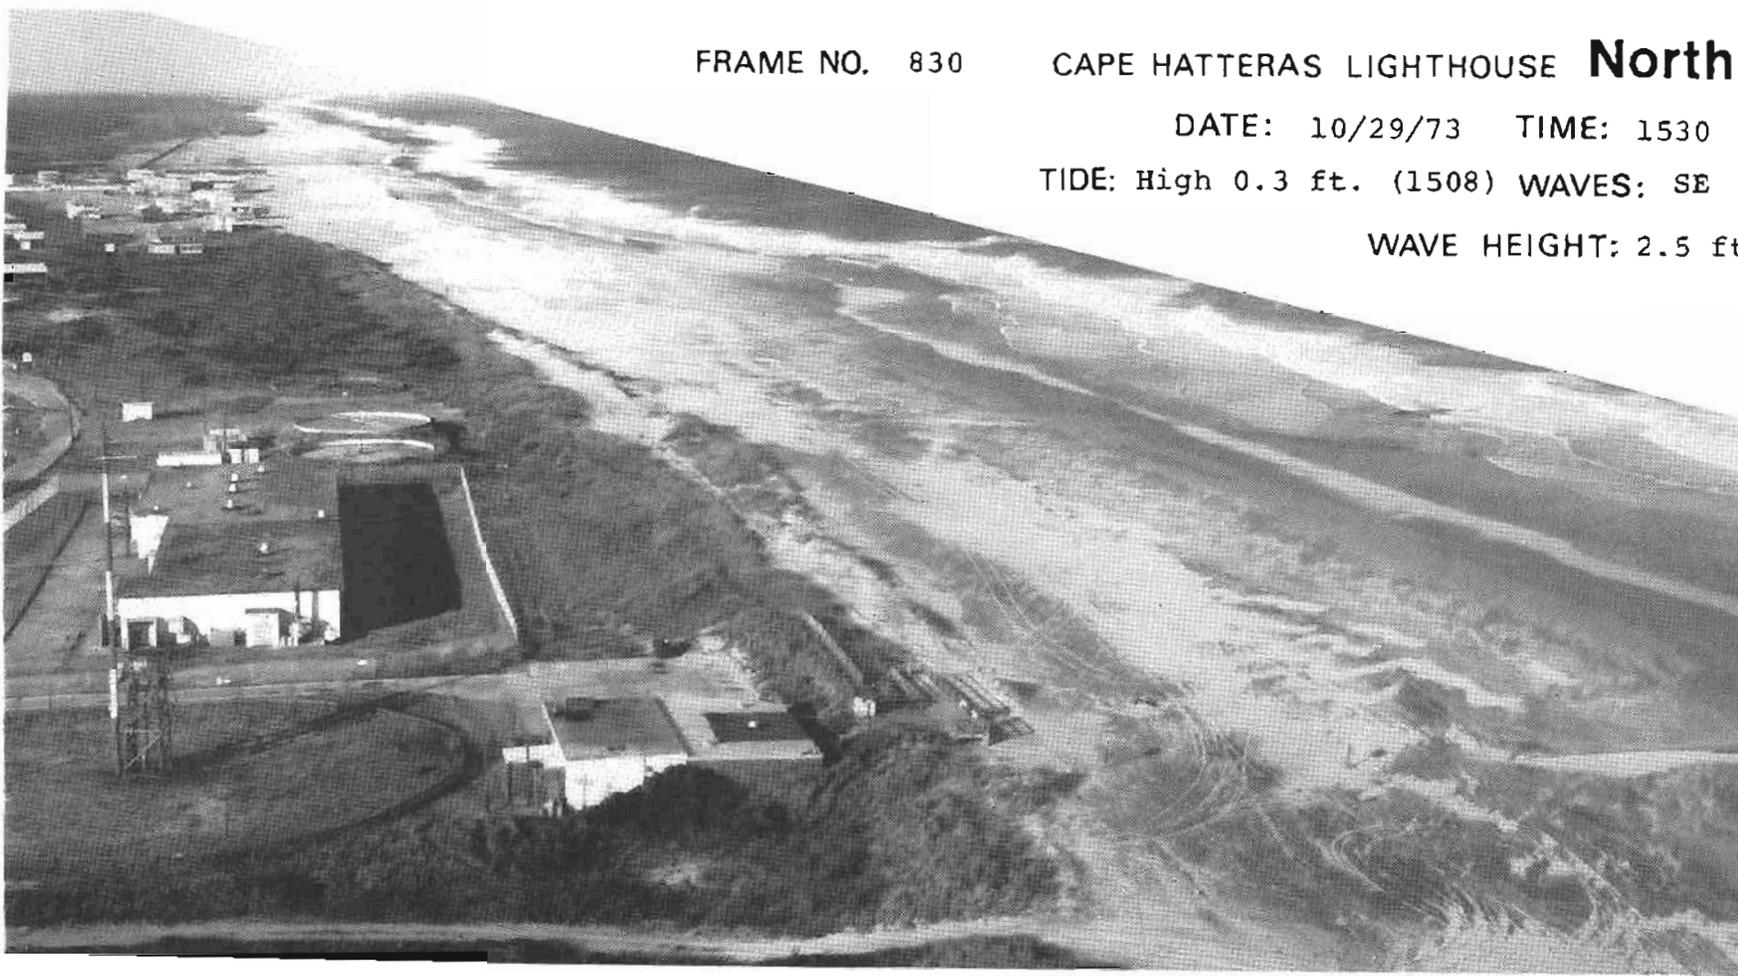
FRAME NO. 830

Tropical Storm Gilda was the first severe storm to influence the nourished beach. About 180,000 yds.<sup>3</sup> of nourishment material moved offshore or was lost; an additional 50,000 yds.<sup>3</sup> was moved from the beach face to the landward side of the fill by overwash. While Gilda caused some flooding of the highway, only minor property damage occurred. The nourished beach seems to have passed its first test. A significant percentage of the pumped material has moved from the beach face, but an inner bar has formed along the northern half-mile of the project area. Part of the "lost" material has moved into the groin cells and still more has moved offshore. By the end of November, over 50,000 yds.<sup>3</sup> of material was re-worked back onto the nourished beach.

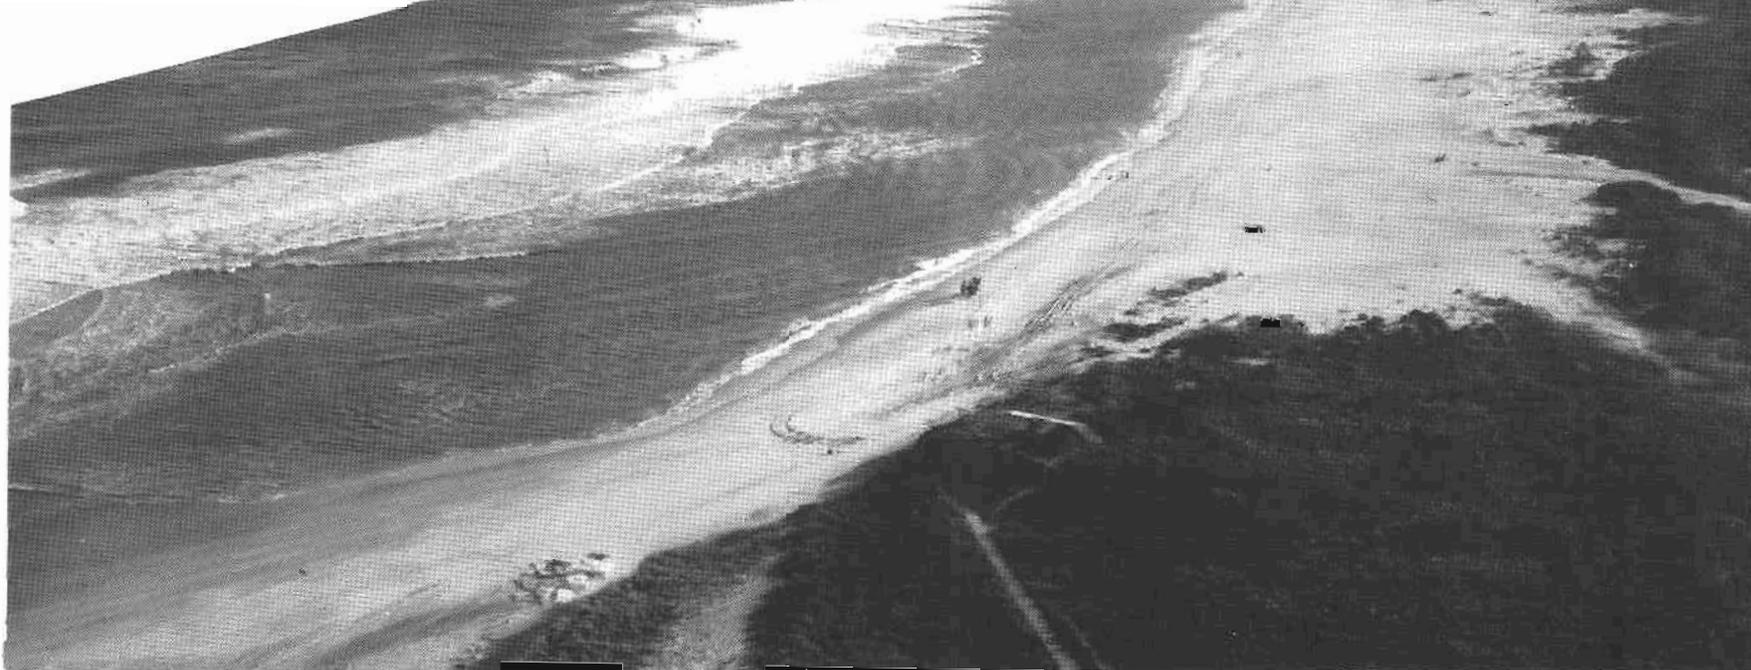
**South** CAPE HATTERAS LIGHTHOUSE FRAME NO. 831

Beach loss was greatest in the vicinity of the old lighthouse ruins. Further south there were only moderate decreases in beach width. This trend once again demonstrated the influence of the groins. Three days after the storm there is a wide inner bar which may have been formed by some of the material from the nourished beach. By the end of November, much of the material from this bar moved onshore. Transport of the sand from the nourished beaches is now beginning to have an impact on the southern beach.
