**SURFACE WATER STATION DESCRIPTION  
MONTEZUMA WELL OUTLET NEAR RIMROCK, AZ – 343853111450201  
MONTEZUMA CASTLE NATIONAL MONUMENT**

Updated by: Gwen Gerber Date: 3/22/2006

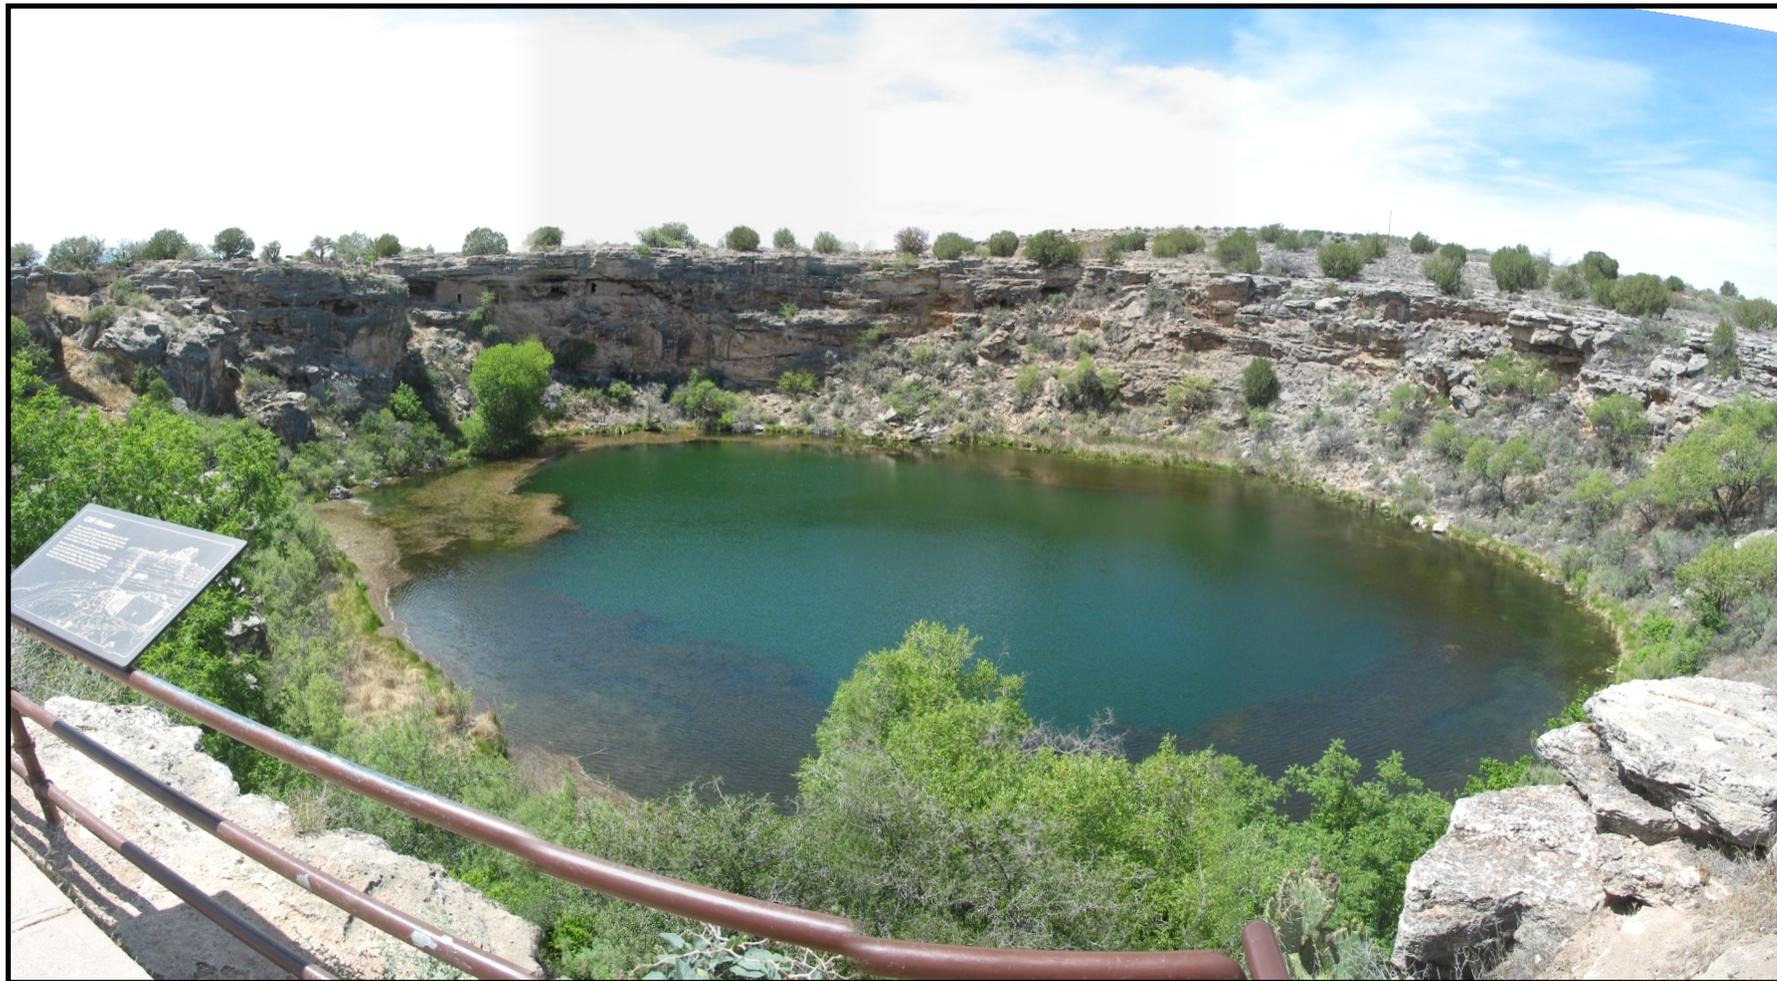
**Figure 5:** Photo of Montezuma Well from above (Photo taken 5/2004 by Paul Christensen)

The Station is located approximately 140 feet downstream of the Well Outlet in an ancient irrigation ditch (**Figures 3 and 4**). Flow originates from Montezuma Well, a 300 foot wide limnocrene (a pooled spring) fed by water rising from the confined aquifer (**Figure 5**). Water in Montezuma Well flows through a screen (also referred to as a grate) to catch leaves and debris to a small opening (also referred to as a swallet, **Figure 6**) in the rock wall on the south side of the Well. Water then travels about 180 feet horizontally and drops about 20 feet vertically before exiting from the Well Outlet (**Figure 3**) into the Outlet Ditch (Ward, 2005).

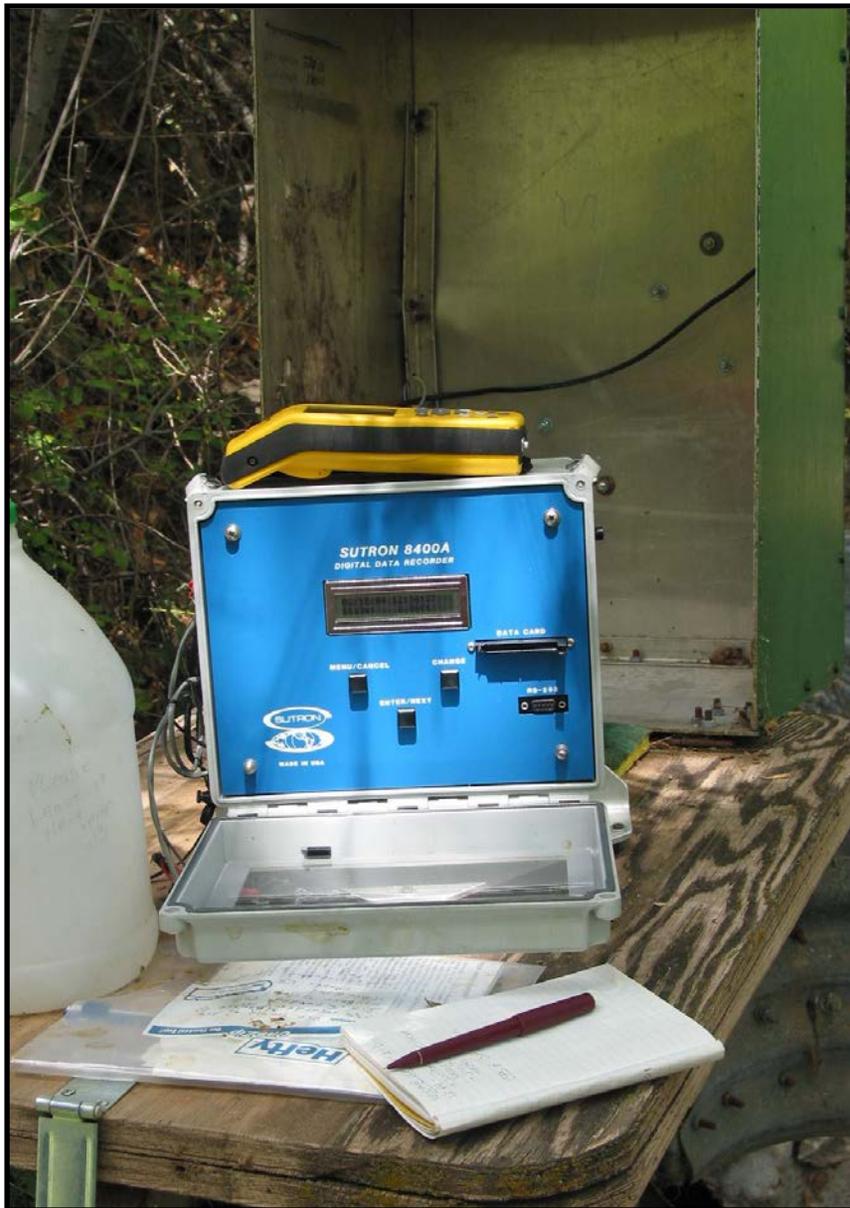
**Figure 8:** Photo of instrument shelf and Sutron 8400 (taken by Gwen Gerber in 8/2004)

A Sutron 8400 was installed in the original USGS stilling well and enclosure on February 28, 2002. NPS data collection officially began on March 1, 2002. The stilling well is a 12-inch diameter corrugated metal pipe with a plywood instrument shelf (**Figure 7**). The Sutron 8400 is an electronic datalogger combined with a float/weight system with an encoder in a single unit (**Figure 8**). This unit is connected to a 12-volt voltage regulator (replaced in Water Year 2005 due to battery problems) and charged by an attached 10-watt solar panel. A new float and float-tape were installed with the logger. There is no backup recorder. Gage height data is logged at one-hour intervals. Data are stored by the Sutron 8400 and downloaded to a data card for retrieval. MOCA staff mails the data card to the WRD for data processing and storage.

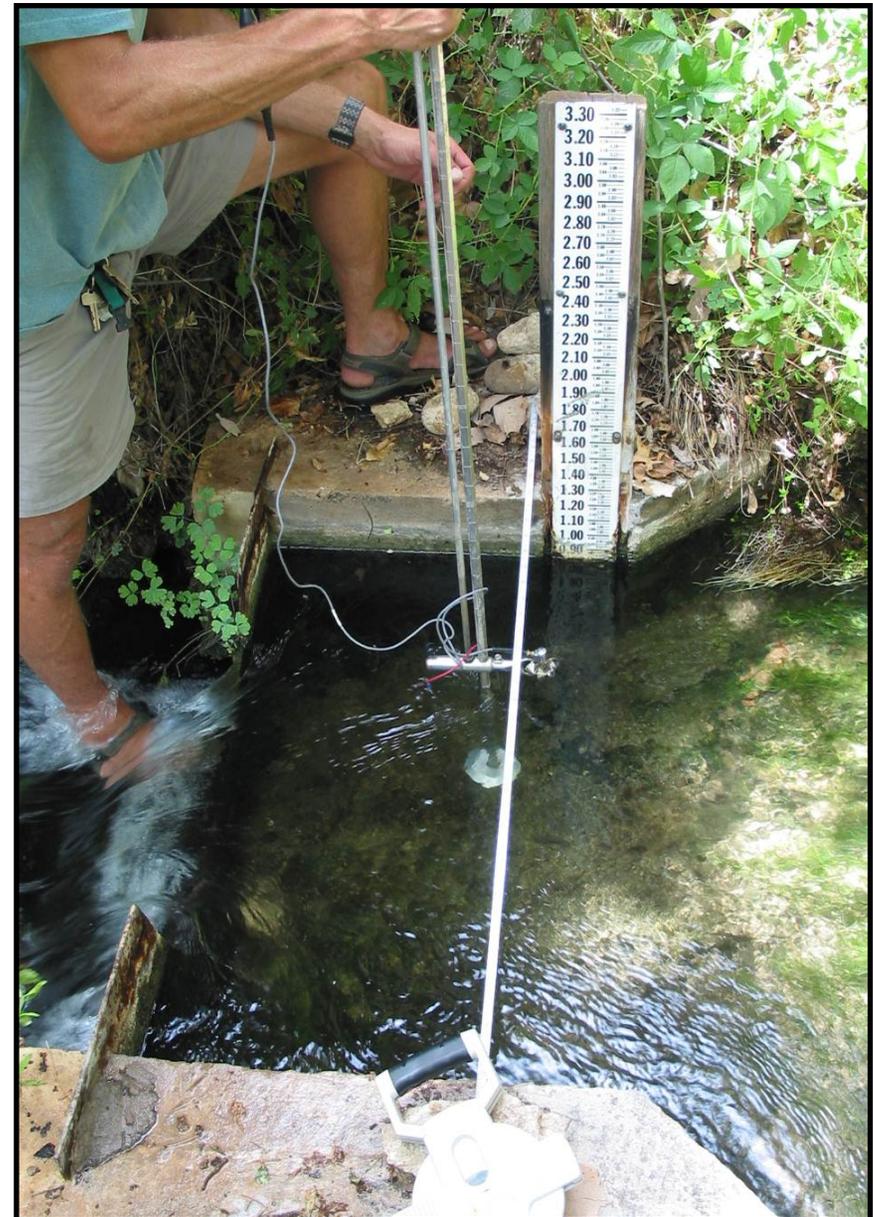
**Figure 9:** Photo of OVS and discharge measurement location (taken by Gwen Gerber in 8/2004)

The base gage is an enamelled outside vertical staff plate (OVS) mounted on a 2 x 6 inch board embedded in concrete immediately upstream of the control. The OVS reads from 0.00 to 3.35 feet. The OVS currently in use is the original USGS gage.

All wading discharge measurements are taken at a cross-section just downstream of the Station's staff gage (**Figure 9**). The cross-section has uniformly distributed flow, a smooth channel bottom, and concrete banks. A pygmy meter is used to measure discharge with section widths of 0.20 feet. Only 15 verticals are measured because the channel width is fixed at 3.1 feet. Since the channel is rectangular, bank coefficients are used when calculating total discharge (Rantz, 1982). Algae growth within the channel and vegetation growth both in and adjacent to the channel likely explains measurement variation from the rating curve. Measurement accuracy is good.
