# 1973 BUXTON BEACH NOURISHMENT PROJECT

AN ANNOTATED PHOTOGRAPHIC ATLAS

CAPE HATTERAS NATIONAL  
SEASHORE  
NORTH CAROLINA

FEBRUARY 1974

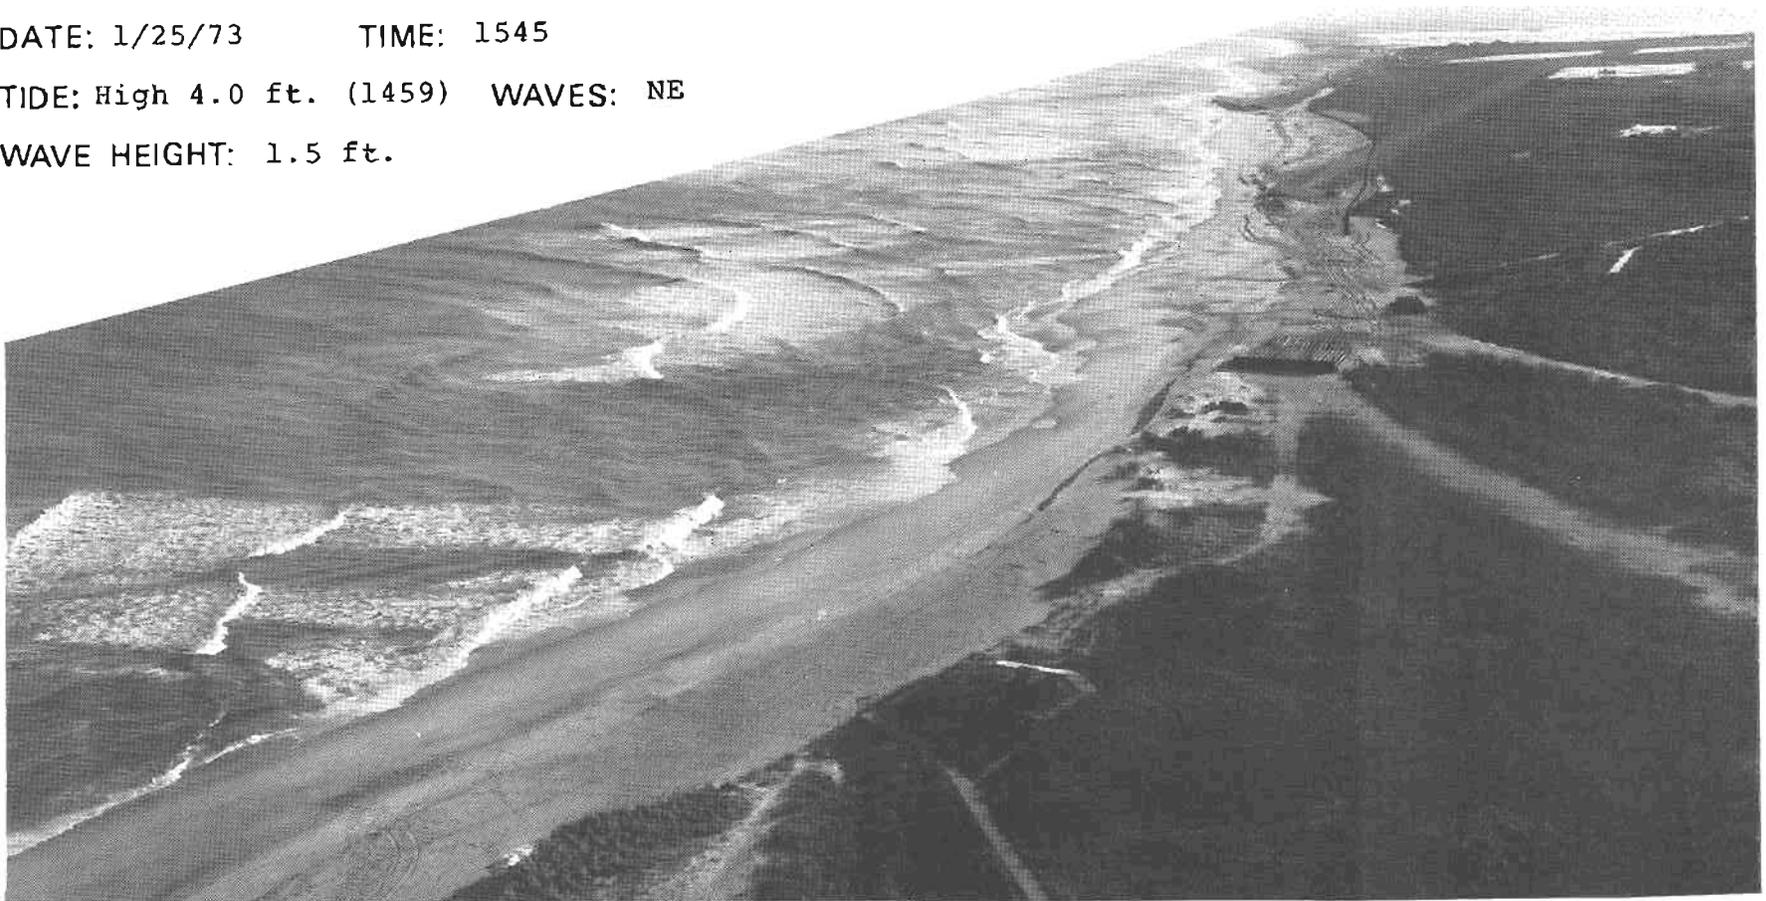
**South** CAPE HATTERAS LIGHTHOUSE FRAME NO. 156

Construction of almost one mile of the 24-inch welded discharge line from the main boosters has been completed. Only minor erosion of the truncated dunes has occurred; however, these dunes are vulnerable to erosion and scarping during moderate seas. The northern embayment in the previous photograph has been filled and is experiencing continued accretion, as evidenced by the beach cusps. A new embayment is developing to the north. Again, note the lack of beach cusps or an offshore breaker zone and the scarping of the beach face within the embayment.

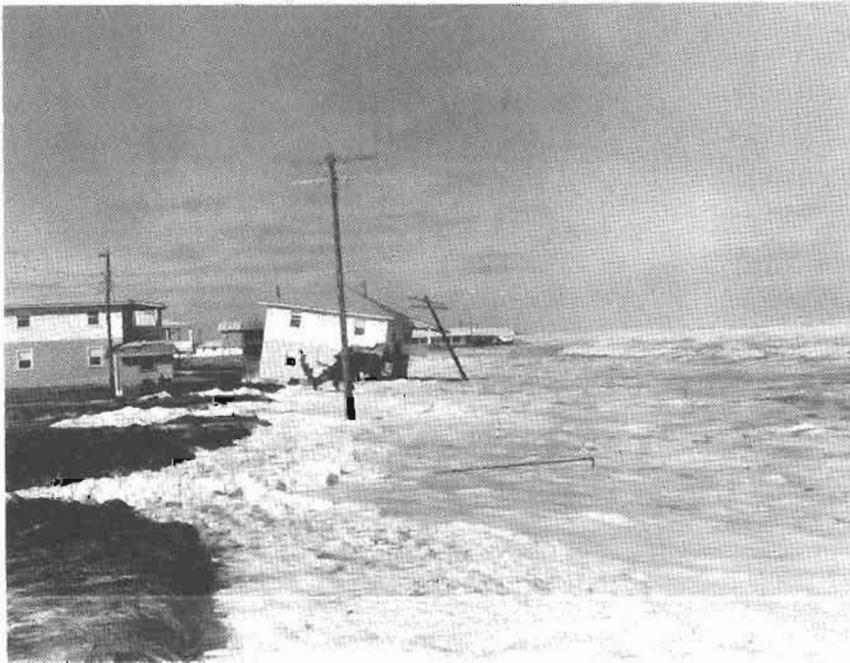
FRAME NO. 185

Two cottages at MP42 were destroyed. A third cottage to the south (see above) was severely damaged while others received extensive wave and water damage. In addition, cottages in the path of the overwash fan had up to 4 feet of sand deposited under and around them.

The sandbags in front of the motels provided little protection: Several of these two-ton bags were washed 100 to 200 feet offshore. Extensive damage occurred to the ocean-front units of each motel. One three-room unit was moved 20 to 30 feet inland. The motels are now less than 100 feet landward from the mean sea-level shoreline.

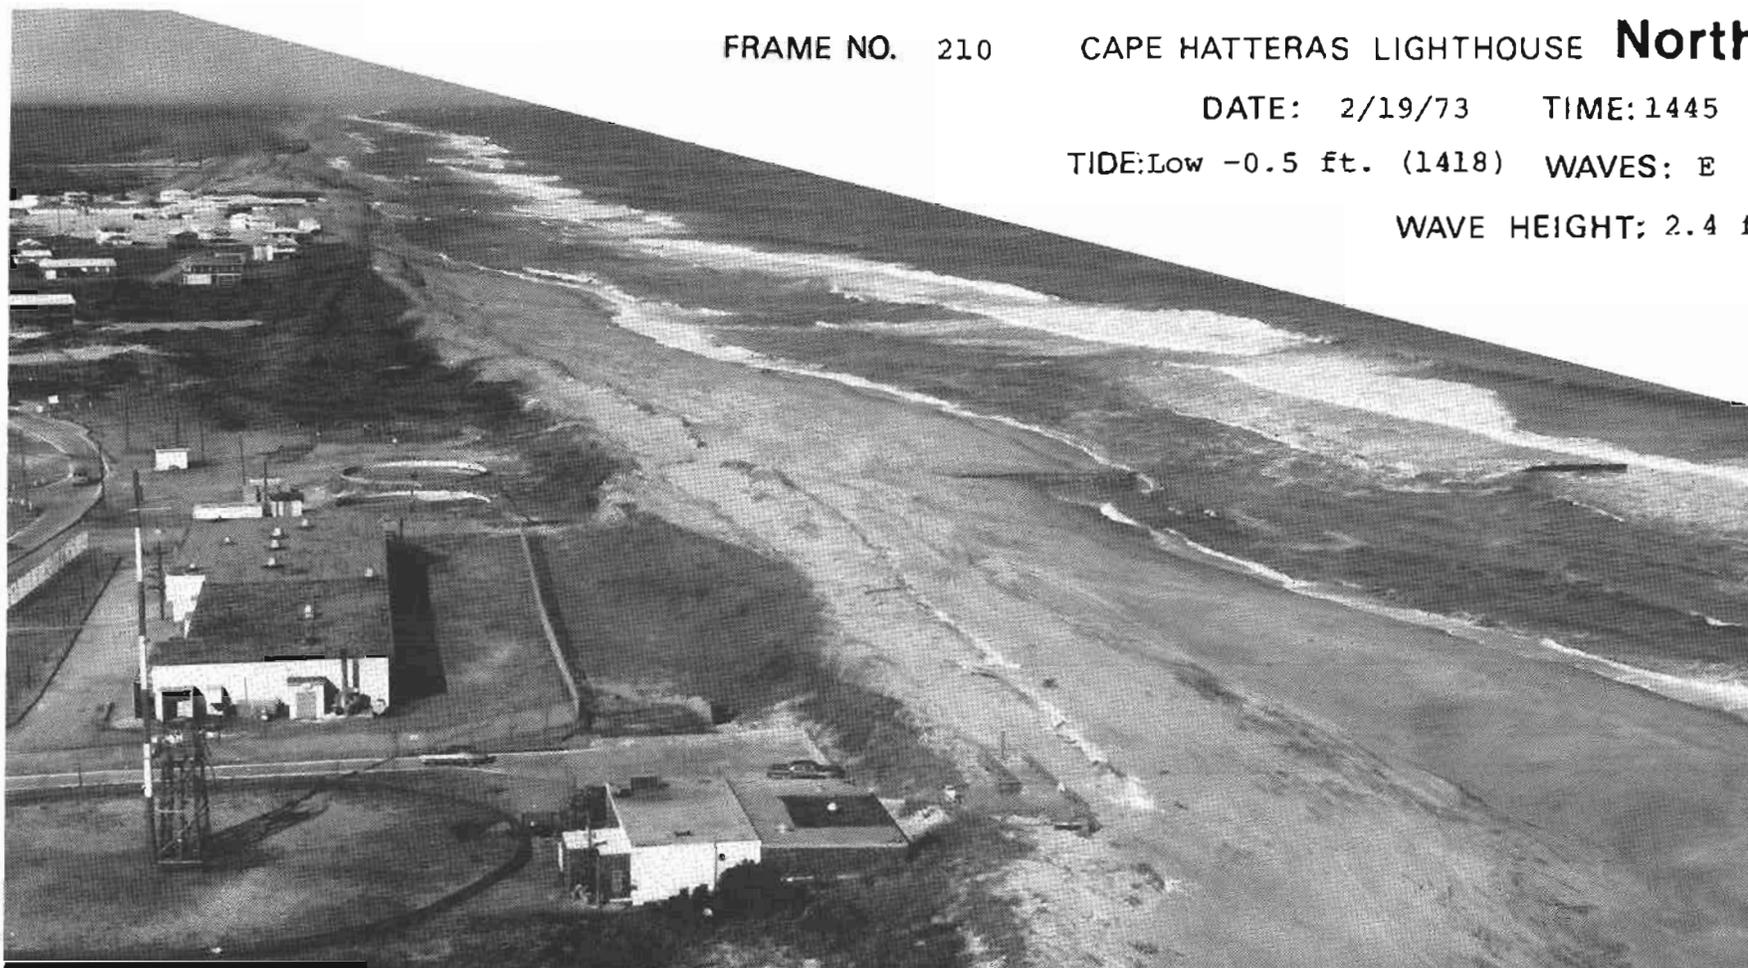
FRAME NO. 210

Less than one week after the Lincoln's Birthday storm, significant deposition had occurred on the beach face. The beach at MP41 was 50 feet wider than before the storm and little dune erosion had occurred. South of MP42.1 dune erosion was less prominent because of the groins. Although water and sand washed onto and over the dunes behind the groins, only minor damage occurred. The middle groin cannot be seen in this picture because the camera position has been shifted slightly to the left.

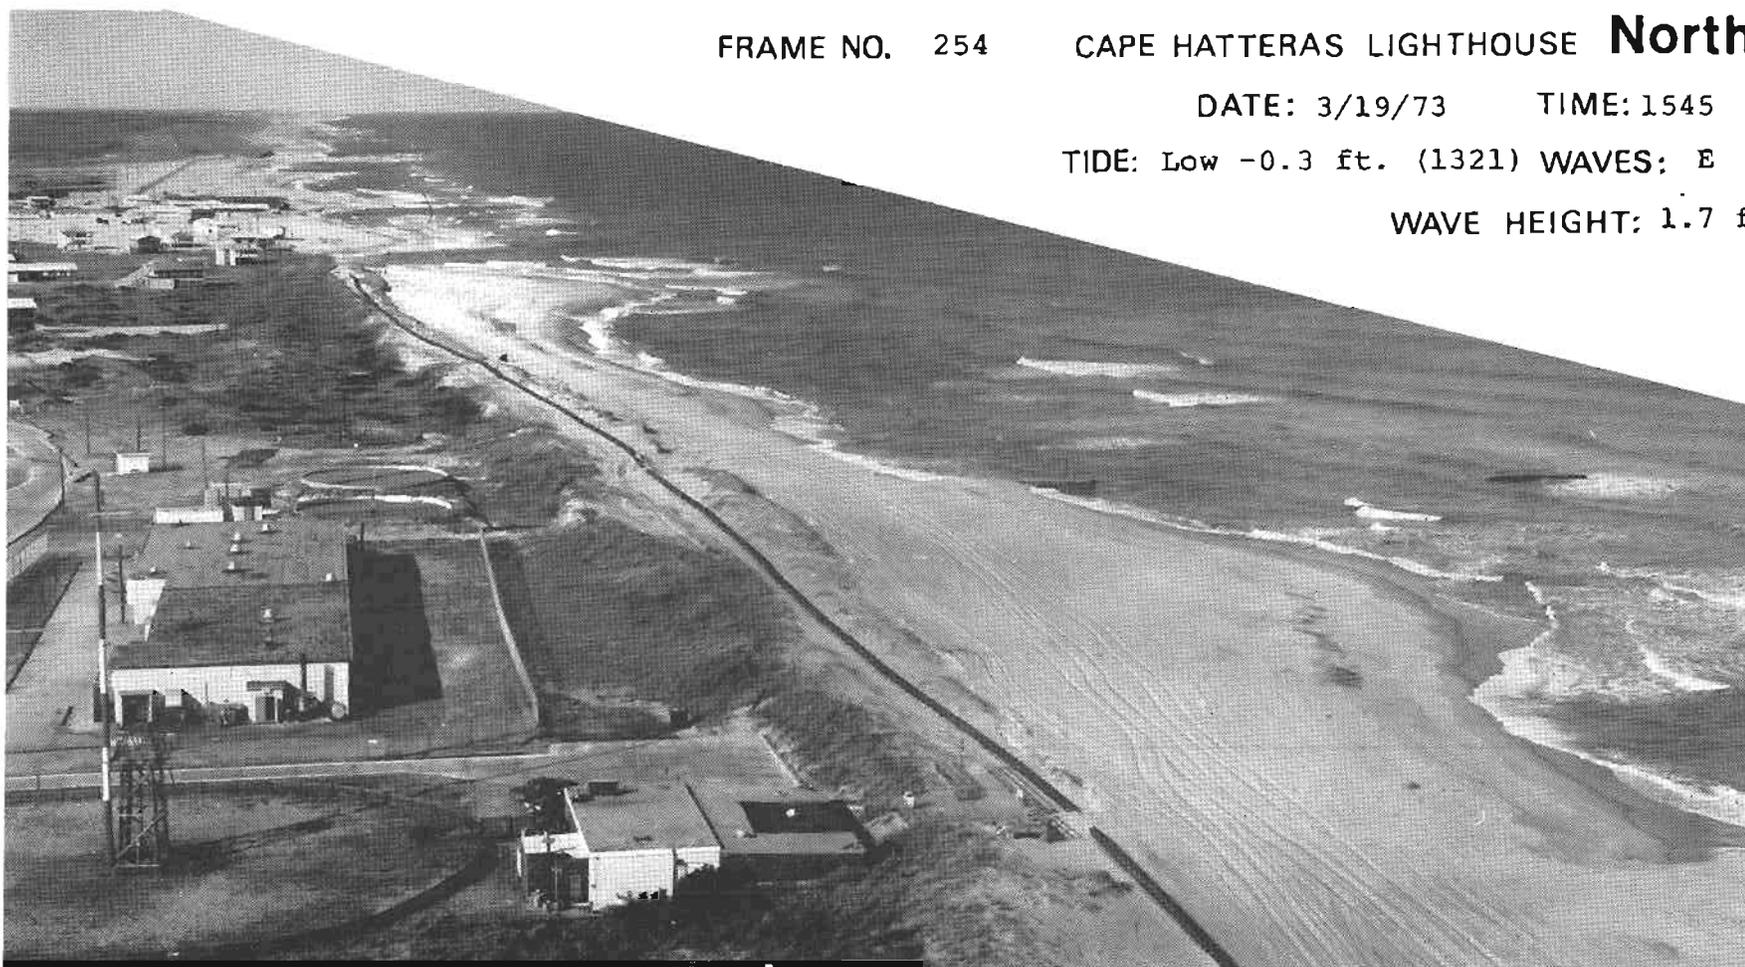
FRAME NO. 254

Because of the major change in beach conditions resulting from the February storms, the original north-to-south pumping plan had to be changed. Instead nourishment was to start near station 2230+00 and proceed northward. Pipe had been laid to the starting point, and pumping was expected to start within a few days. Dune erosion had continued at the southern embayment: 200 feet of dunes had been eroded since mid-February. A second embayment threatens the motels and there are two other deep embayments north of the motels.

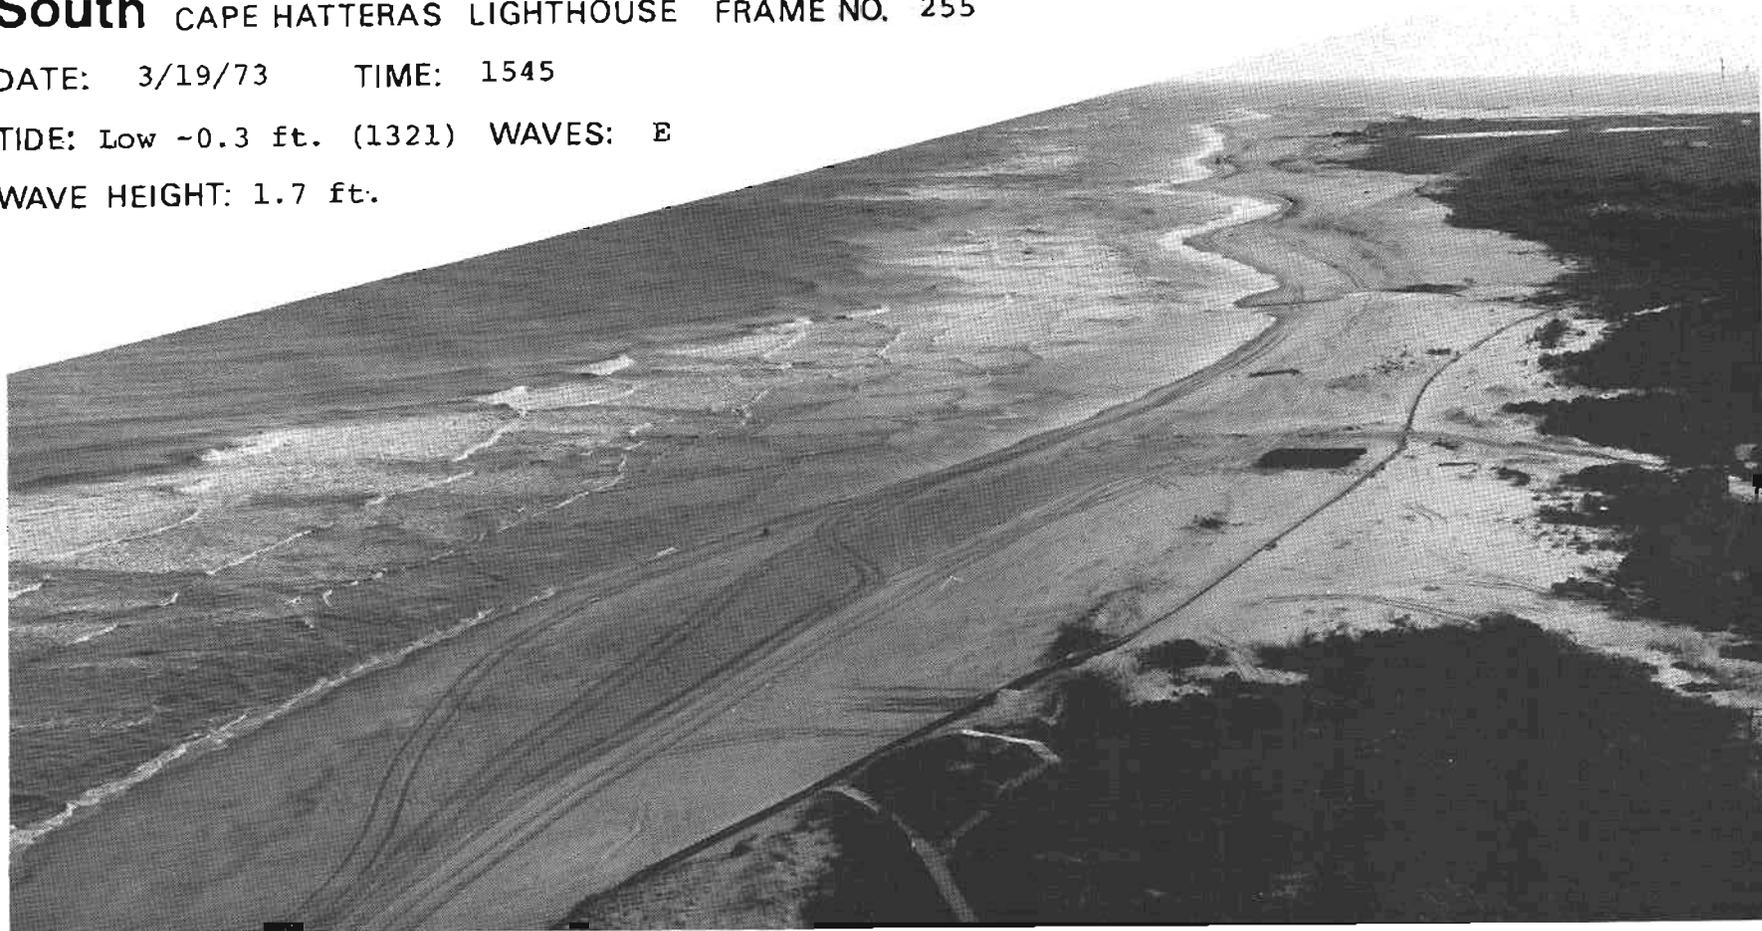
**South** CAPE HATTERAS LIGHTHOUSE FRAME NO. 255

Accretion has occurred along much of the shoreline south of the Lighthouse. The beach is 75 feet wider adjacent to the old lighthouse ruins, and the channel to the borrow pit has filled, building beach elevation as high as 5 feet and beach width as broad as 250 ft. In spite of the general trend of accretion, some erosion has taken place in the two embayments seen in the foreground. The channel to the marsh cut during the Lincoln Birthday storm is still draining and has built a small delta in the first embayment. A wide offshore bar extends for over one-third of a mile south of the groins.

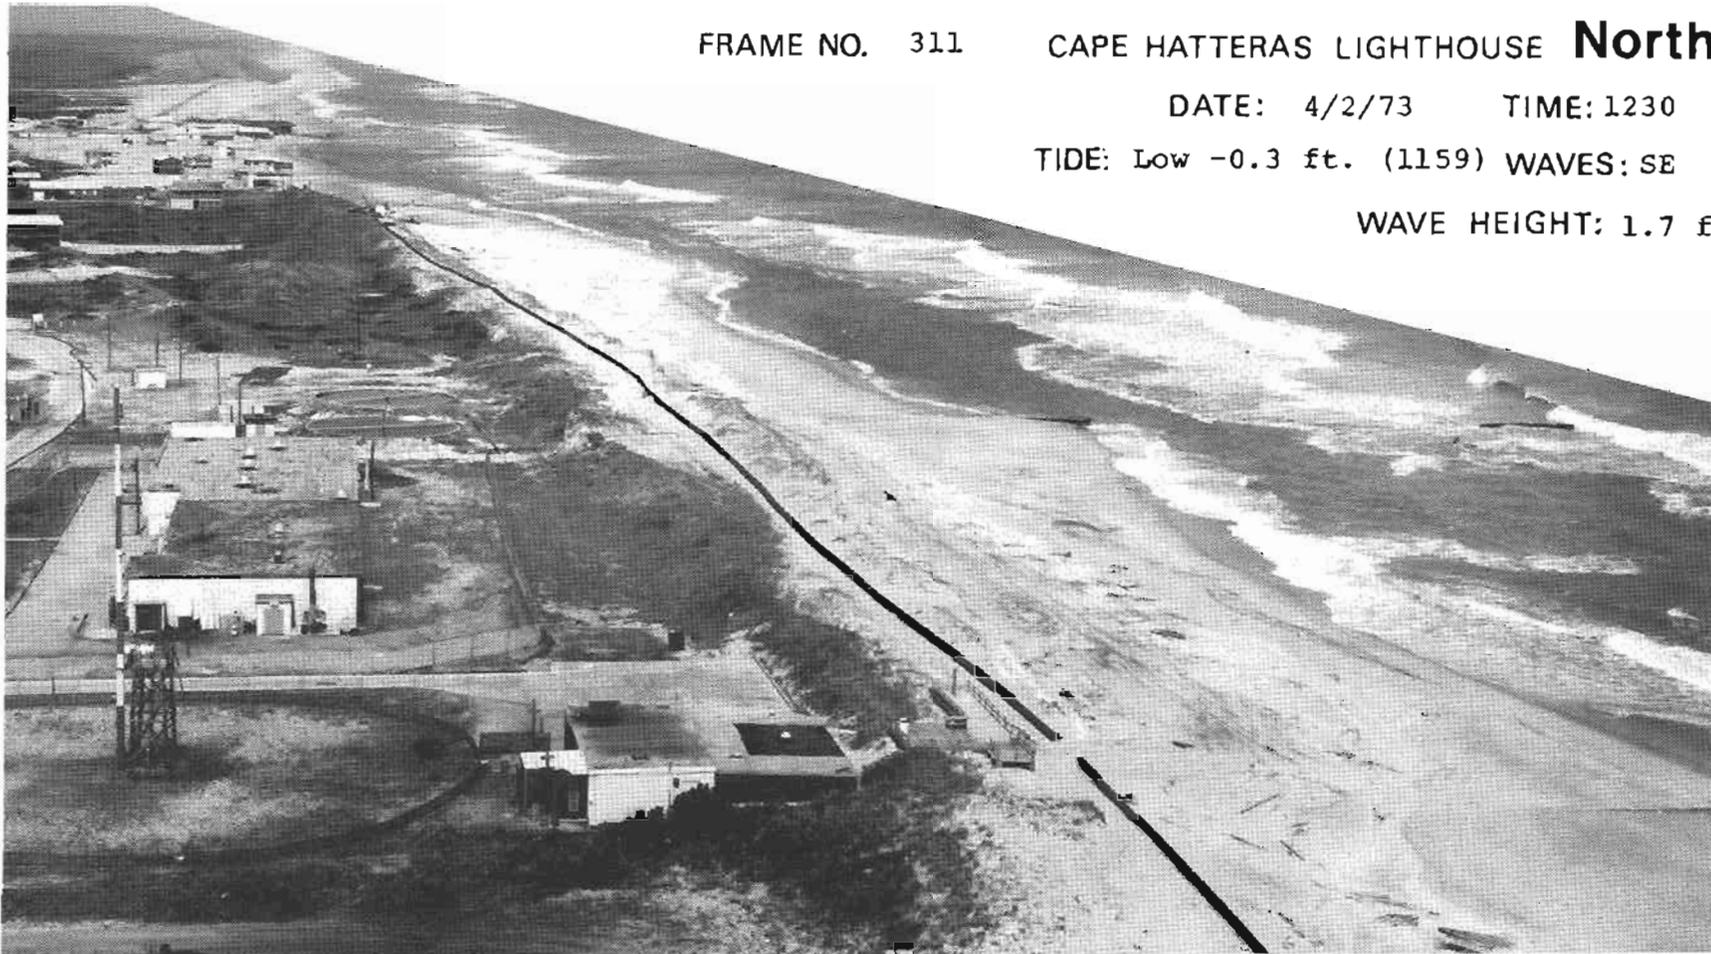
FRAME NO. 311

Five days after the 1973 beach nourishment project began, the outlet had been moved 100 feet north and pumping began on the south side of the large embayment at MP42. A peat layer up to 2 feet thick was exposed along the entire beach face of this embayment and has been carbon-dated at  $580 \pm 205$  years B.P. Recent storms deepened this embayment and deposited a wide bar offshore. This bar inhibited later beach-face erosion and facilitated filling the embayment by causing a decrease in the loss of nourishment material.

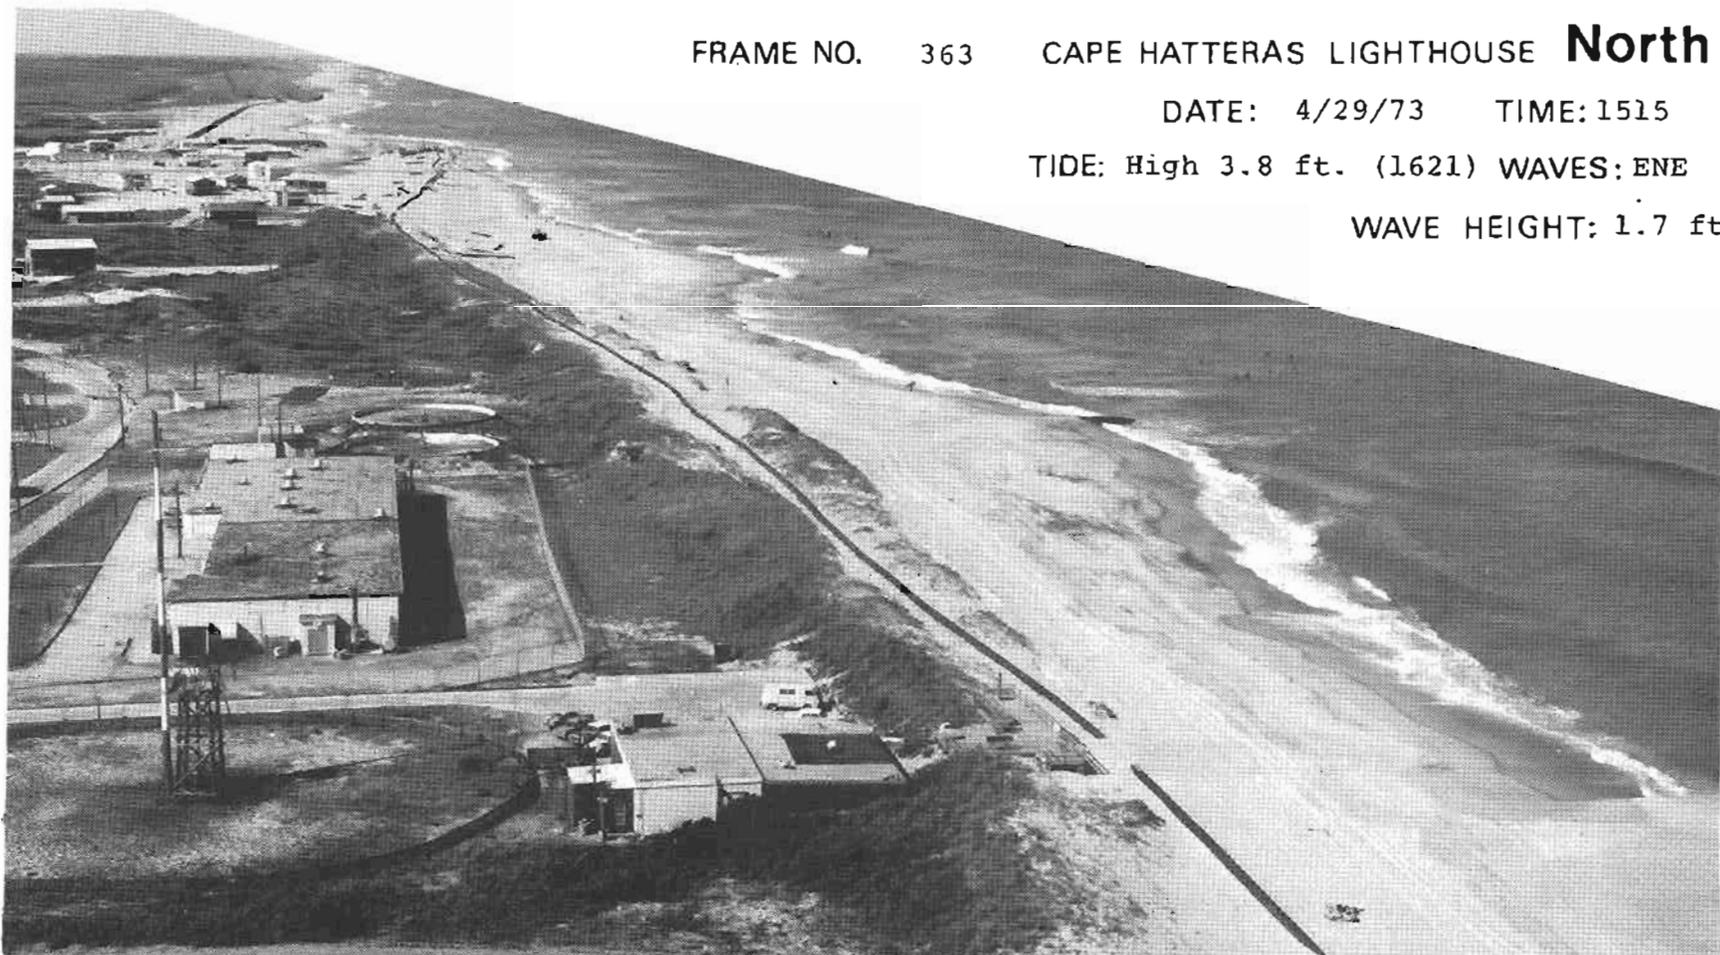
FRAME NO. 363

With over 2,000 feet of nourished beach, a protective beach was established in front of the private property. Continued rapid movement of the discharge outlet to the north was expected to give added protection to North Carolina Route 12. Beach erosion continues in the two embayments north of the outlet although waves have been low. The width of the nourished beach has been increased as much as 260 feet with relatively little material loss. In general, there is an initial loss of 20 to 30 feet of beach once a section is out of the influence of the discharge. After this initial loss, the section appears to stabilize.

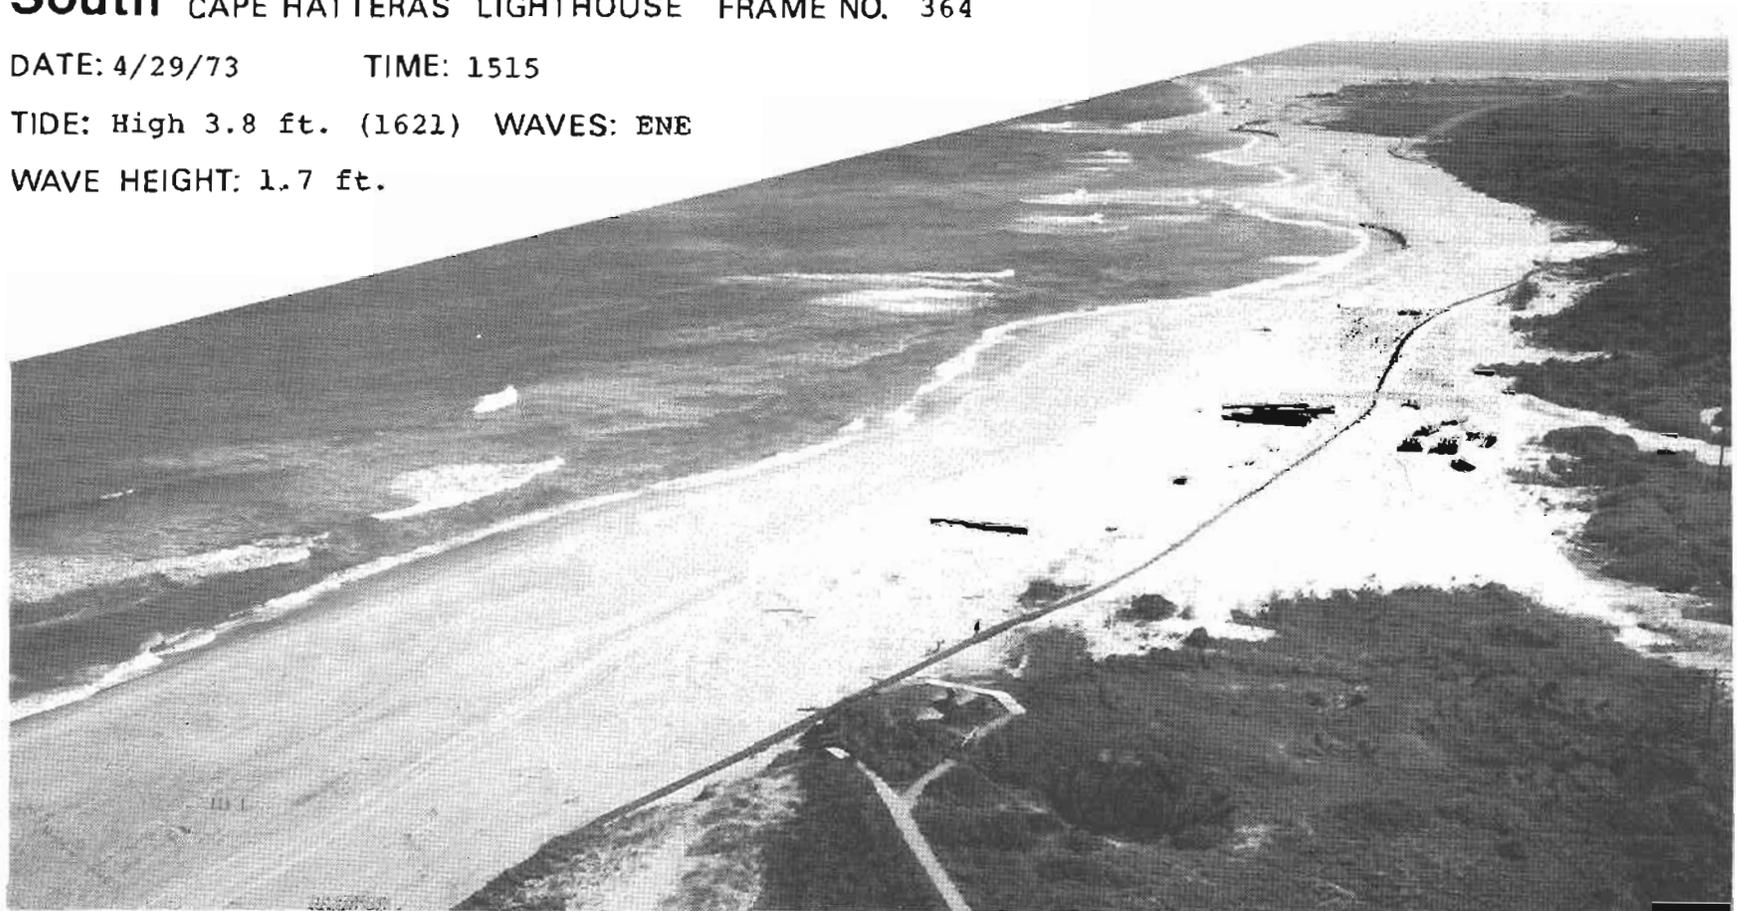
**South** CAPE HATTERAS LIGHTHOUSE FRAME NO. 364

Accretion in front of the old lighthouse ruins continues as a result of the change to SE summer waves. Erosion is still occurring at the head of the three embayments. Nearer Cape Point two wider embayments can be seen. The point separating these two features is seaward of the NE corner of the borrow pit in approximately the same location as the February overwash channel. This is an increase in beach width of over 300 feet.

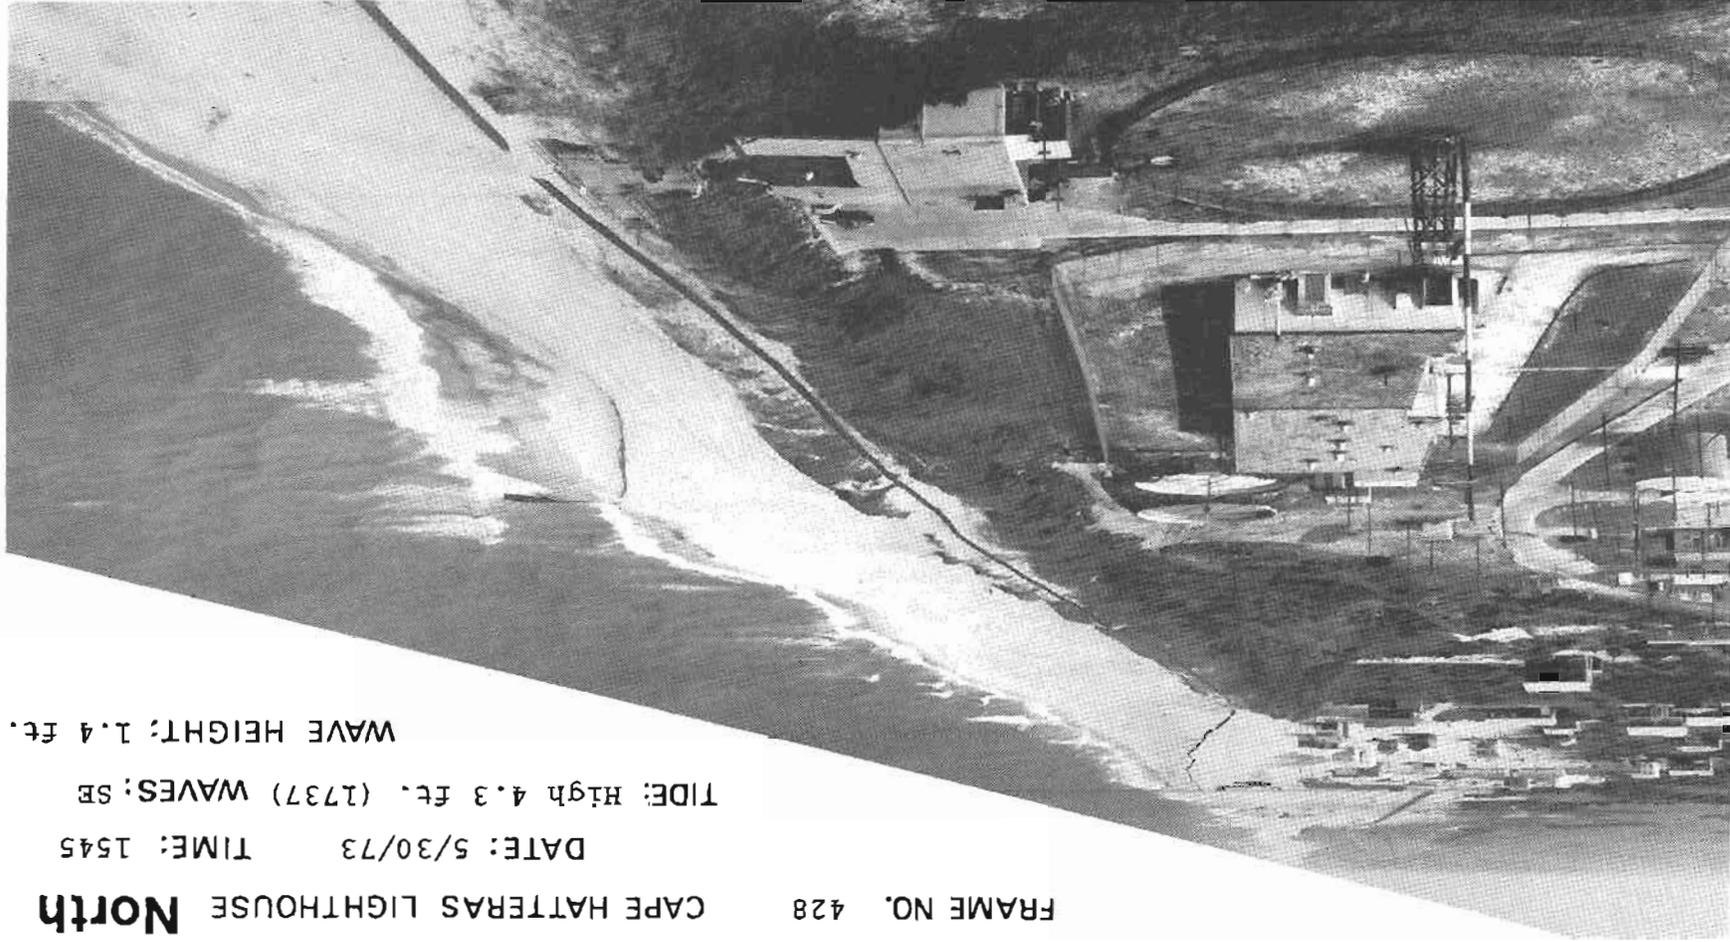
FRAME NO. 428 CAPE HATTERAS LIGHTHOUSE North

By the end of May over three-fourths of a mile of shoreline had been nourished, establishing a protective beach along the vulnerable north shoreline. All of the embayments north of Buxton were filled and did not appear to be reforming. Because of the relatively small loss of nourishment material, a straight shoreline paralleling the discharge line has been produced.

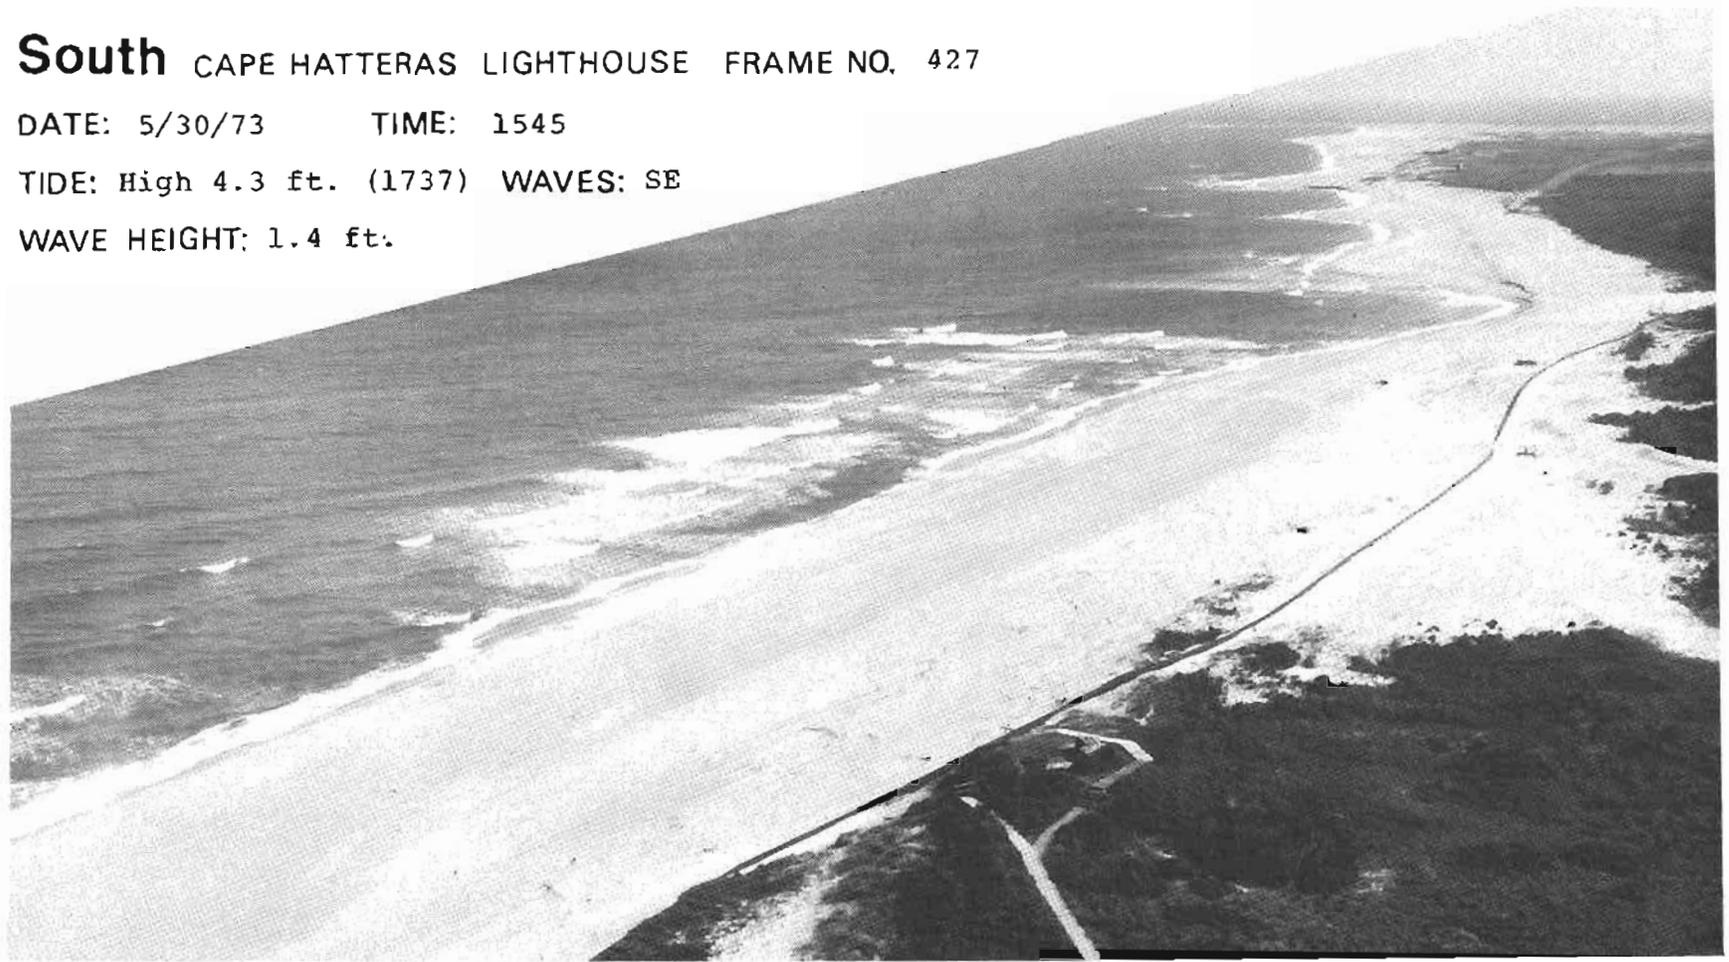
**South** CAPE HATTERAS LIGHTHOUSE FRAME NO. 427

Along the southern beach relatively little change has taken place. An accretion trend continues except in the embayments where the position of the shoreline has remained unchanged. The shoreline is highly embayed with small waves breaking adjacent to each embayment. The spatial relationship between shoreline embayments, overwash fans, and shoreline recession is clearly evident.

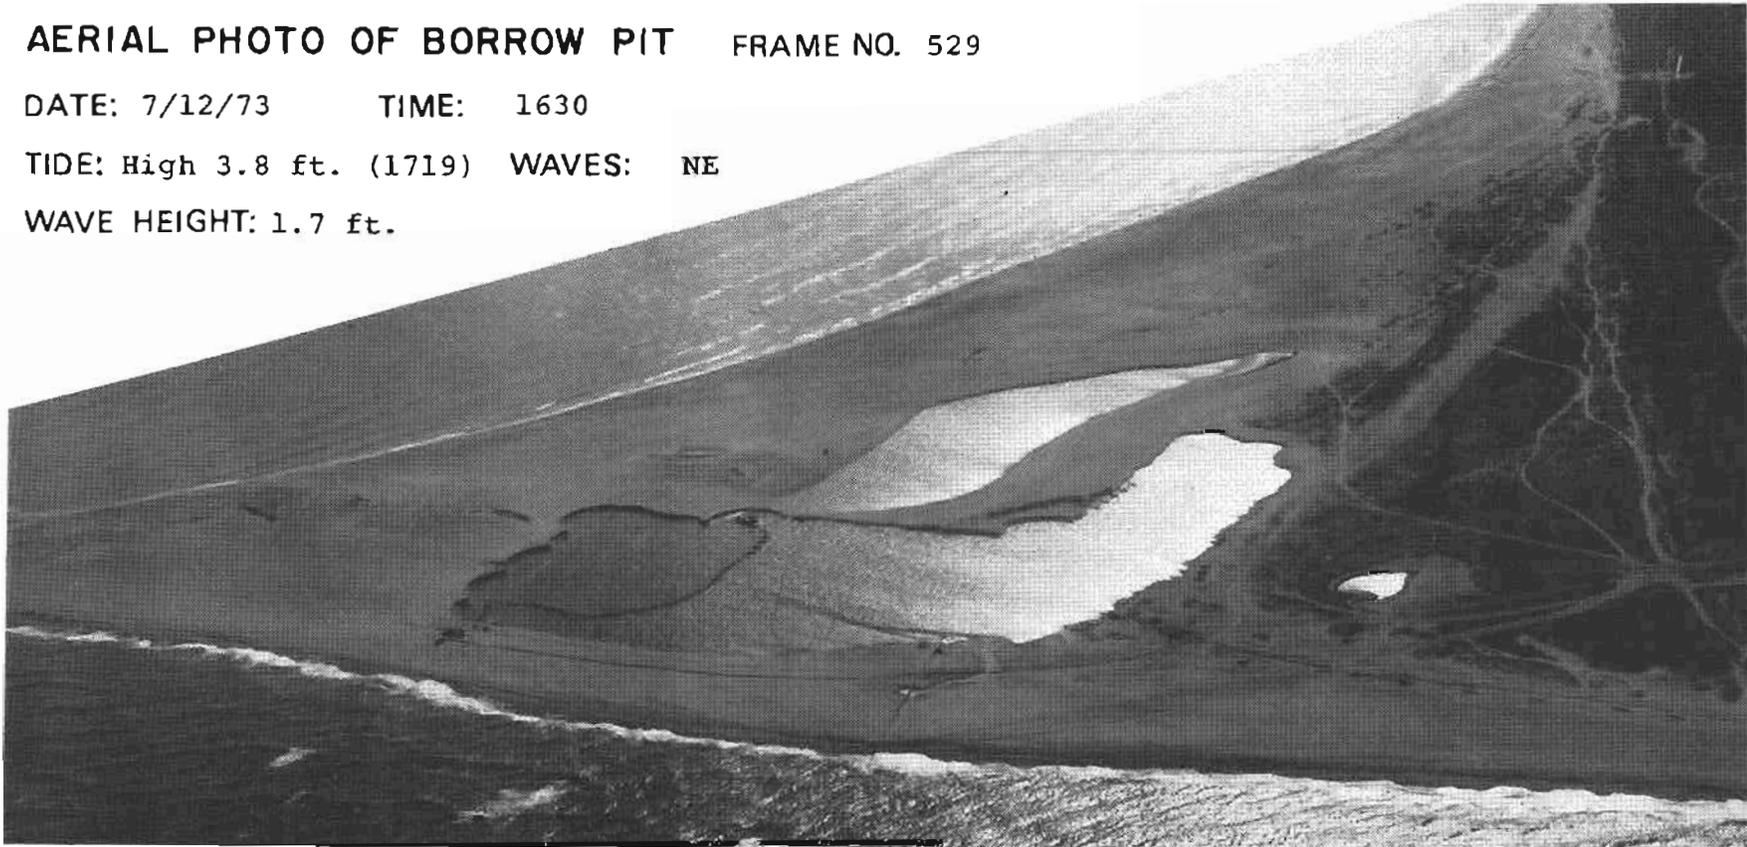
AERIAL PHOTO OF BORROW PIT    FRAME NO. 529

Over 750,000 yards<sup>3</sup> had been excavated from the borrow pit at the time of this photo. At present, the distance from the dredge to the discharge outlet is near its maximum, over 3 1/2 miles. Excavation in the NW corner of the borrow pit was discontinued when finer material was encountered and coarser overwash material along the southern edge is now being dredged. Limited amounts of organic material were encountered in the area immediately adjacent to the natural lake west of the borrow pit.

Analyses of the Emerita talpoida (mole crab) population at the discharge location indicated a larger-than-normal population decrease. This, it is believed, is due to hydrogen sulfide in the discharge material: hydrogen sulfide is toxic to organisms, such as the mole crab, which have high oxygen requirements.

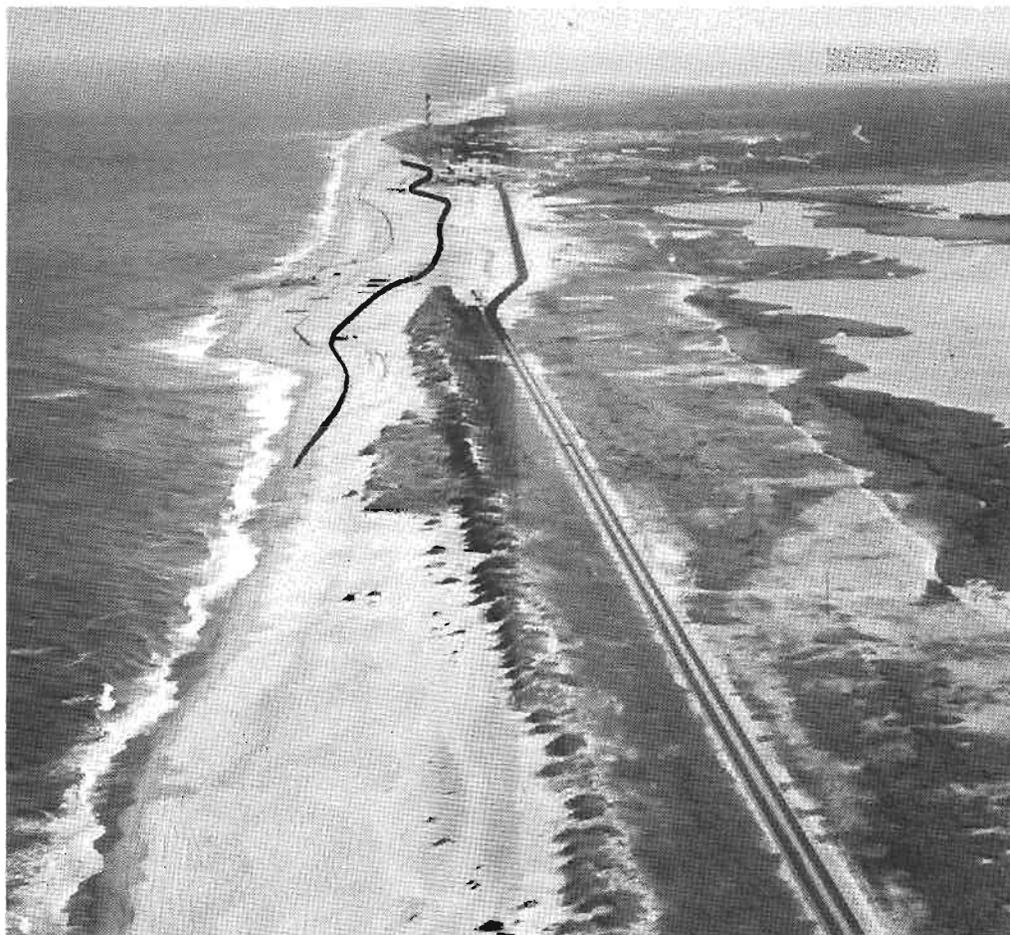
FRAME NO. 539

In this photo the northern end of the project has been reached and the contractor has retreated to station 2180+20 for a second south-to-north move along the surf zone. It was anticipated that southeast waves should form a natural adjustment between the northern nourishment limits and the unnourished beach. Note the contrast which is shown between the straight nourished beach and the natural beach south of the lighthouse.

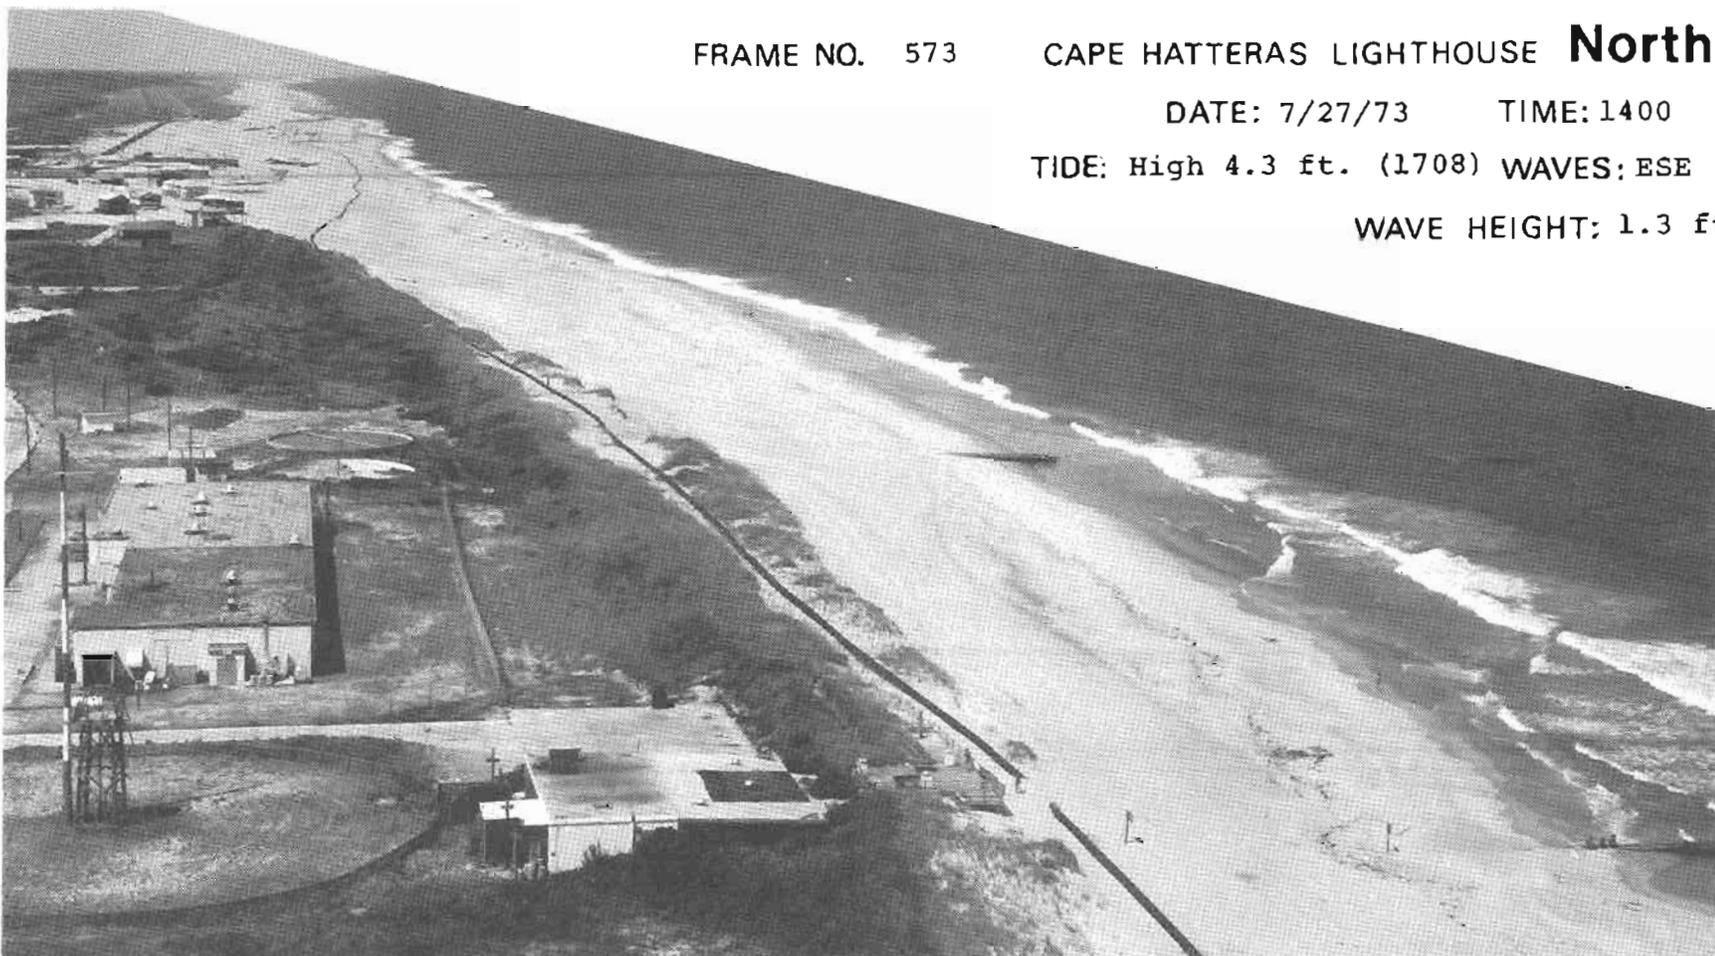
FRAME NO. 573

As the discharge outlet was moved to the south, the seaward slope of the fill adjusted to the energy patterns of each area. Calm seas and favorable winds continued to prevail, contributing greatly to the high retention of nourished material.

One noticeable feature of the nourished beach is the lack of an inner bar. Nourishment material has filled the inner trough, covered the inner bar, and filled the landward side of the outer trough. Fathometer profiles offshore show that the outer trough is immediately offshore of the beach face, 25 feet deep, and only 500 to 600 feet offshore.

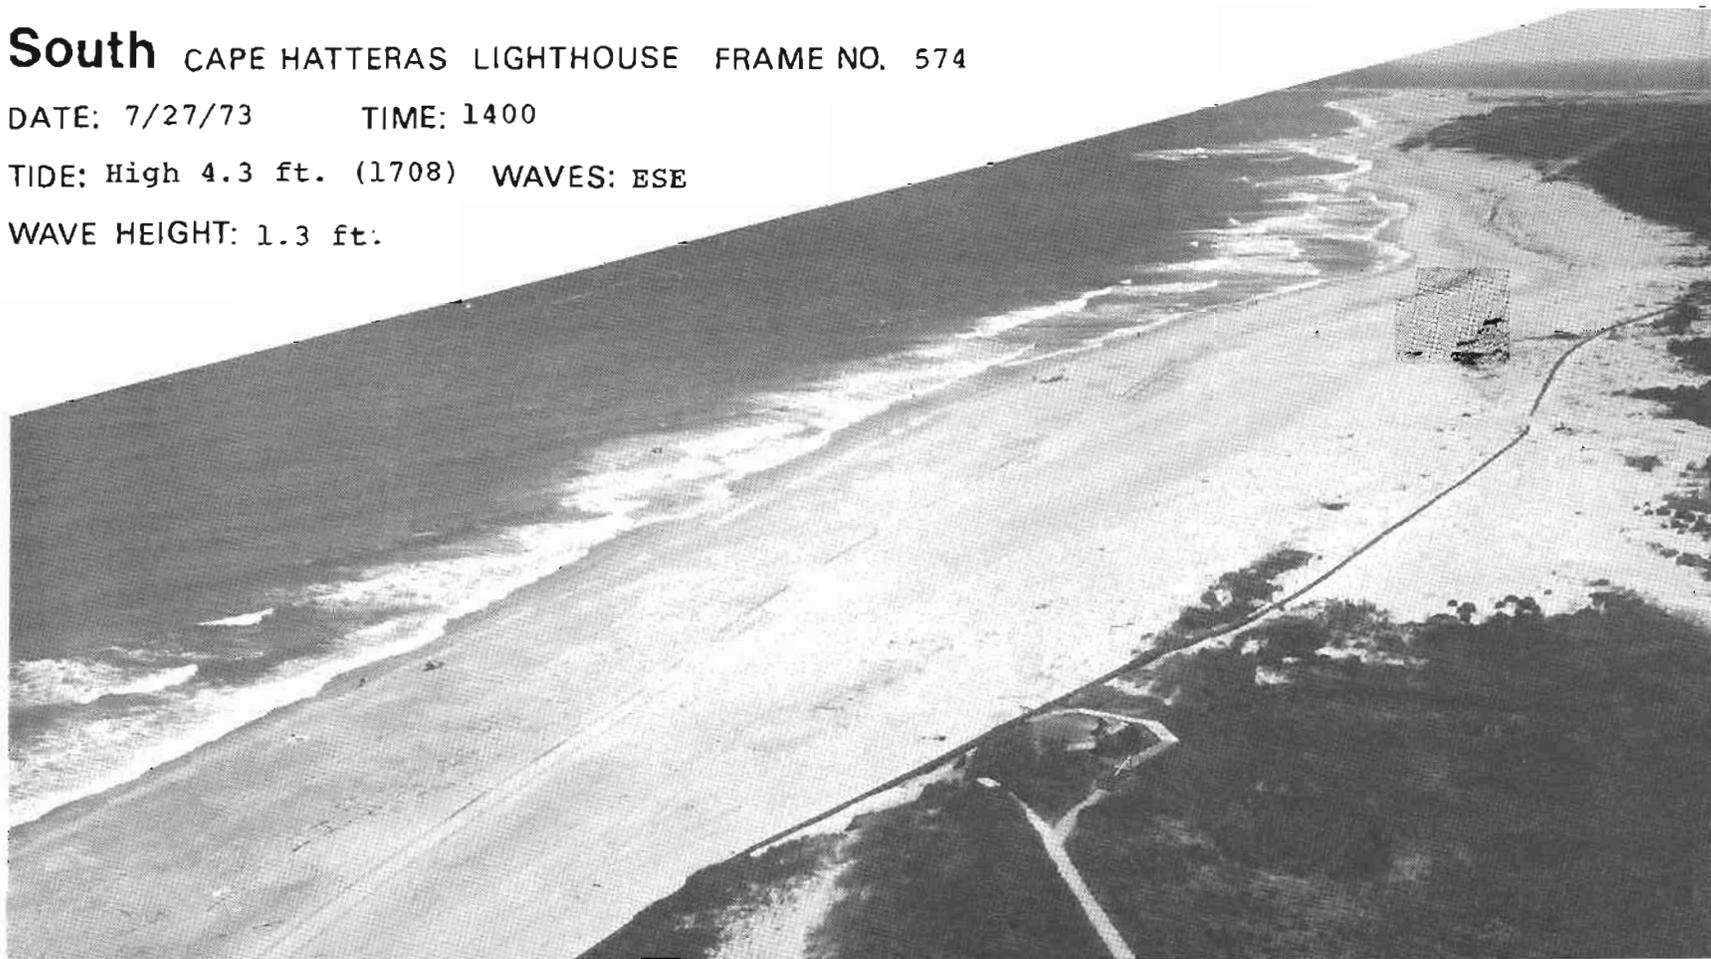
**South** CAPE HATTERAS LIGHTHOUSE FRAME NO. 574

To the south the beach continues to widen concurrent with the filling of the embayments. Breaking waves in the foreground embayment suggest that a bar has formed or enlarged in this area which may be the beginning of sediment deposit from sands discharged to the north.
