# 1973 BUXTON BEACH NOURISHMENT PROJECT

AN ANNOTATED PHOTOGRAPHIC ATLAS

CAPE HATTERAS NATIONAL  
SEASHORE  
NORTH CAROLINA

FEBRUARY 1974

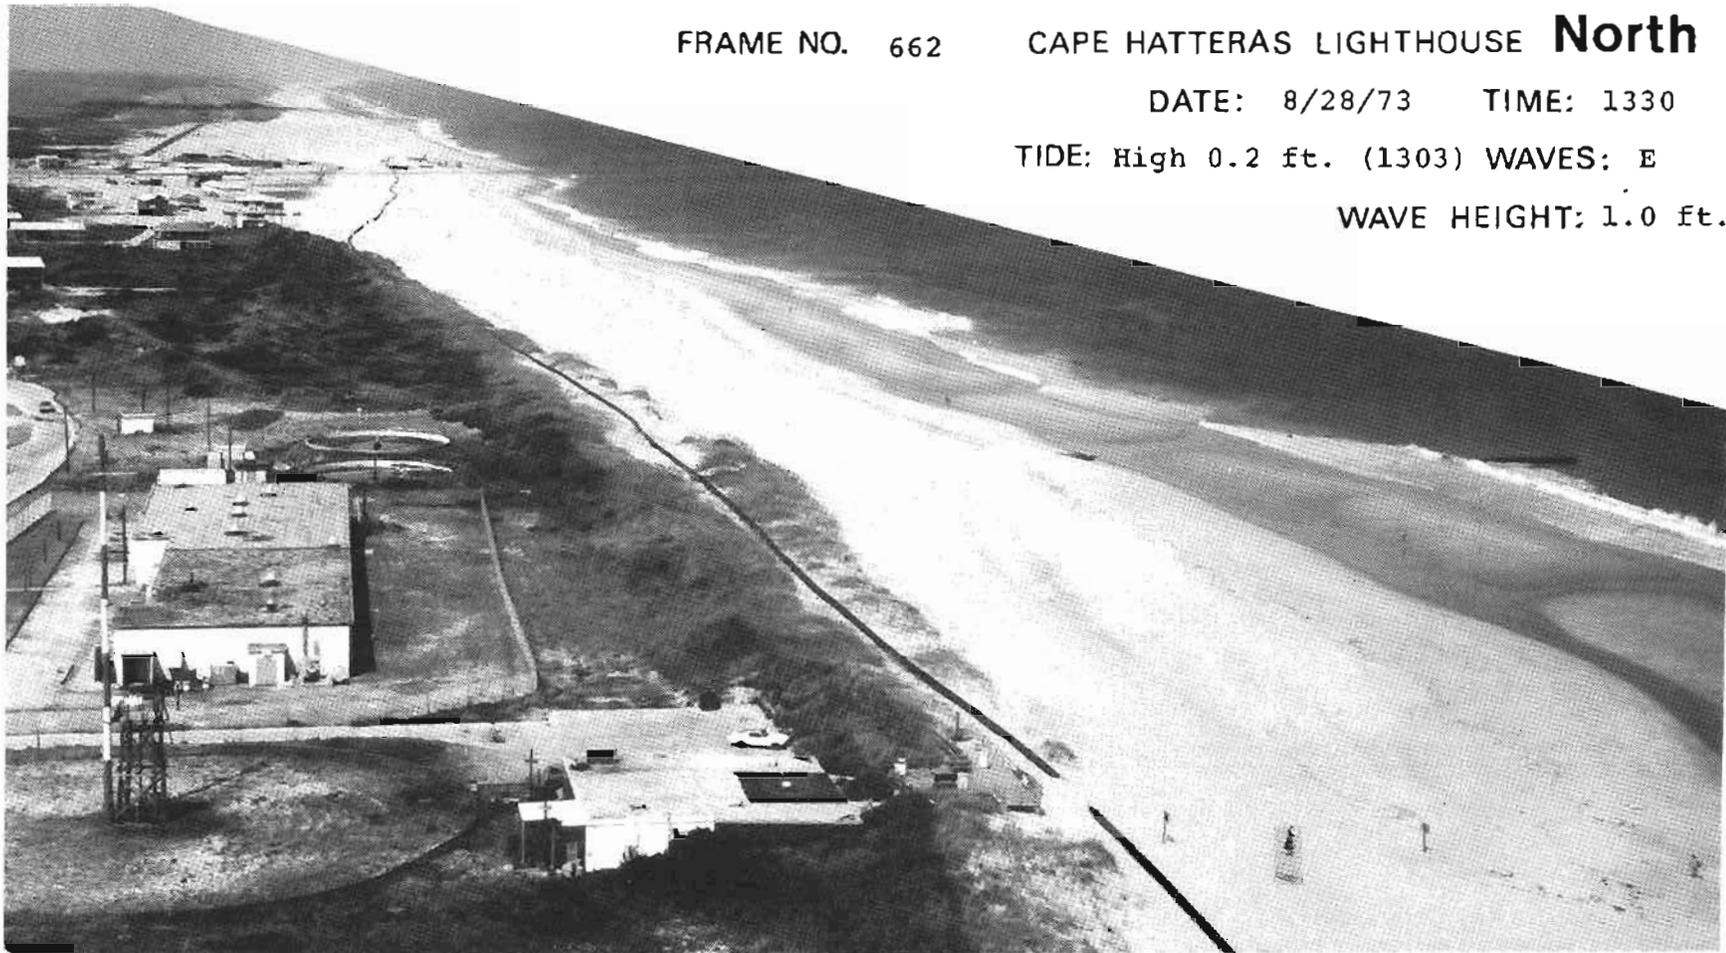
FRAME NO. 662

The straight nourished beach and the outlet fan continue to be typical features of each picture. As fall approaches the dominant wave direction is shifting from southeast to northeast. Northeast wave have caused the sediment to start to move south causing significant beach build-up in the groin cells.

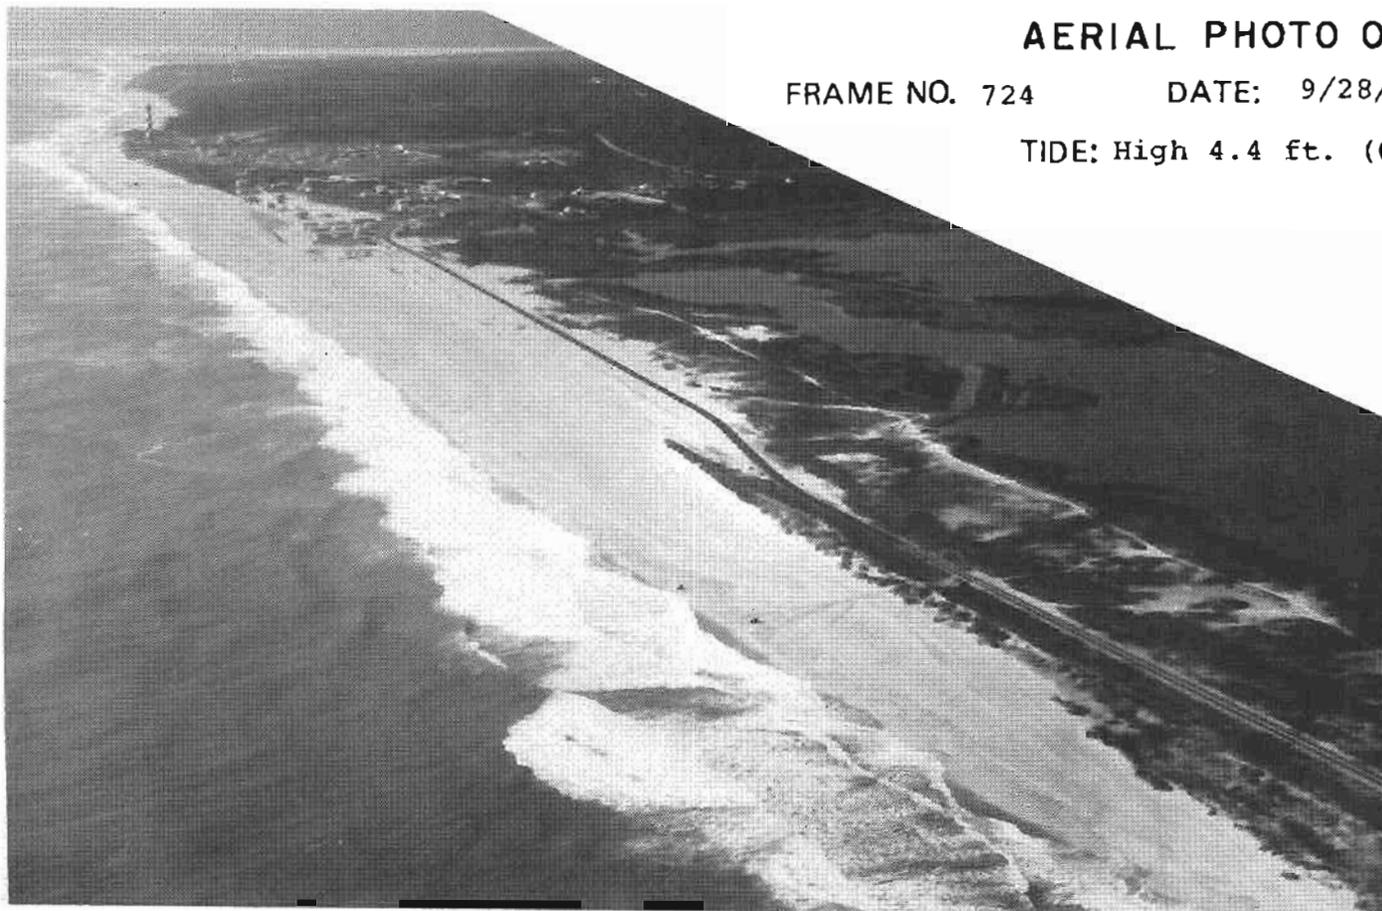
FRAME NO. 724

A straight beach is still a dominant feature after completion of the nourishment project. The northern protrusion noted in July has been eroded by southeast waves and the northward drift of fill material has formed a more natural beach face and shoreline alignment. Southern sediment movement in August and September filled in the embayment that existed between the south end of the project at station 2235+00 and the groins. The westward curvature of the beach south of the Lighthouse remains unaffected by the 1,300,000 yds.<sup>3</sup> of sand pumped.

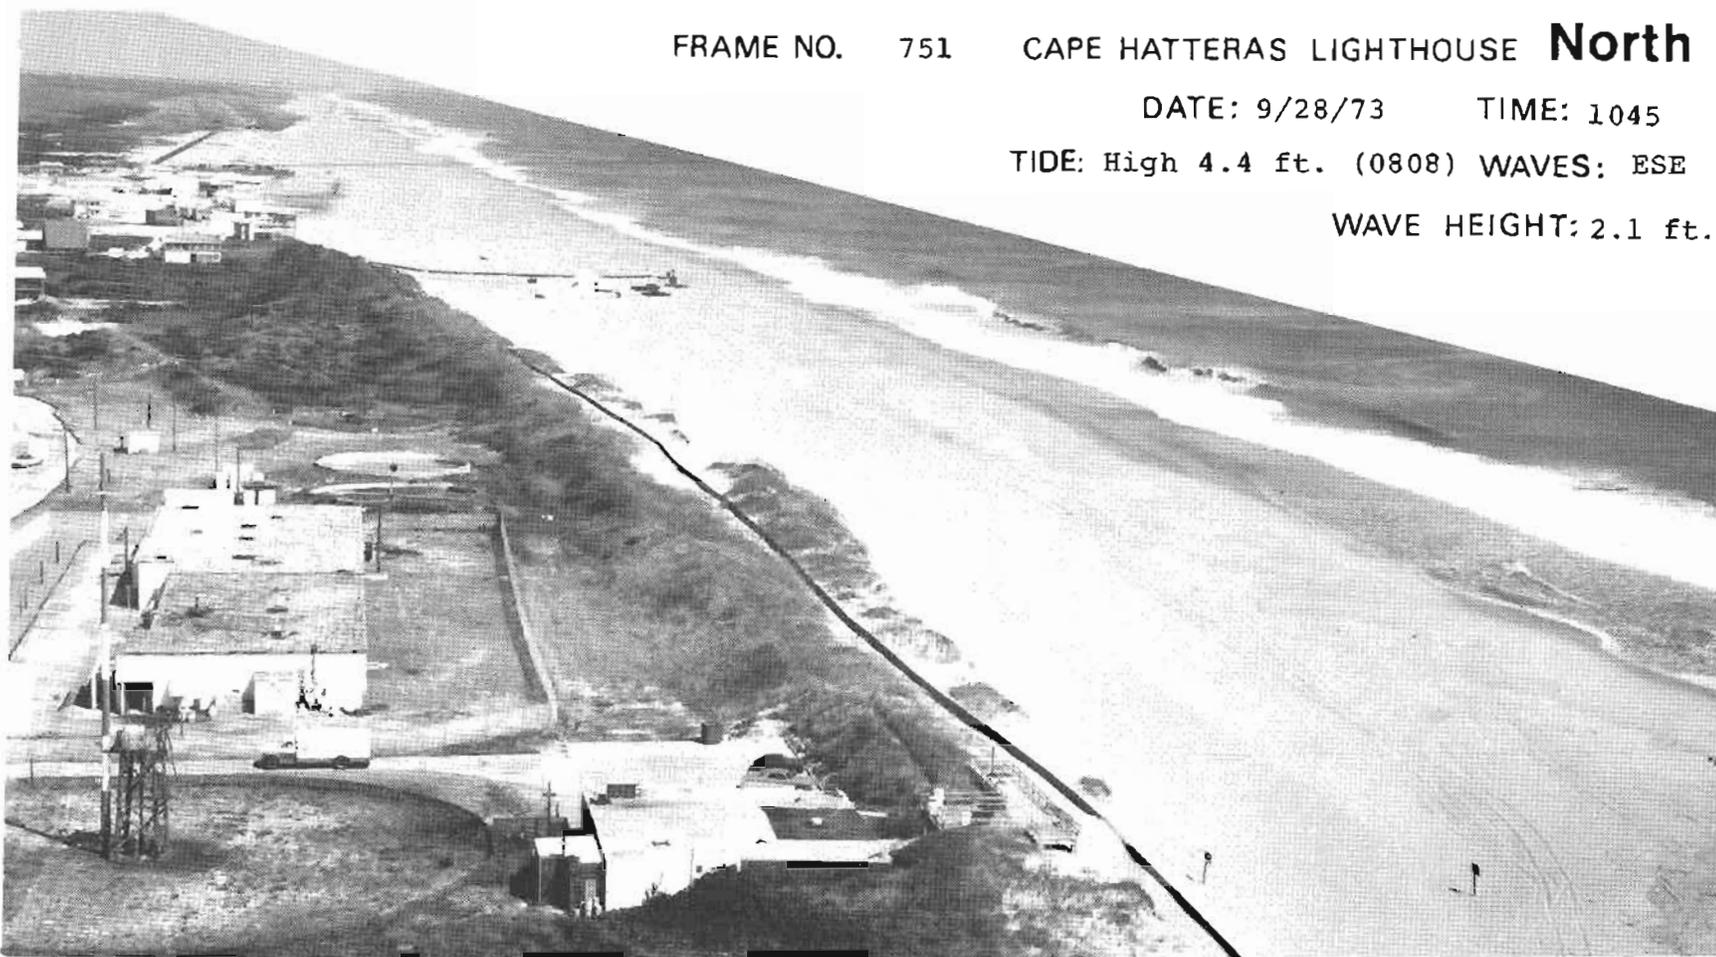
FRAME NO. 751

When the nourishment project was completed, the beach was generally wider by 300 to 350 feet with some increases of over 400 feet. Although no material was pumped into the groin cells, southern sediment drift caused a build-up of up to 200 feet. In spite of this obvious loss of nourishment material to the southern beach, the final retention figure in the project area was approximately 85%.

An inner bar is still absent along most of the nourished area and the inner bar at the groins has been covered by deposition. However, a bar appears to be developing at the northern end of the project area. Although the nourishment appears highly successful, the entire area remains vulnerable to oceanic overwash.

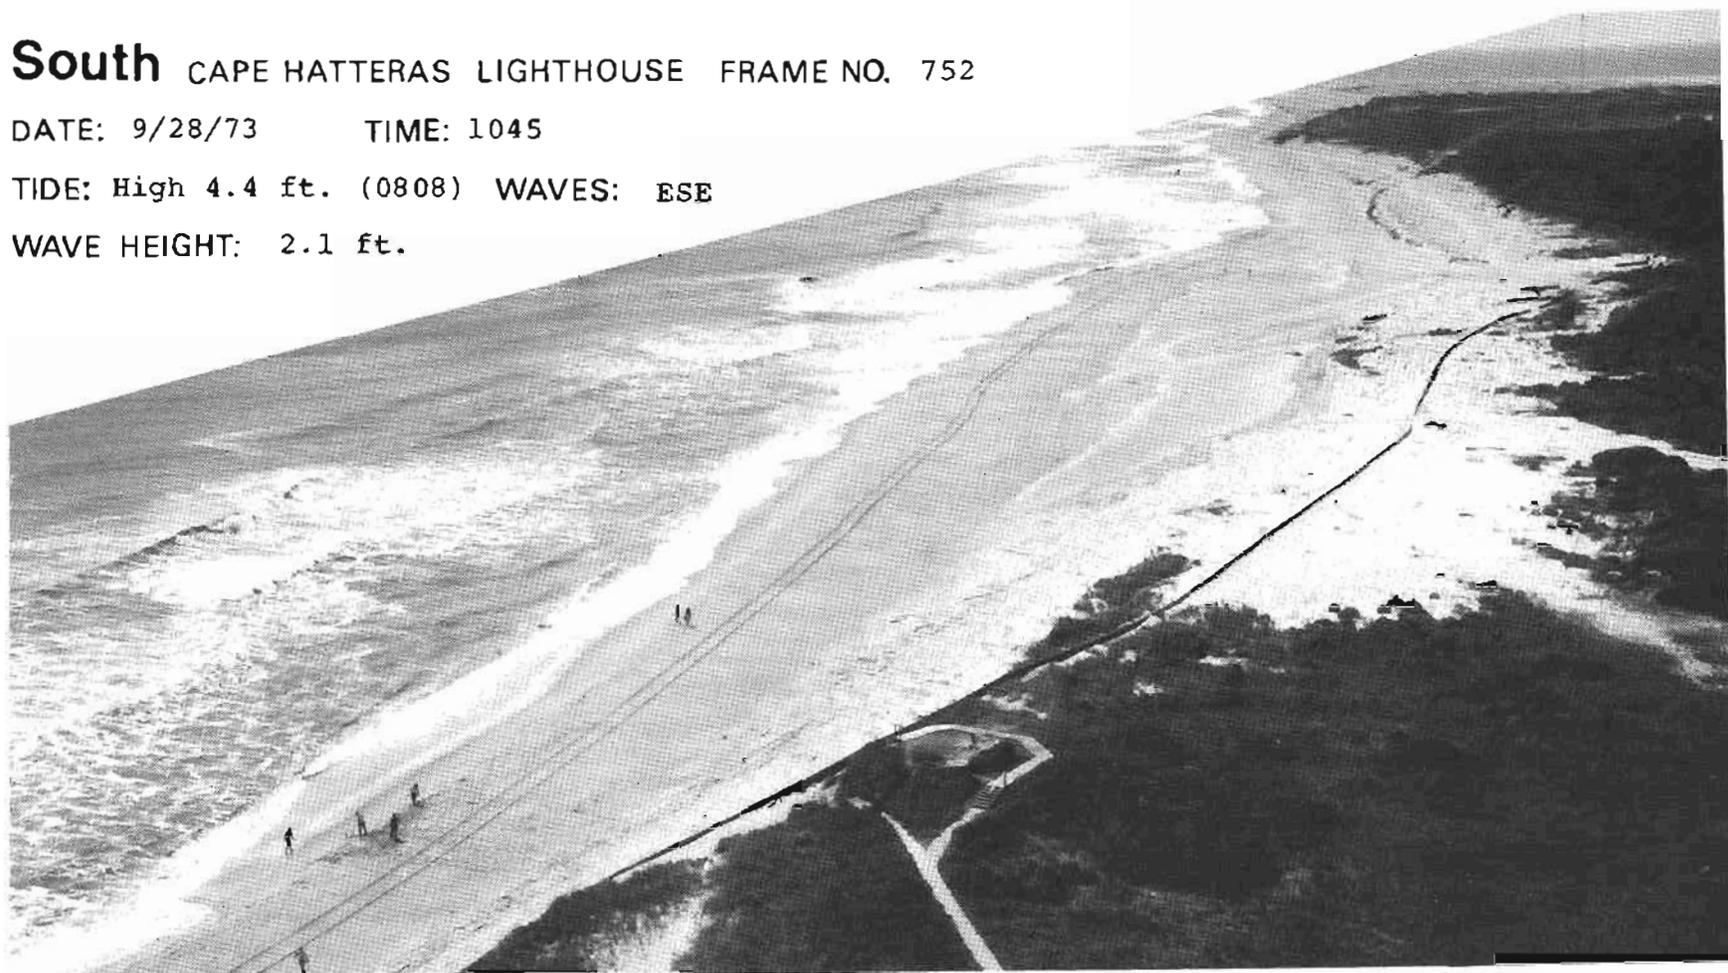
**South** CAPE HATTERAS LIGHTHOUSE FRAME NO. 752

There are also significant changes south of the Lighthouse. Sand continues to be deposited near Station 2175+00 where the cut to the marsh was made in February. However, north of this area erosion has replaced deposition. Up to 100 feet of beach has been lost in front of the old lighthouse ruins because of material trapped on the north side of the groins.

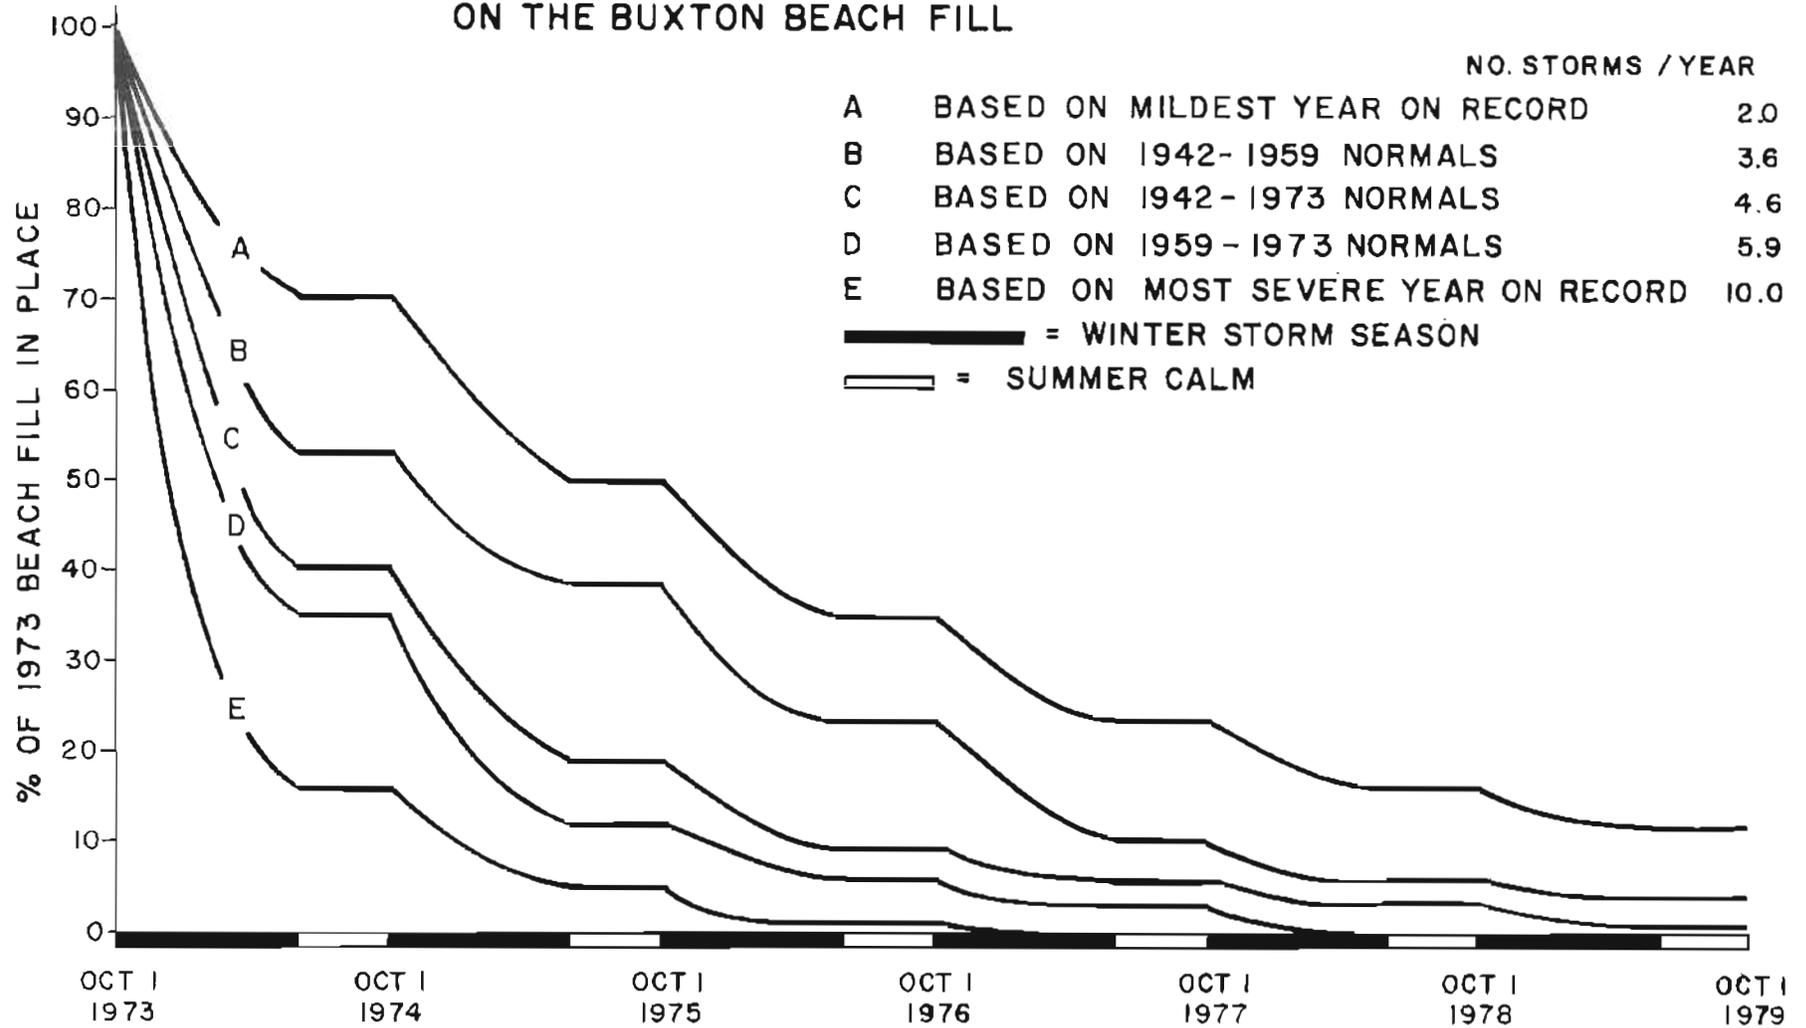
IMPACT OF STORM GENERATING  
DEEP WATER WAVES  $\geq$  11 FEET  
ON THE BUXTON BEACH FILL

The most recent storm patterns differ significantly from the long-term normals; there has been a lower frequency of severe storm years. Based upon storm-frequency statistics, the yearly retention expected for various storm conditions can be calculated. Five curves are plotted: One curve for a series of the mildest years (two "11-foot" storms a year); another for a series of the

most severe years (ten "11-foot" storms a year); and therefore expectations based upon the 1) 1942-1959, 2) 1959-1973, and 3) 1942-1973 climatic normals. Based on these estimates, under the most favorable conditions 25% of the beach fill would be retained at the end of 4 years, while under the most severe conditions only 16% would be retained after a single year and almost none after four years. Using the 1959-1973 mean figures, approximately 10% of the fill would remain at the end of 3 years, a condition more likely than those predicted by the use of extreme figures. If these figures are even in the right order of magnitude, the temporary nature of beach nourishment for high-energy coasts is clear.

Number of Storms Generating Deep- Water Waves $\geq$ 11 Feet	Percentage of Fill Remaining at End of One- Year	Storm Frequency of Years 1942-1973		Storm Frequency of Years 1959-1973	
		Percentage	Storm No.	Percentage	Storm No.
0	100	0	0	0	0
1	84.0	0	0	0	0
2	70.6	16.7	5	0	0
3	59.3	26.7	8	21.4	3
4	49.8	13.3	4	21.4	3
5	41.8	13.3	4	14.3	2
6	35.1	10.0	3	7.1	1
7	29.5	3.3	1	7.1	1
8	24.8	0	0	0	0
9	20.8	10.0	3	14.3	2
10	17.5	6.7	2	14.3	2
11	14.7	0	0	0	0
12	12.3	0	0	0	0
