Chaco Culture National Historical Park

Monitoring Chaco Wash Using Monumented and Surveyed Cross-sections

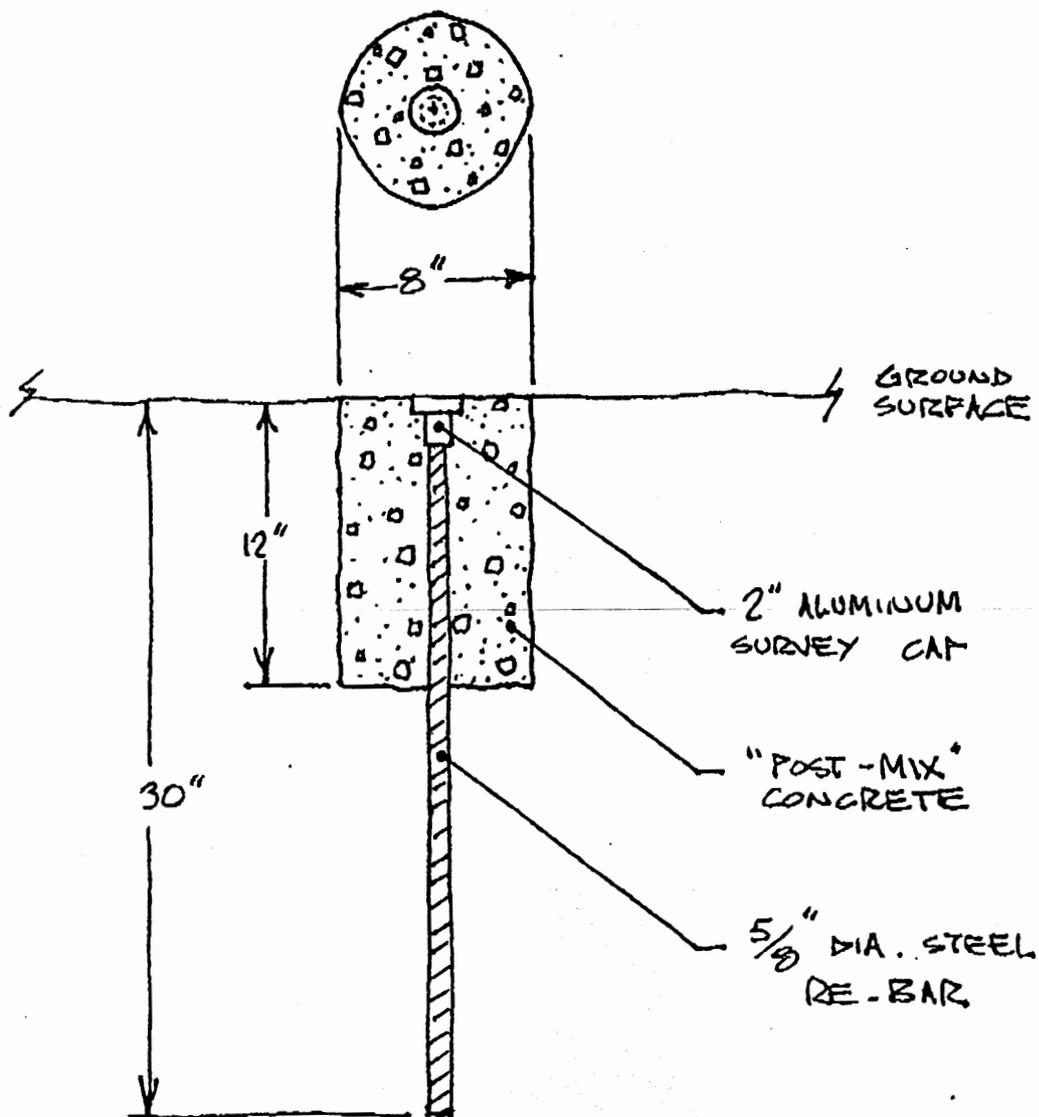
Park CHACO CULTURE N.H.P.	NATIONAL PARK SERVICE SOUTHWEST REGION		Sheet
Area SAN JUAN CO., NM			of
Project CHACO WASH X.S. NETWORK	By NAW	Checked	Pkg.
Feature SURVEY END-POINT BENCHMARKS	Date 3/17/99	Date	Account

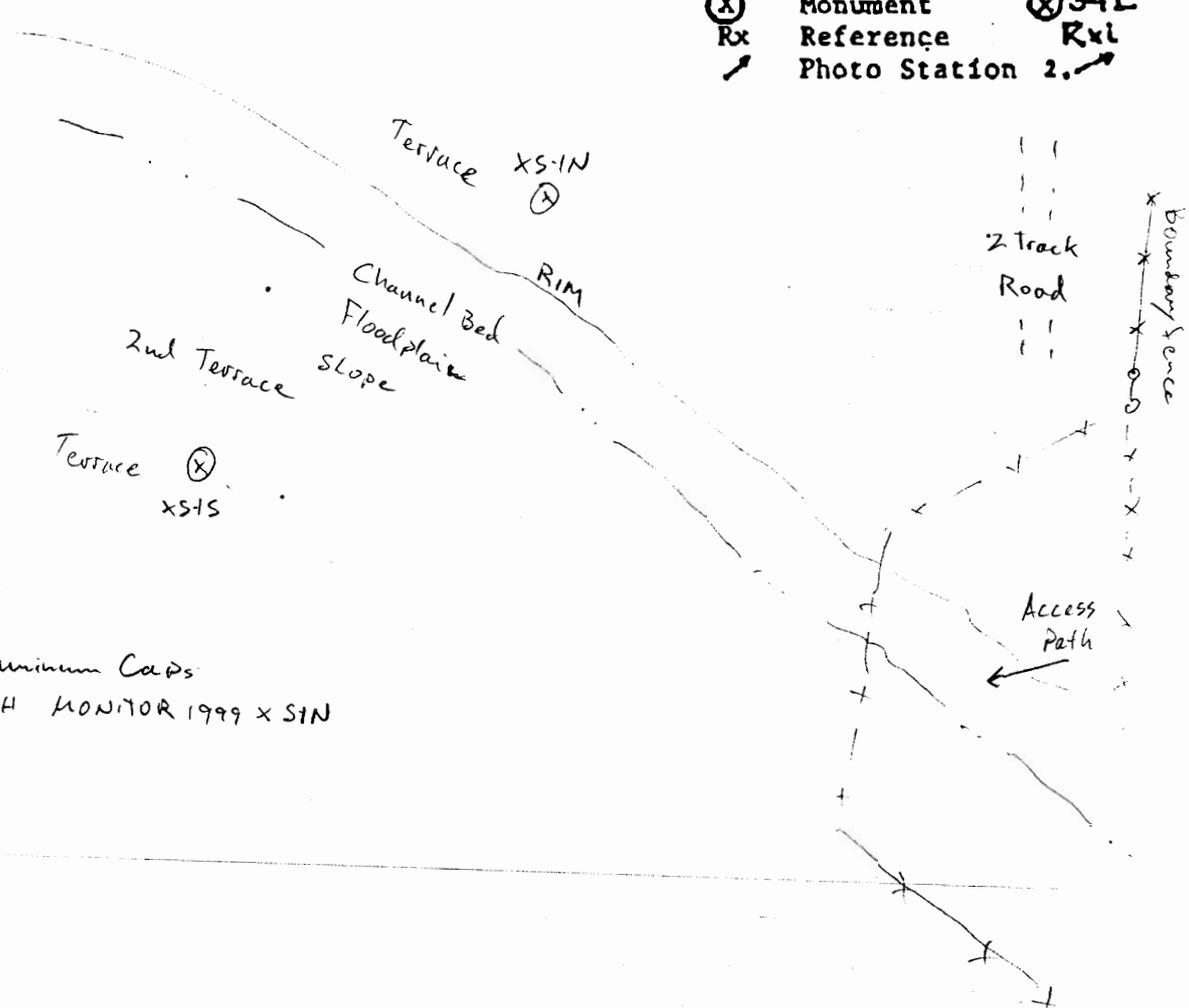
CROSS SECTION # XS-1 at 1980 East Boundary

⊗ Monument ⊗ ex. 34L
 Rx Reference Rxi
 ↗ Photo Station 2. ↗

MONUMENT DESCRIPTION:

X : Cemented Aluminum Caps
"CHACO WASH MONITOR 1999 X SIN"

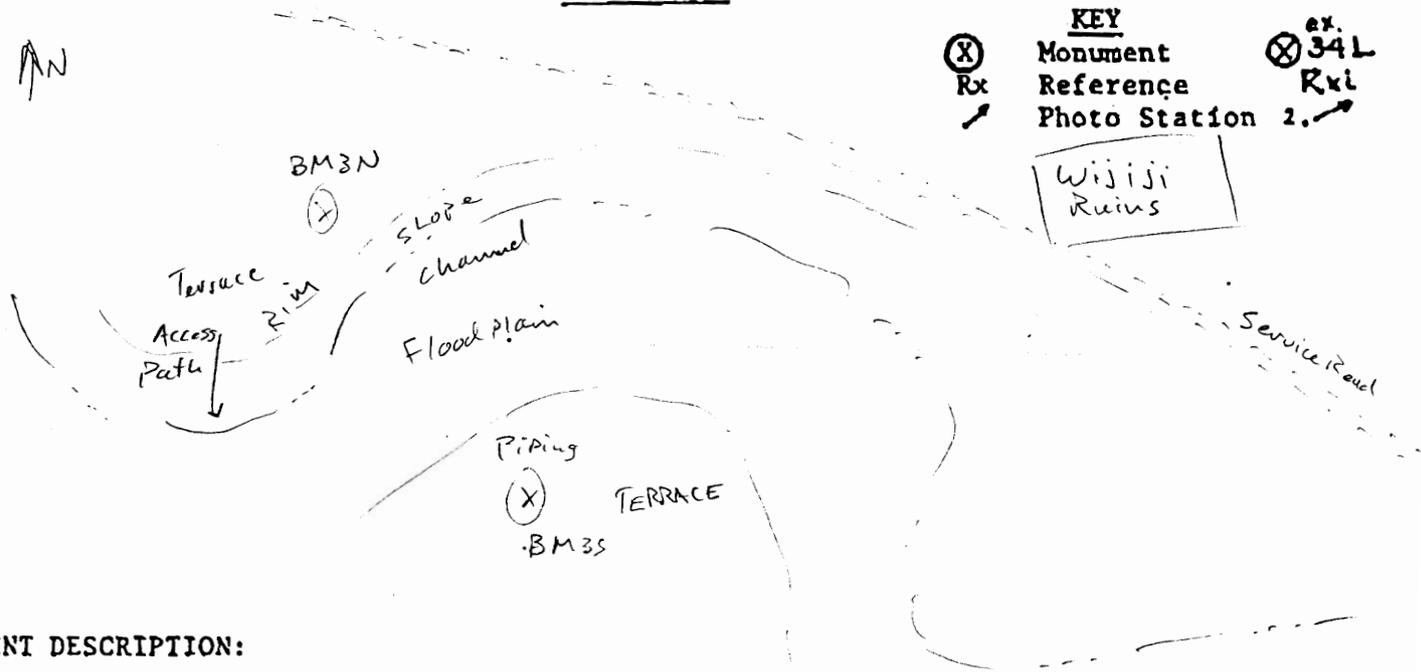
SKETCH MAP

MONUMENT DESCRIPTION:

X : Cemented Aluminum Caps
"CHALO WASH Monitor XS-3S 1999"

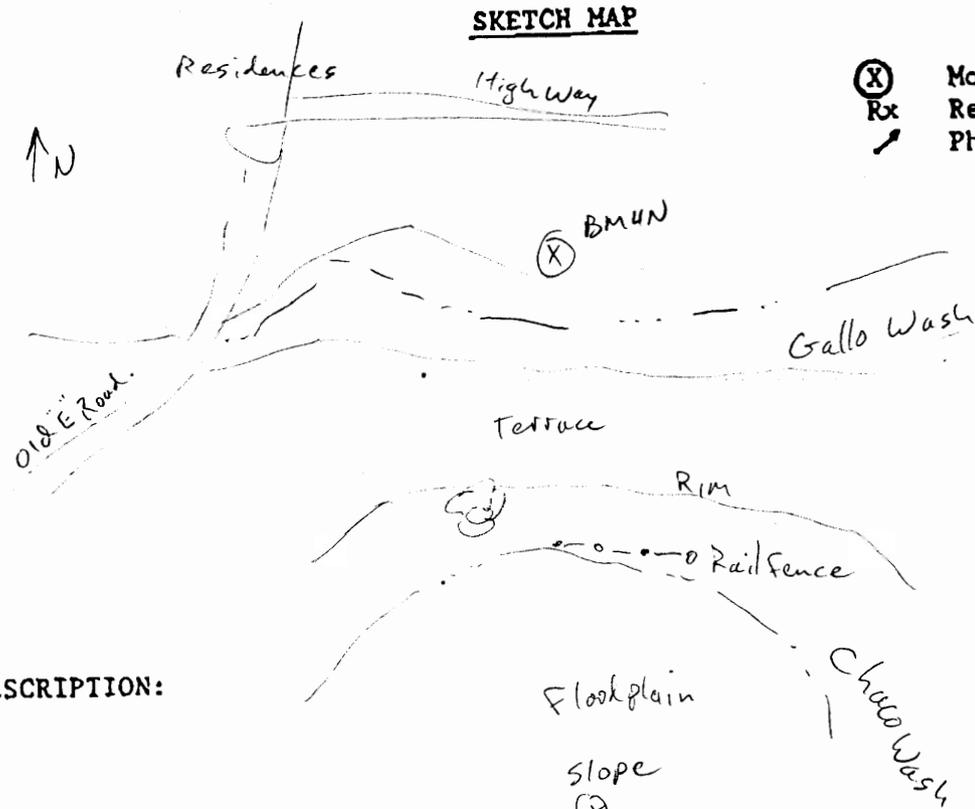
KEY
 (X) Monument
 Rx Reference
 Photo Station 2. →
 ex. 34L
 Rx1

MONUMENT DESCRIPTION:

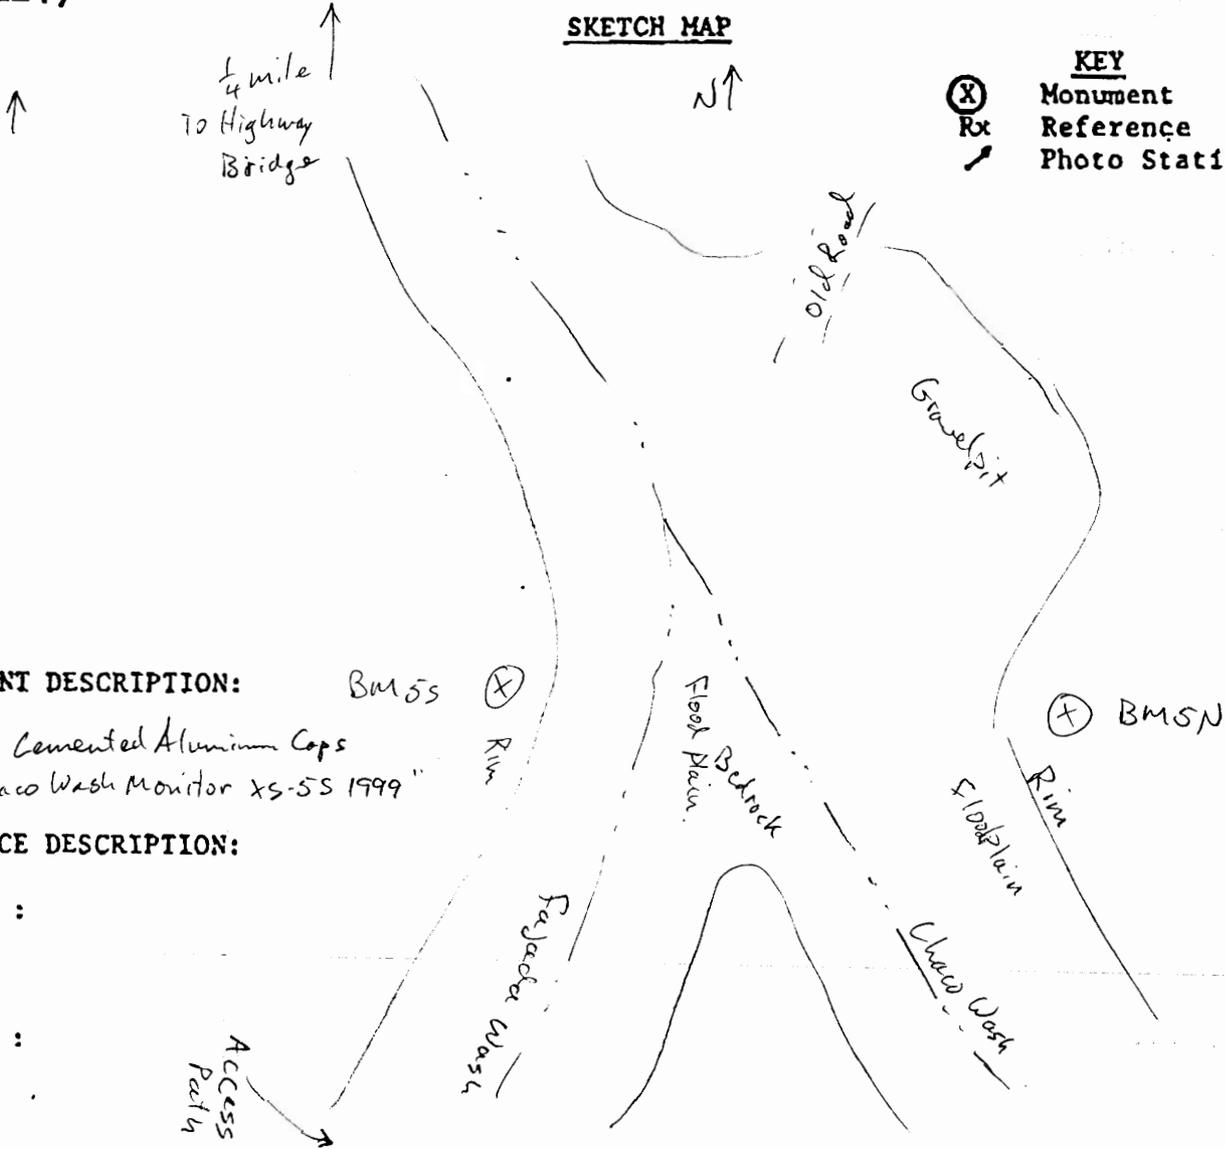
SKETCH MAP

KEY
⊗ Monument
Rx Reference
Photo Station 2. →
ex. 34L
Rxi

MONUMENT DESCRIPTION:

BM 55 ⊗
Rim

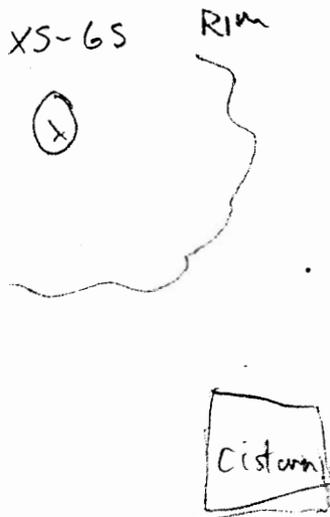
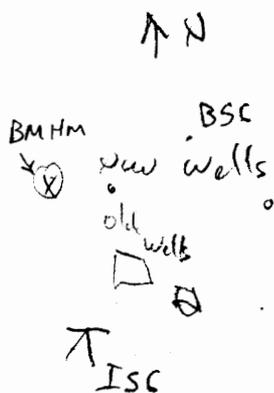
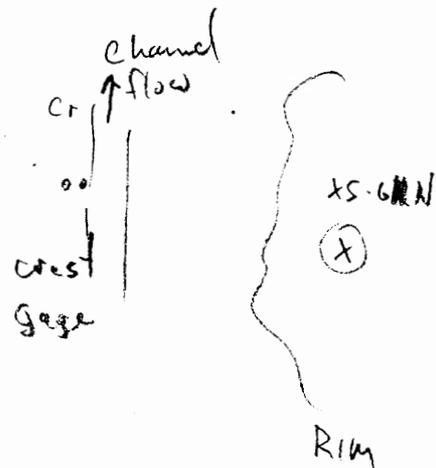
SKETCH MAP

KEY
 (X) Monument Reference Photo Station 1.
 (X) 34L Rxi
 ex. Rxi

MONUMENT DESCRIPTION:

X : Aluminum Cap flush in Ground
 Stamped NPS CACB XS-6

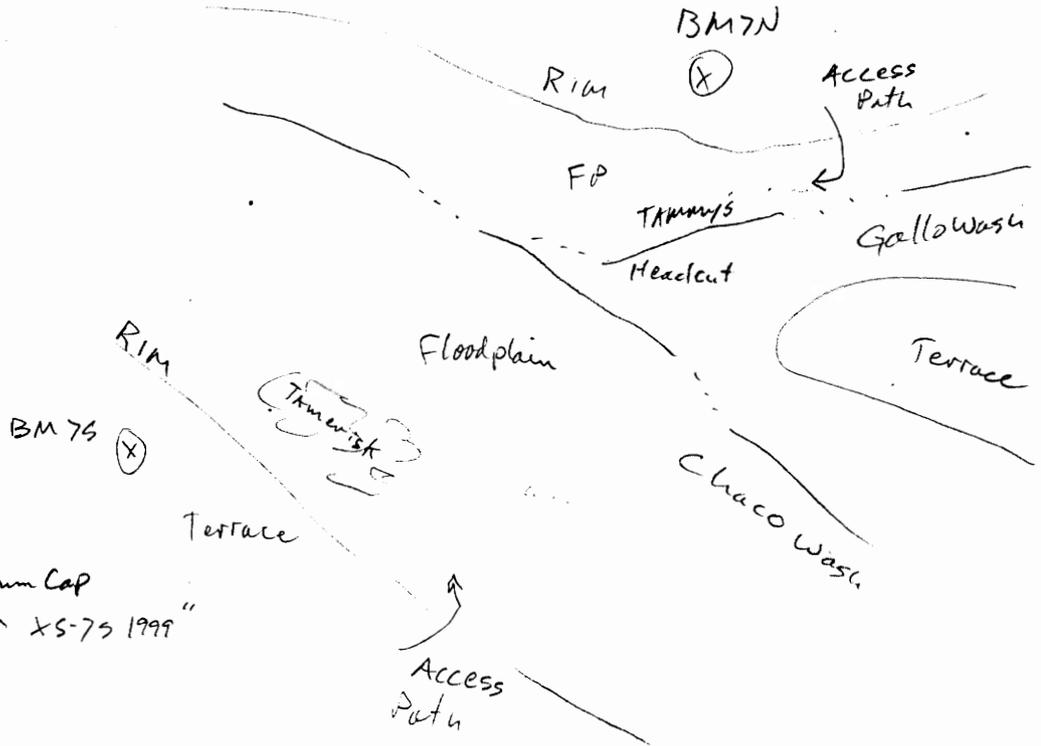
(X) Monument
Rx Reference
Photo Station 2.

MONUMENT DESCRIPTION:

X : cemented Aluminum Cap
"Chaco Wash Monitor X5-75 1999"

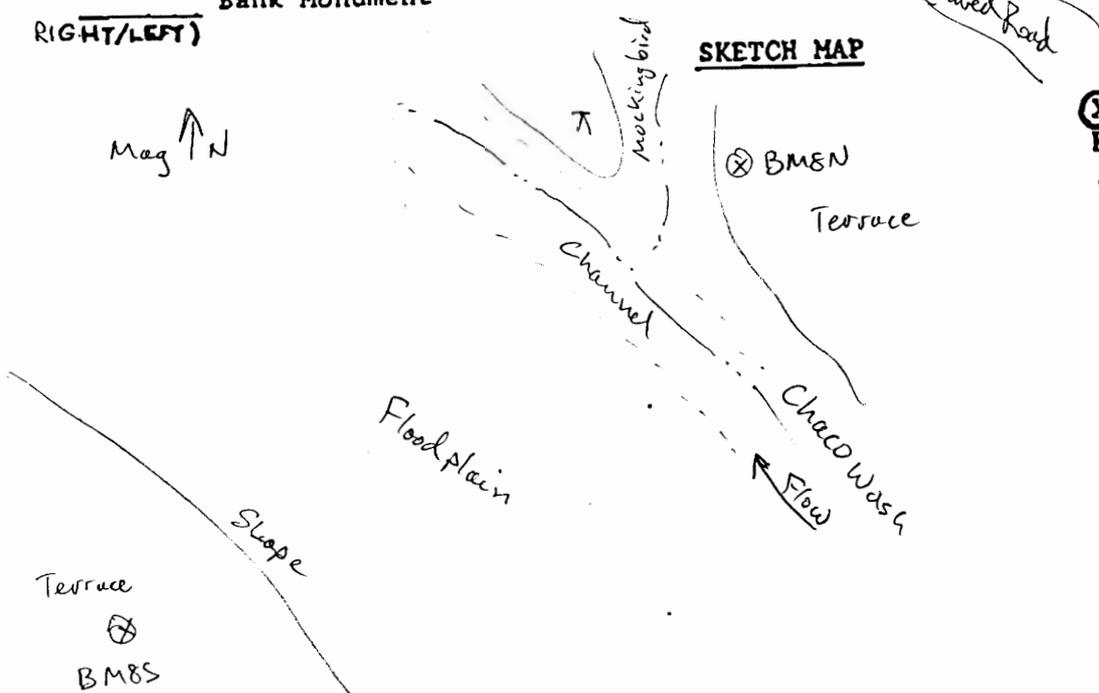
SKETCH MAP

KEY
 ⊗ Monument
 ⊗ Reference
 ⊗ Photo Station 2. →

MONUMENT DESCRIPTION:

X : Cemented Aluminum Cap
 "Chaco Wash Monitor XS-8N 1999"

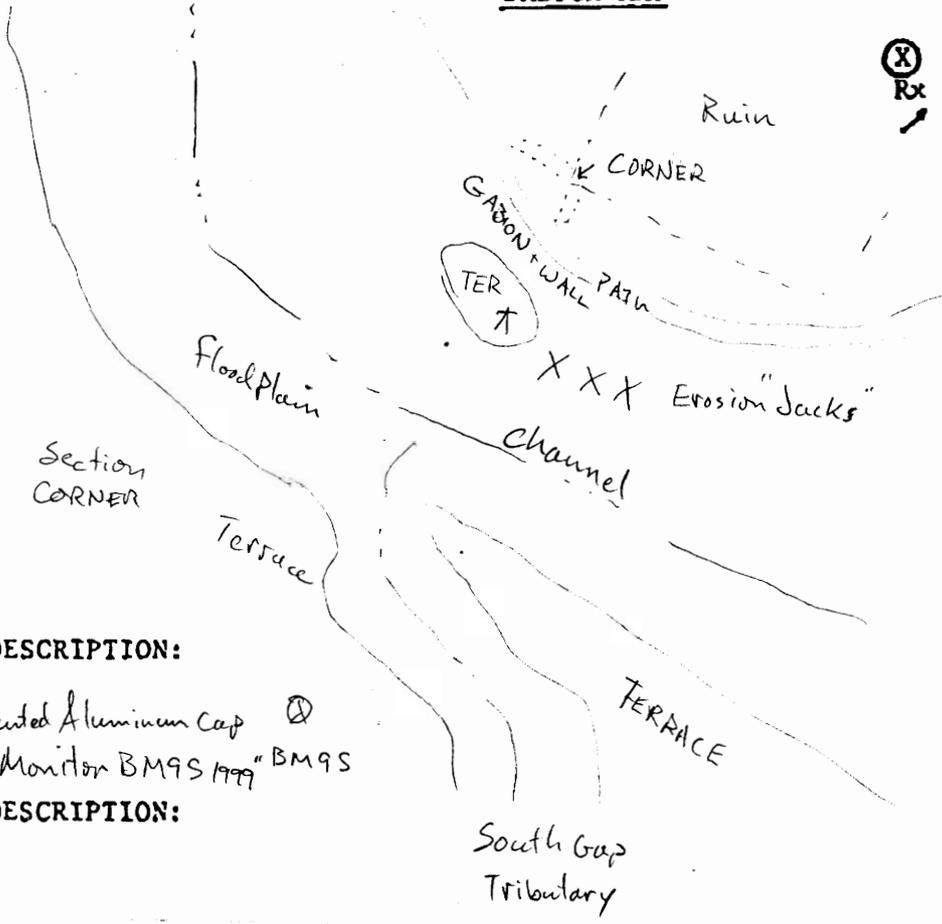
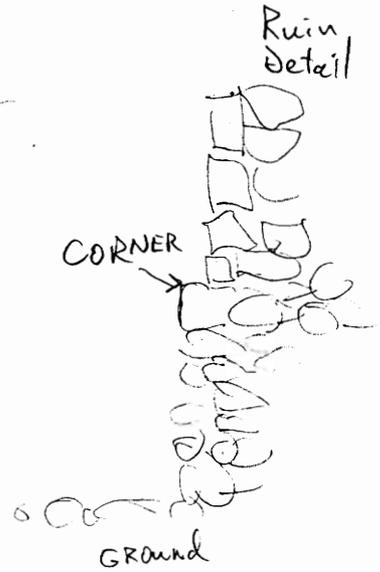
SKETCH MAP

KEY
 (X) Monument
 Rx Reference
 (X) 34L Rxi
 Photo Station 2. →

MONUMENT DESCRIPTION:

X : Cemented Aluminum Cap
 Chaco Wash Monitor BM9S 1999 "BM9S"

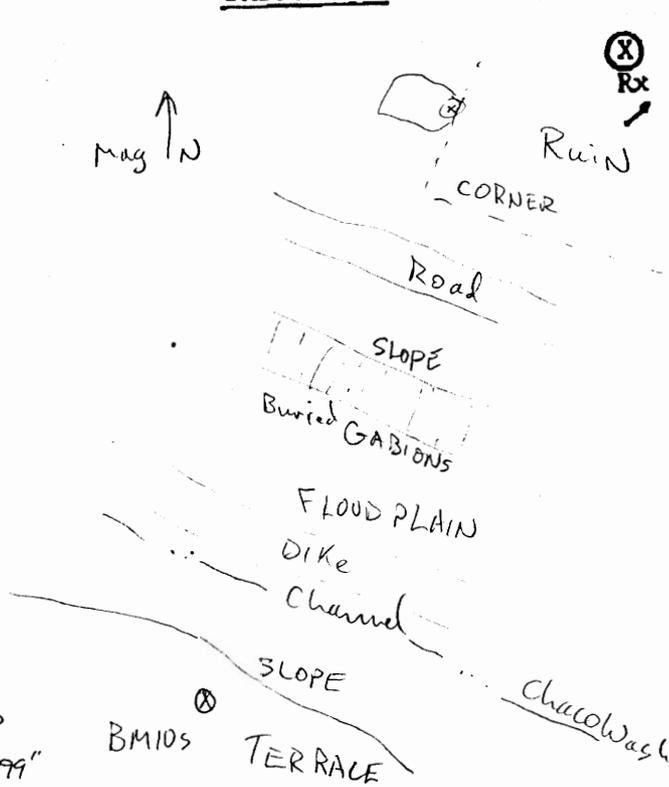
SKETCH MAP

KEY
 Monument Reference Photo Station 2. →
 ex. 34L
 Rxi

Description of North Endpoint:
 Along west wall a large boulder with shell fossils has a highest point next to the wall of the ruin. BM10N is this highest point.

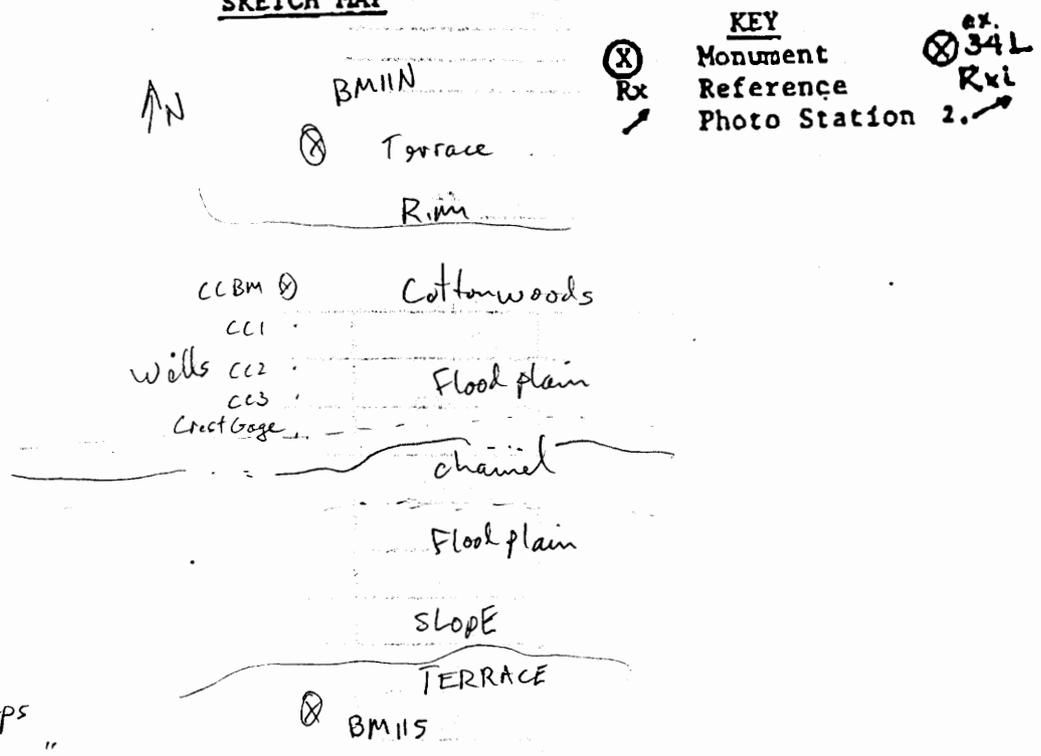
SKETCH MAP

MONUMENT DESCRIPTION:

X : Cemented Aluminum Caps
"Chaco Wash Monitor X5115 1999"

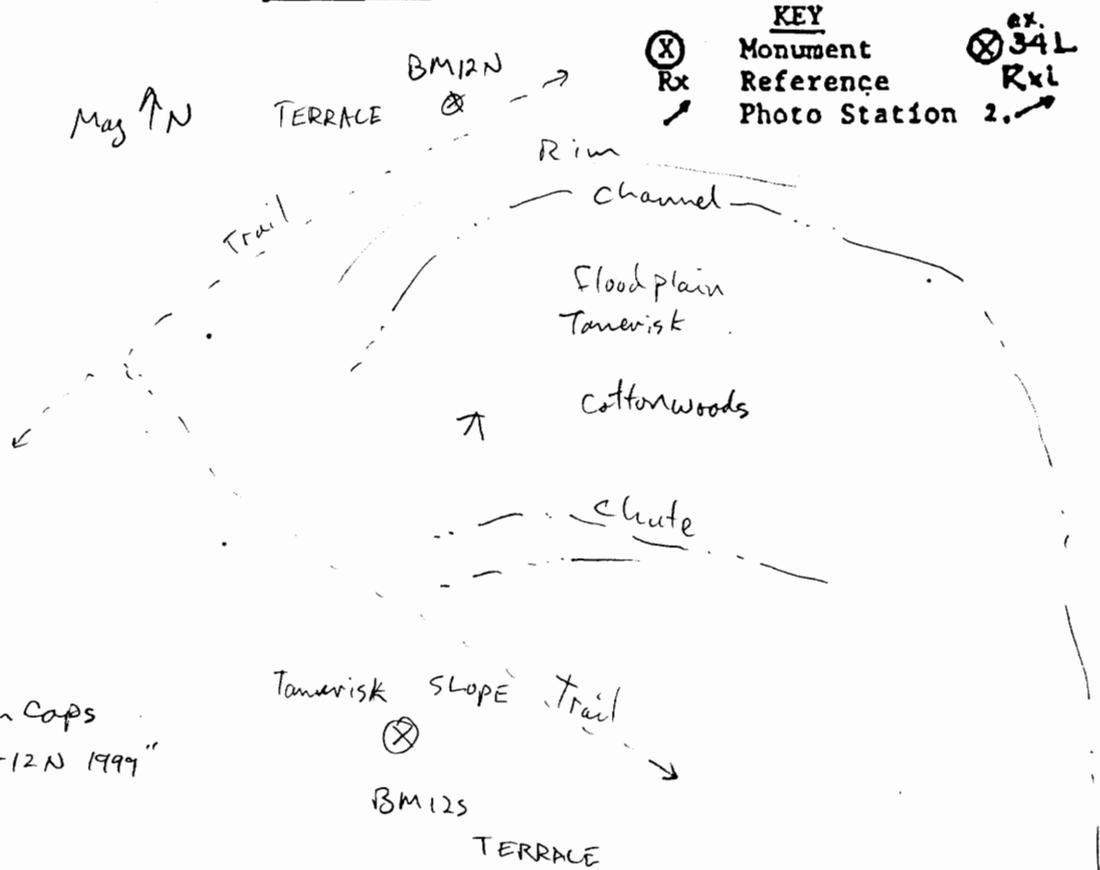
SKETCH MAP

MONUMENT DESCRIPTION:

X : Cemented Aluminum caps
"Chaco Wash Monitor XS-12 N 1999"

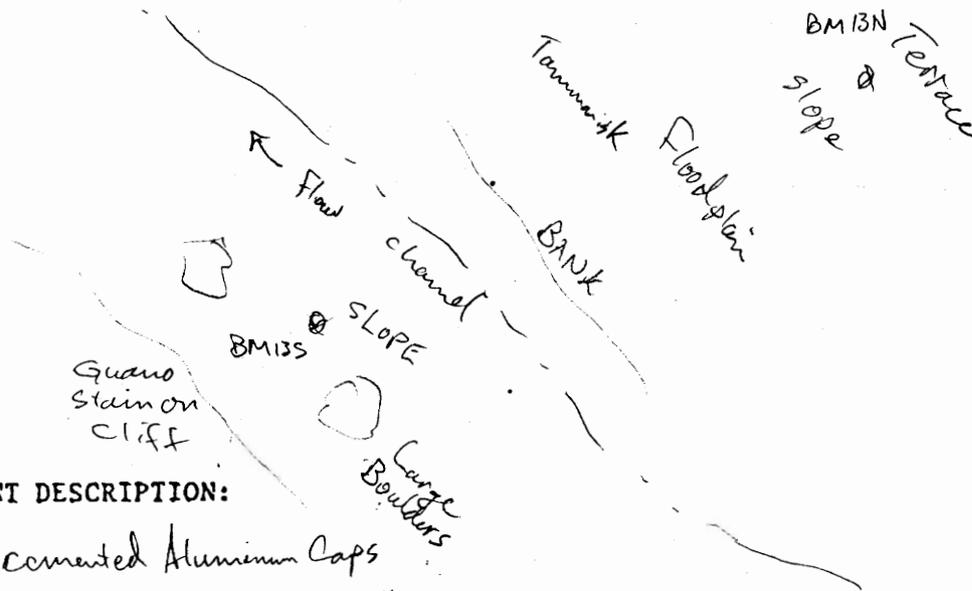
KEY
 (X) Monument
 Rx Reference
 ↗ Photo Station 2.
 (X) 34L
 Rxl

MONUMENT DESCRIPTION:

X : cemented Aluminum Caps

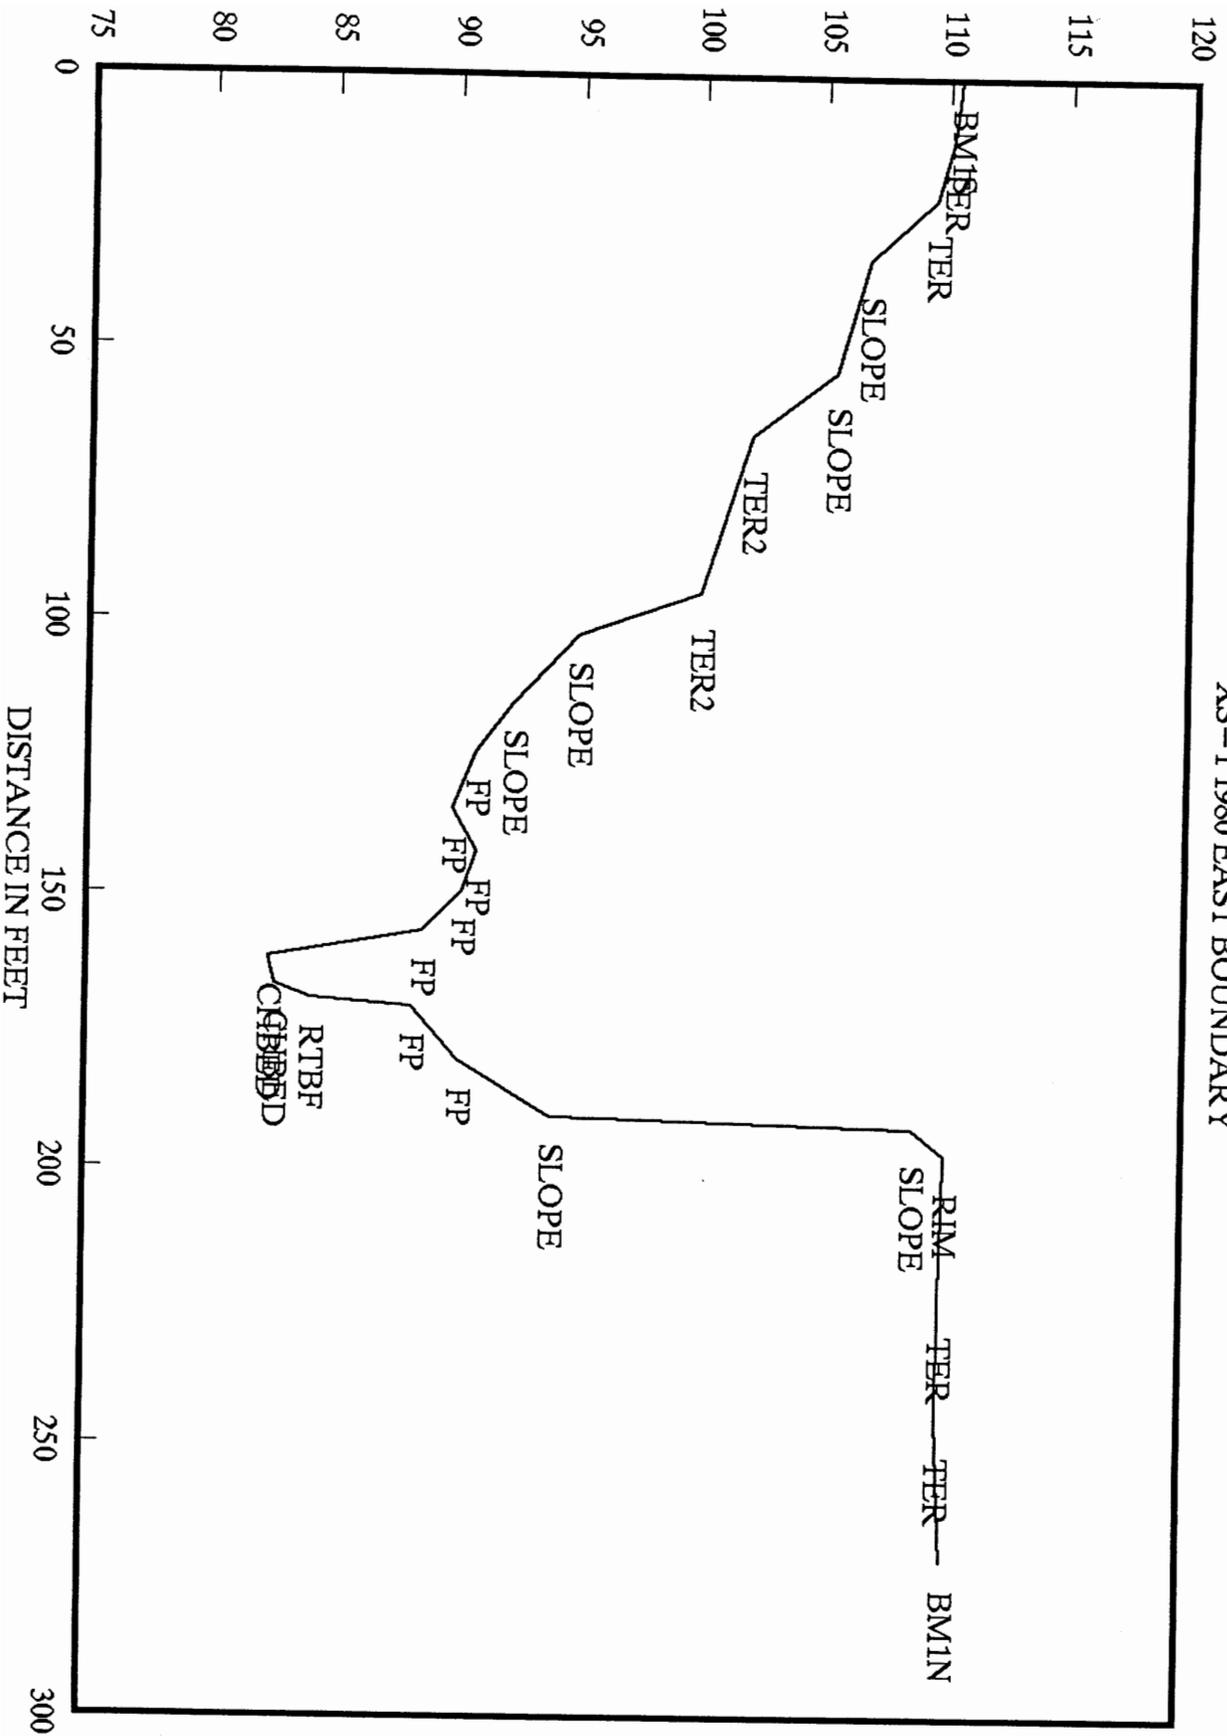
XS-1 1980 EAST BOUNDARY

CHACO WASH

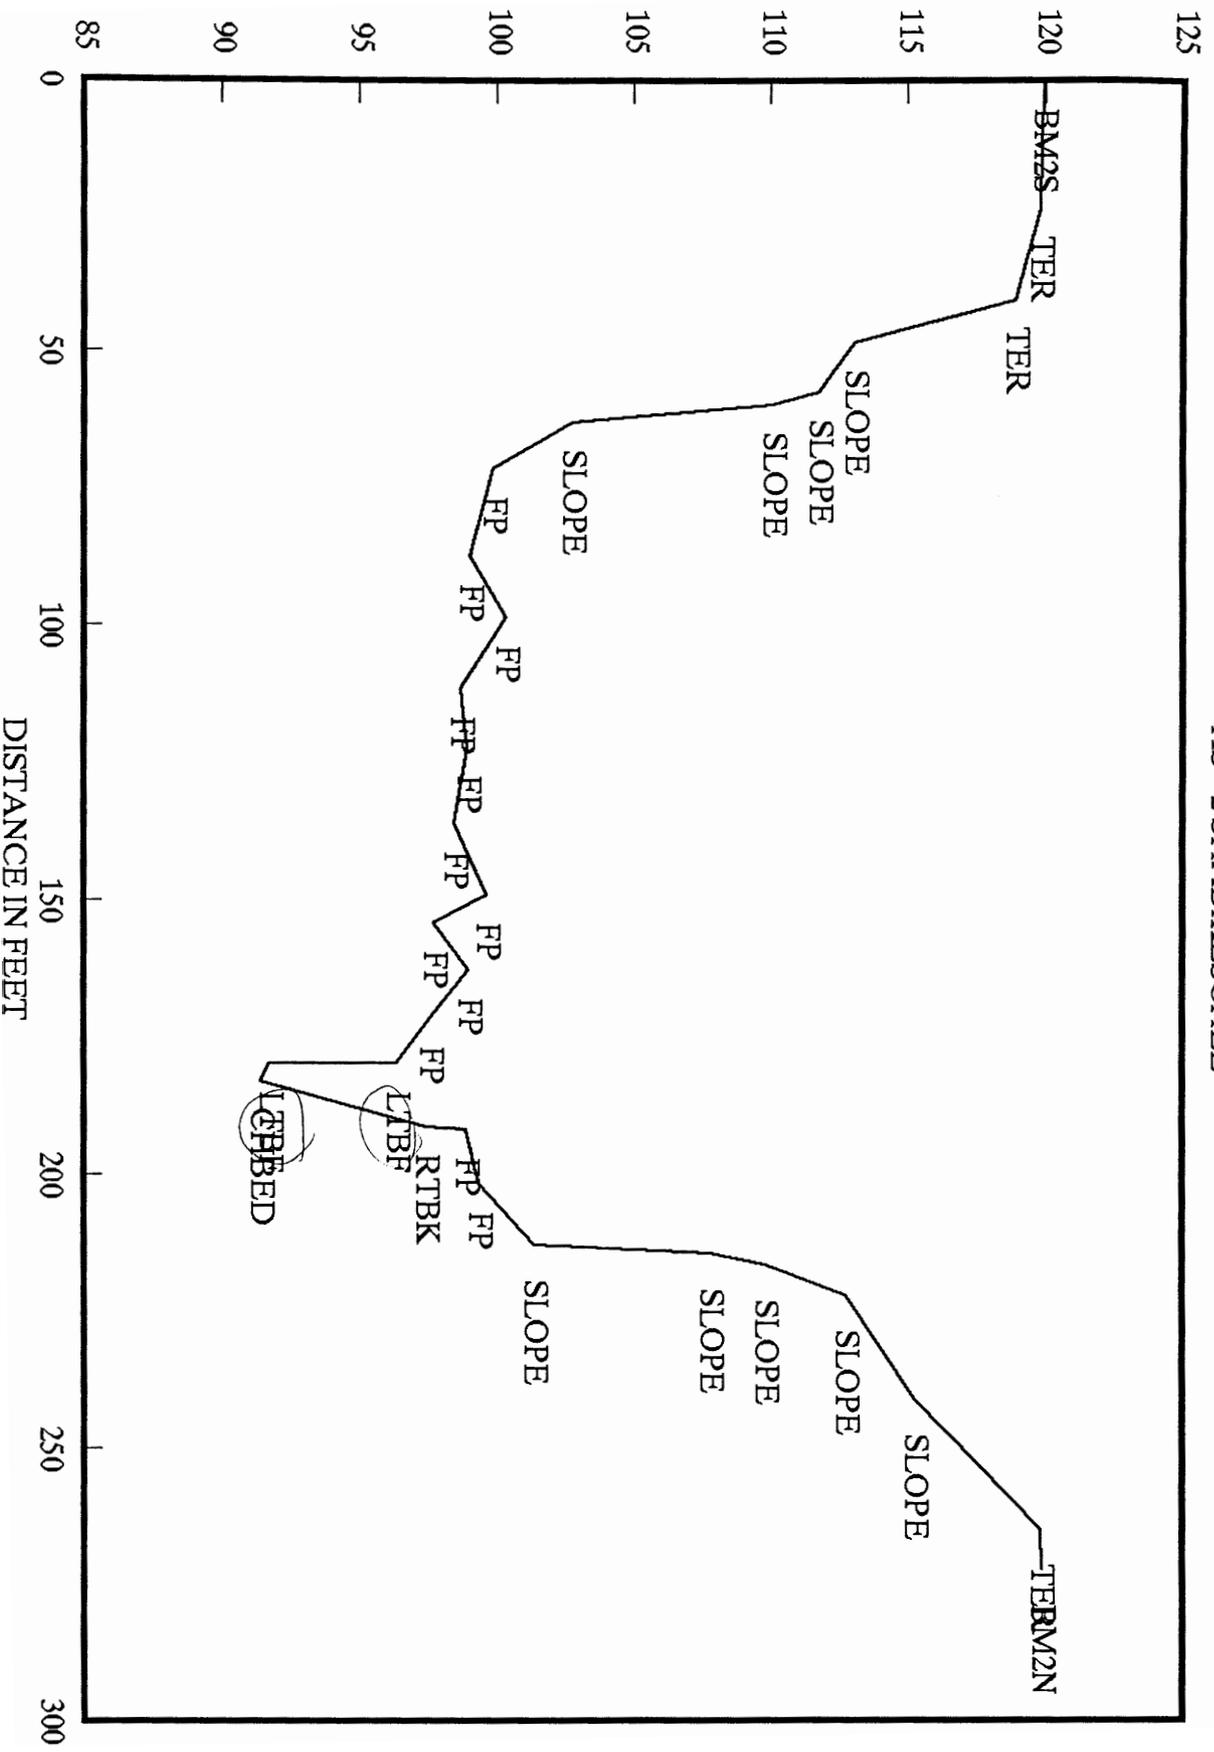
XS-2 SHABIKESCHIEE

CHACO WASH

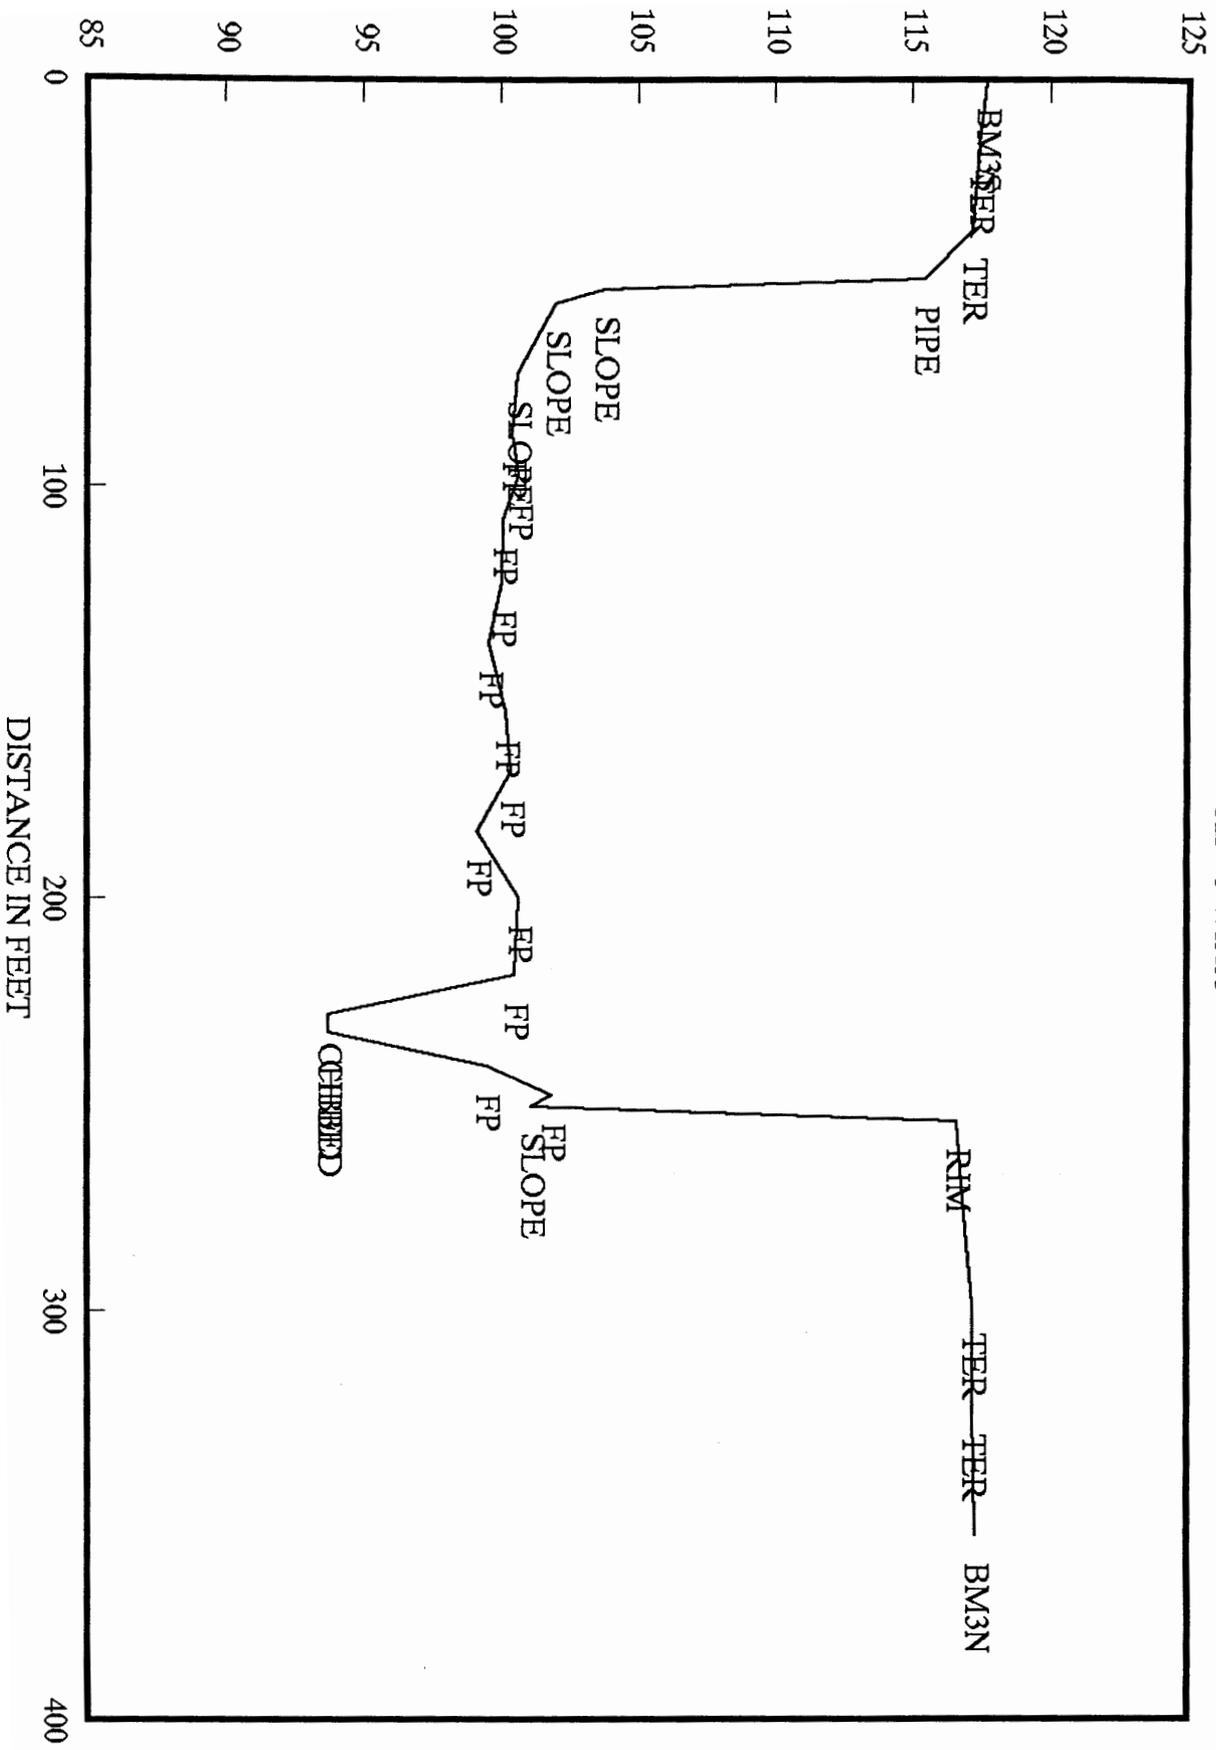
XS-3 WJJI

CHACO WASH

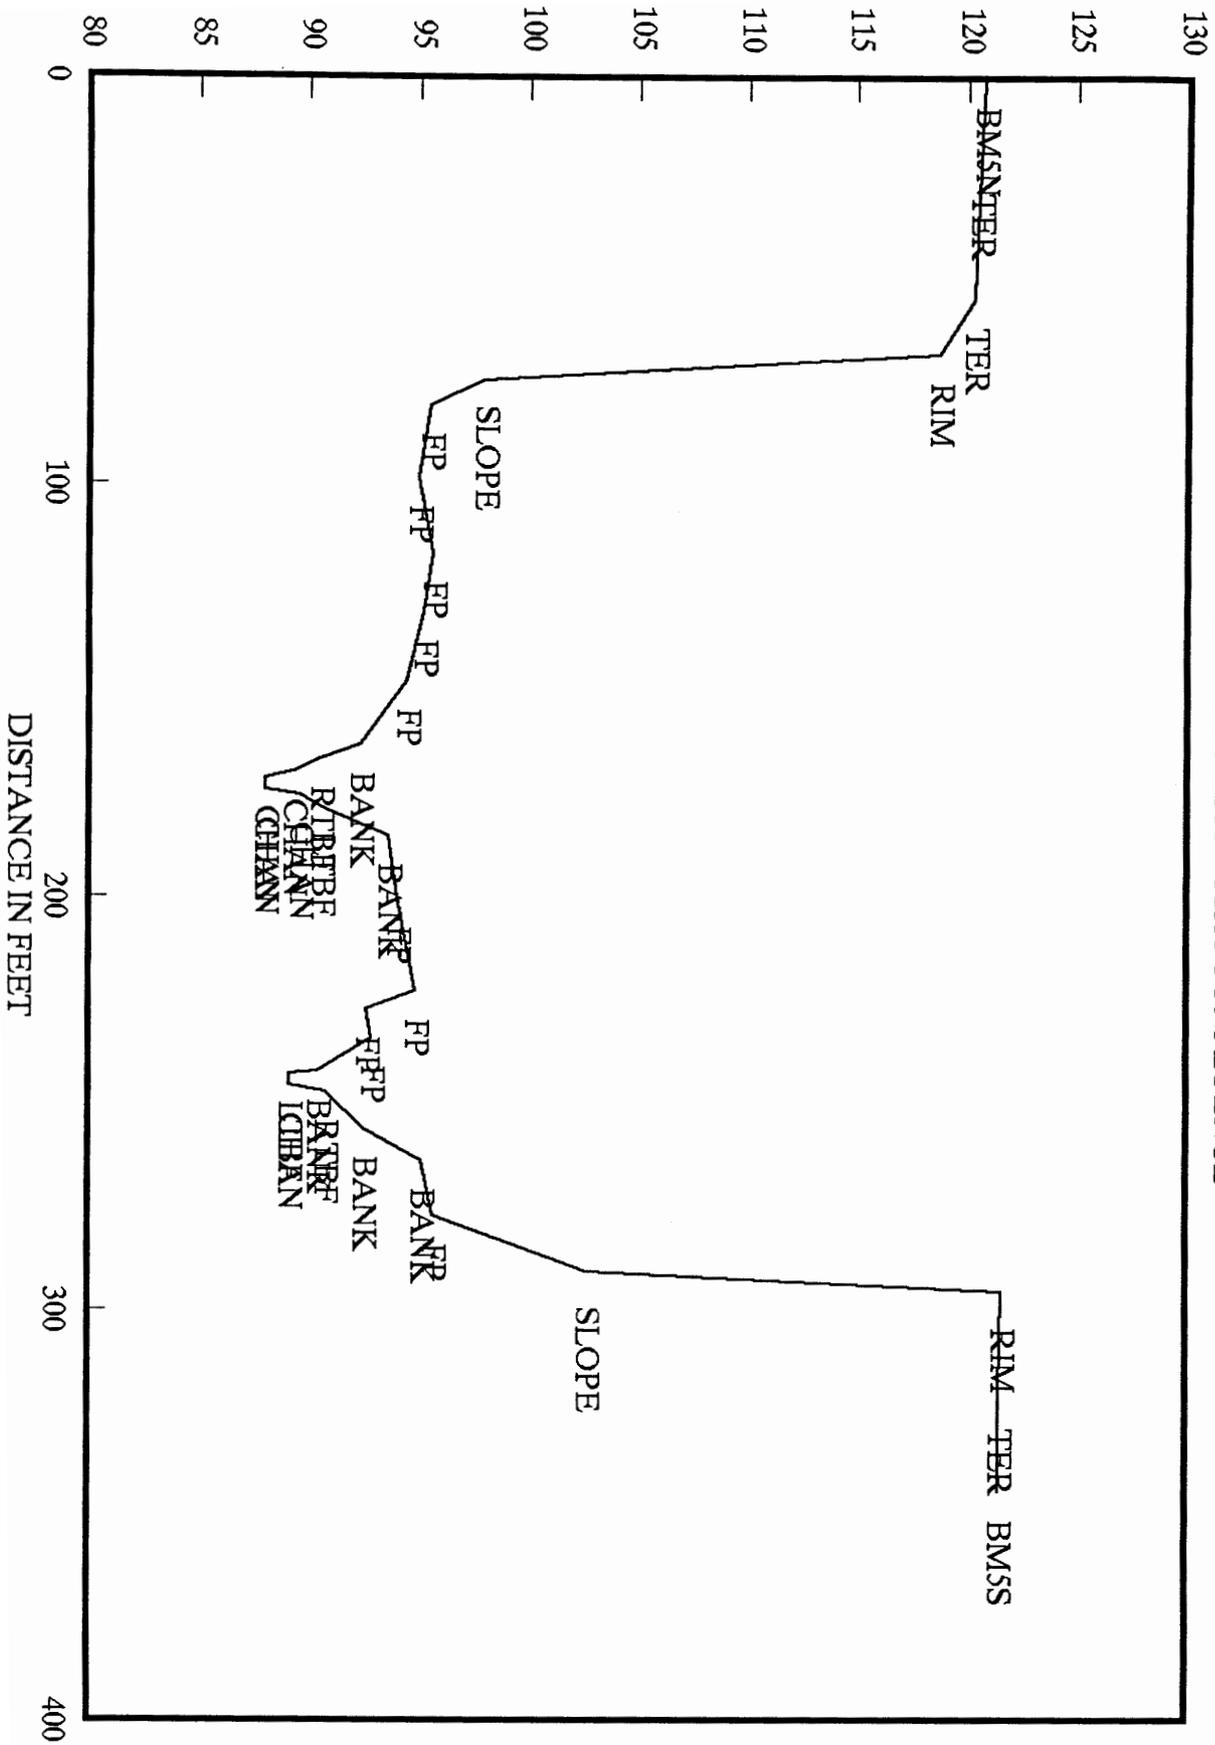
XS-5 FAJADA WASH CONFLUENCE

CHACO WASH

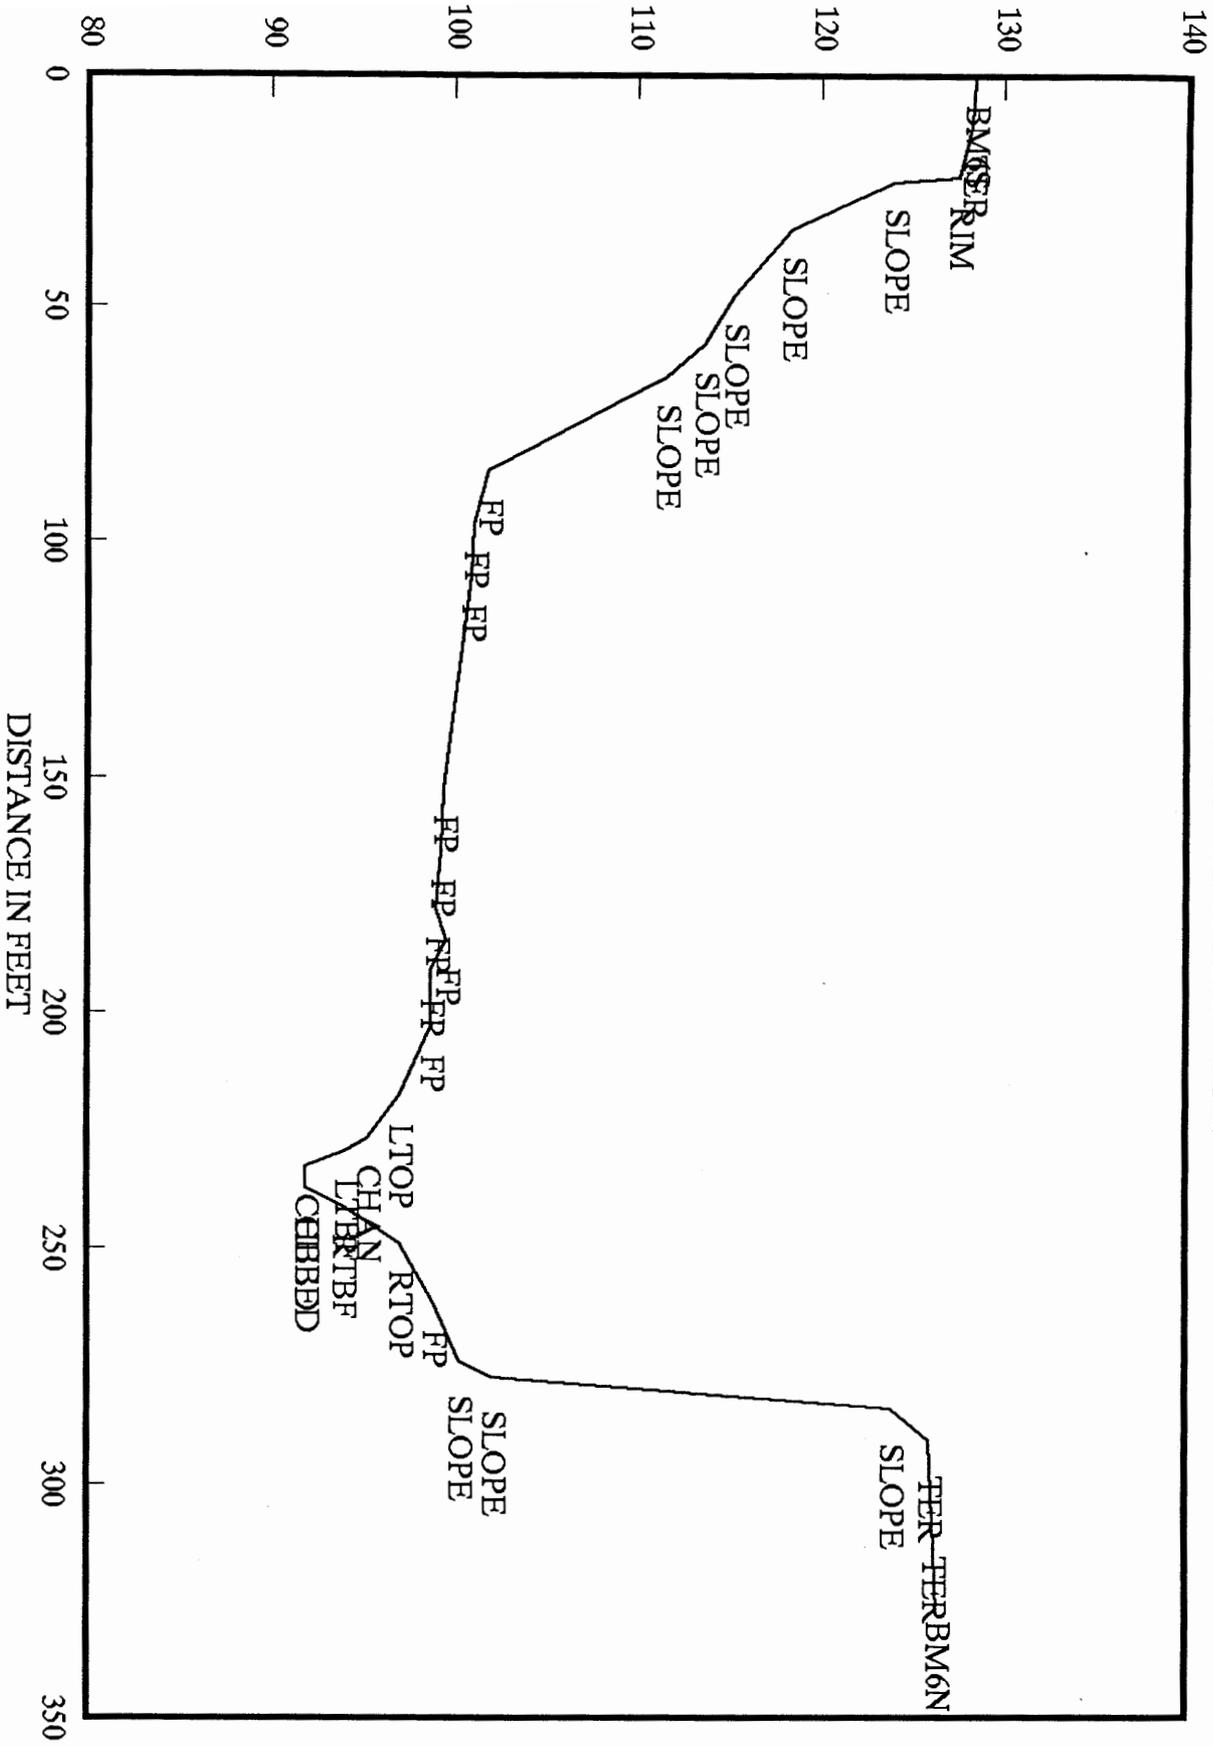
HISTORIC MASONARY WELLS

CHACO WASH
