Chaco Culture National Historical Park

Monitoring Chaco Wash Using Monumented and Surveyed Cross-sections

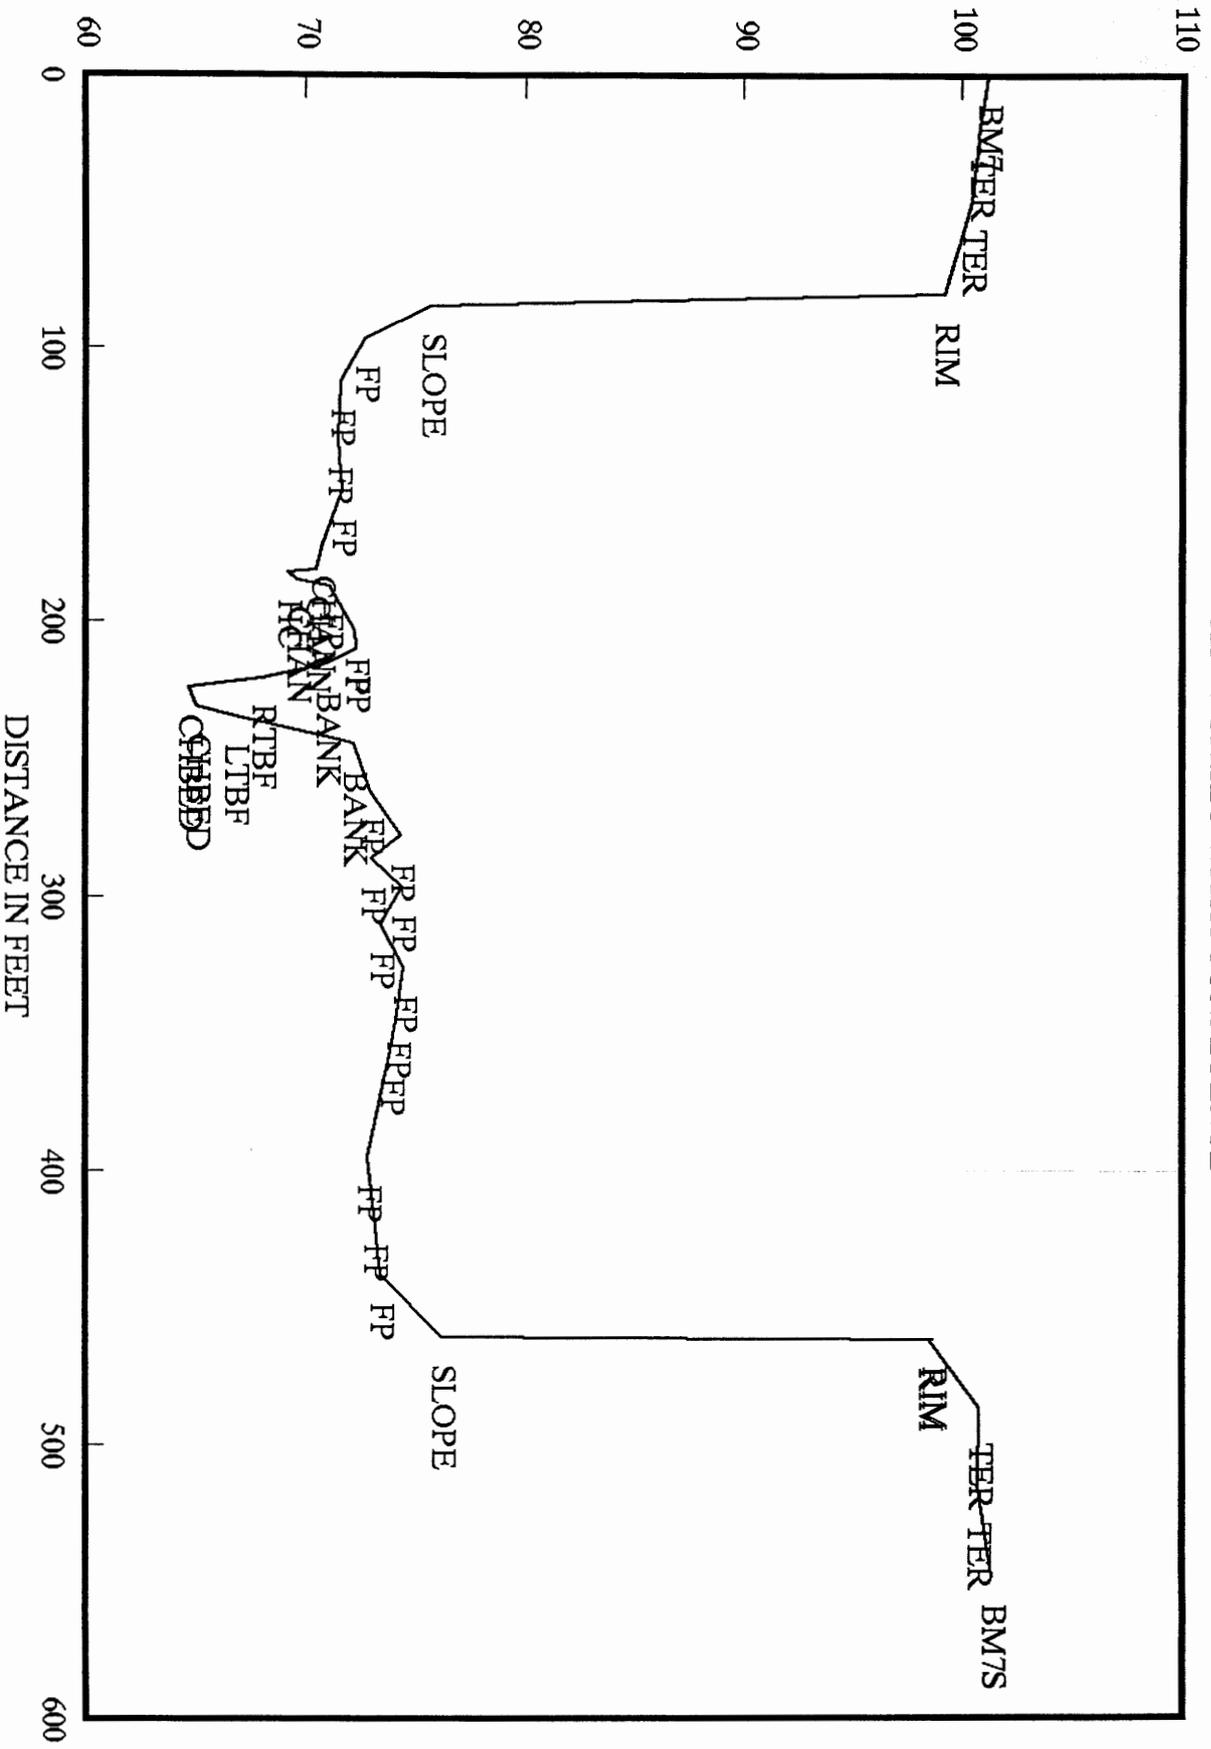
XS-7 GALLO WASH CONFLUENCE

CHACO WASH

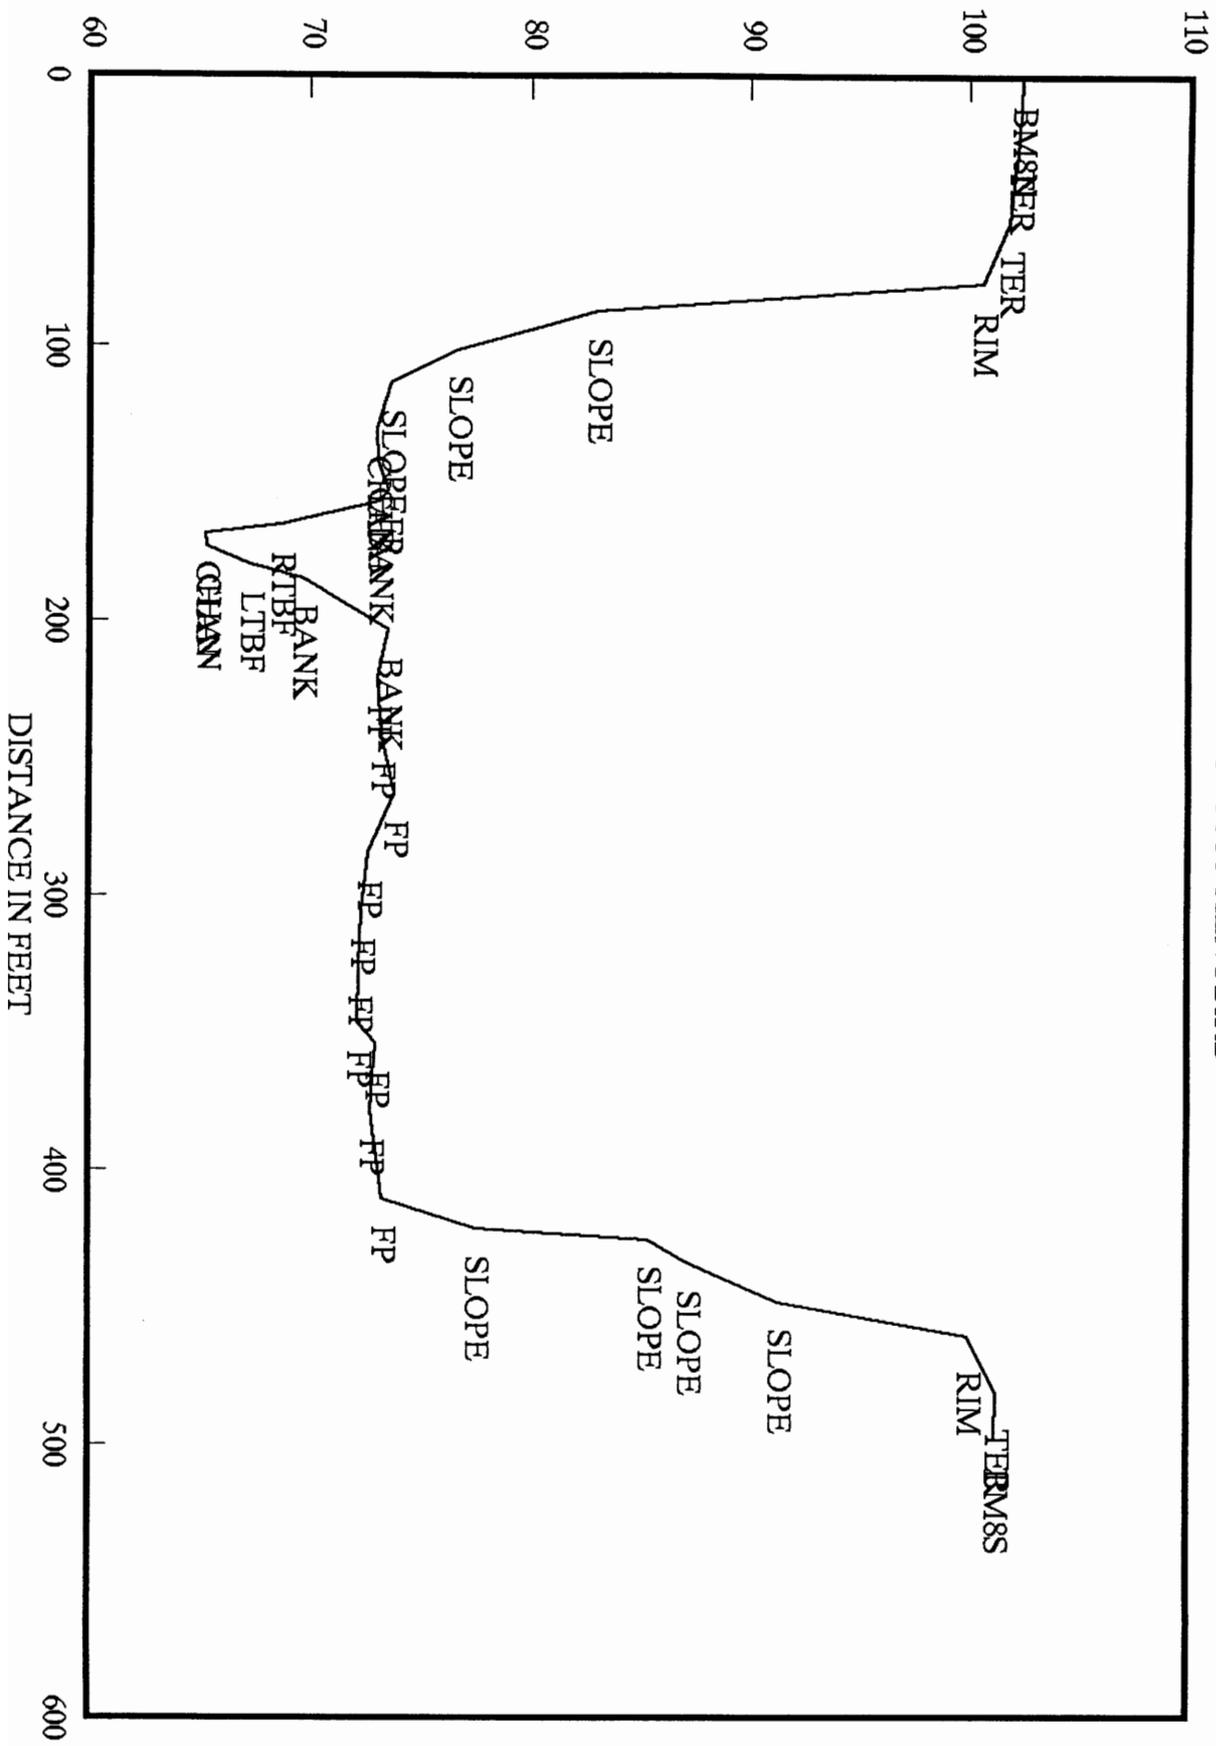
XS-8 MOCKINGBIRD

CHACO WASH

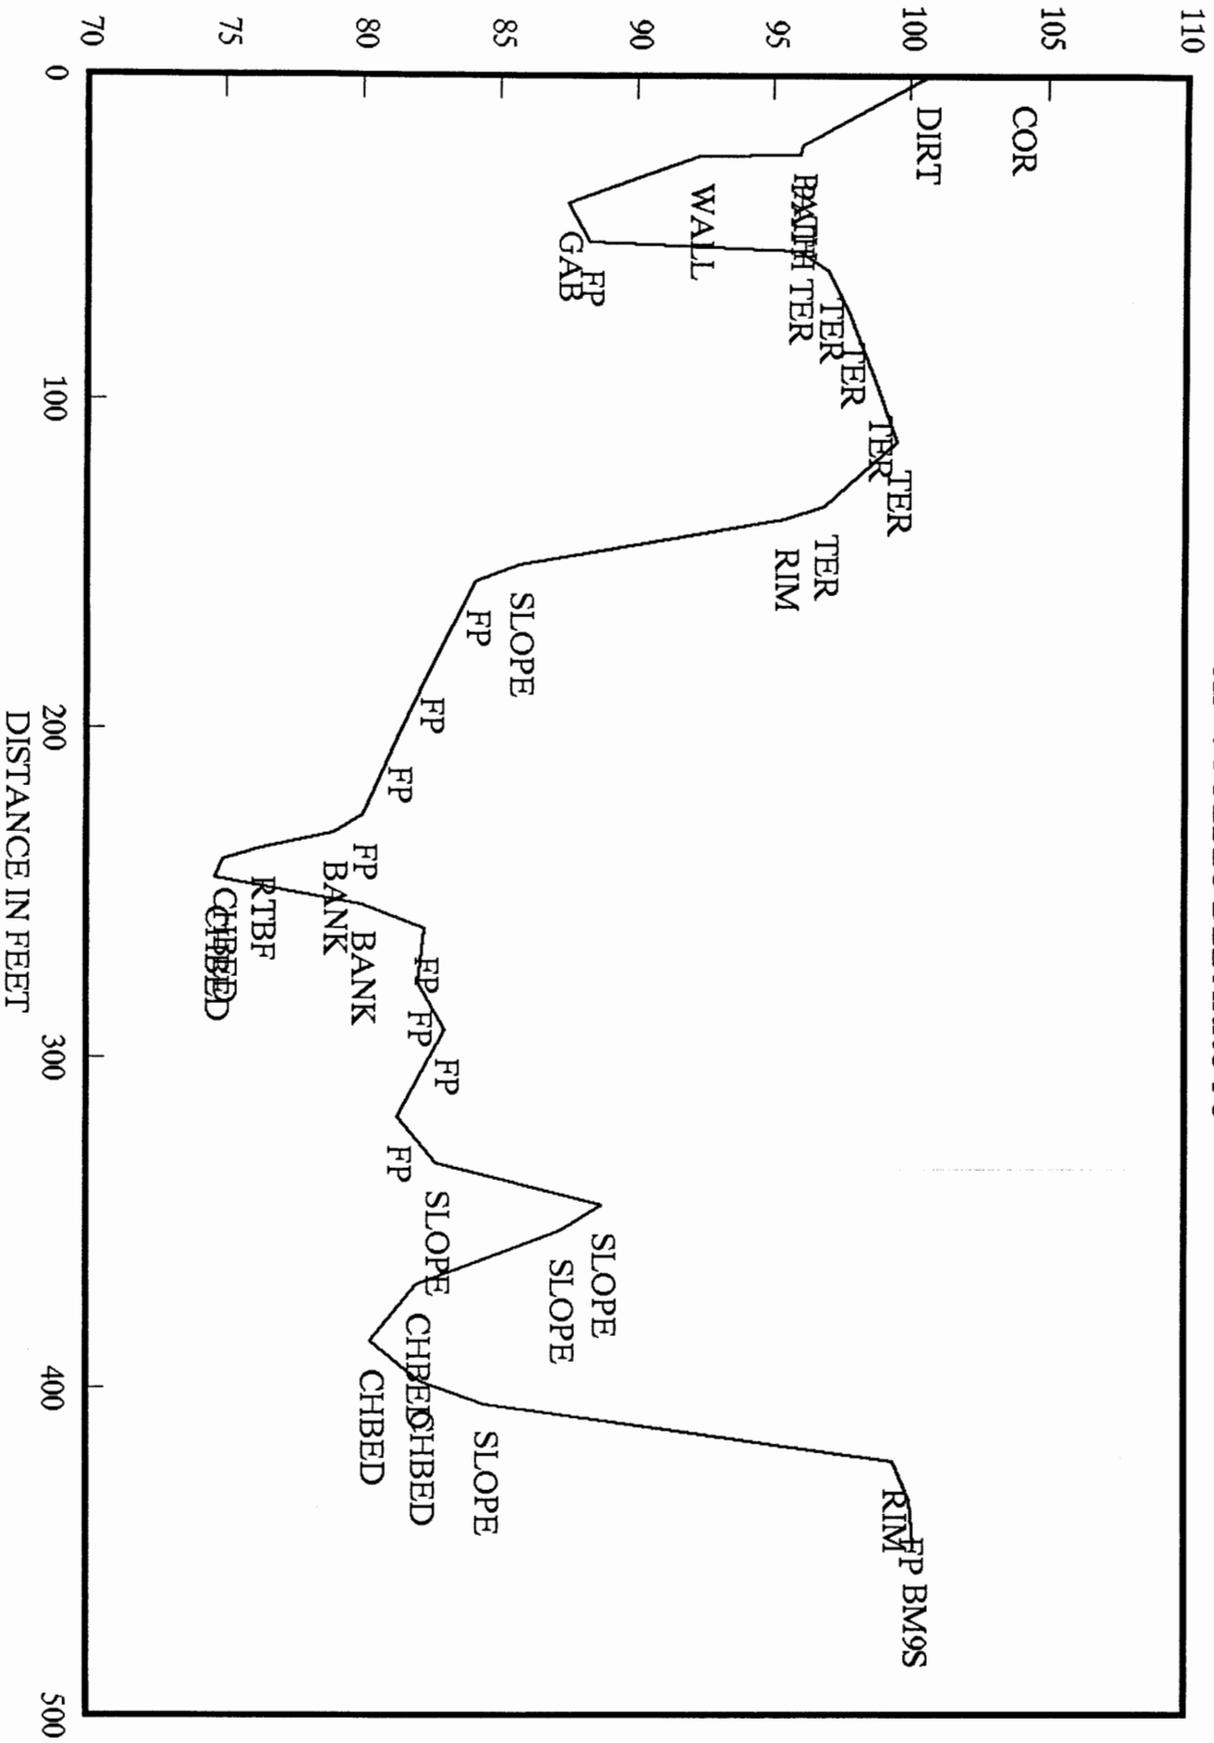
XS-9 PUEBLO DEL ARROYO

CHACO WASH

First and foremost, the Water Resources Division believes that a real and present threat to Pueblo del Arroyo exists from likely future erosion of the right bank (looking downstream) of Chaco Wash. Our assessment is shared and confirmed by other hydrologists, hydraulic engineers, and civil engineers, including professionals from Simons, Li and Associates, the Bureau of Reclamation, and the Corps of Engineers. Risk to Pueblo del Arroyo stems from potential failure of the right bank of the wash rather than from possible inundation by flood waters. This fact makes precise quantification of risk more difficult than for more traditional flood inundation analysis. However, we will try to provide you with our best quantification of that risk.

While several mechanisms could result in the undermining and failure of the right bank of Chaco Wash at Pueblo del Arroyo, the most probable cause of failure would be an extremely large flood. We think that floods of roughly a 50-year magnitude would threaten the structure, and we feel pretty confident in saying that a 100-year return period (or greater) flood would be extremely destructive to the site. If you recall from our discussions, a 100-year flood would just about fill the wash in its present configuration, have extremely high velocities (15-20 ft. per second), and possess considerable erosive power. A flood of this magnitude is difficult to imagine; however, the risk of a 100-year flood occurring is greater than is commonly appreciated.

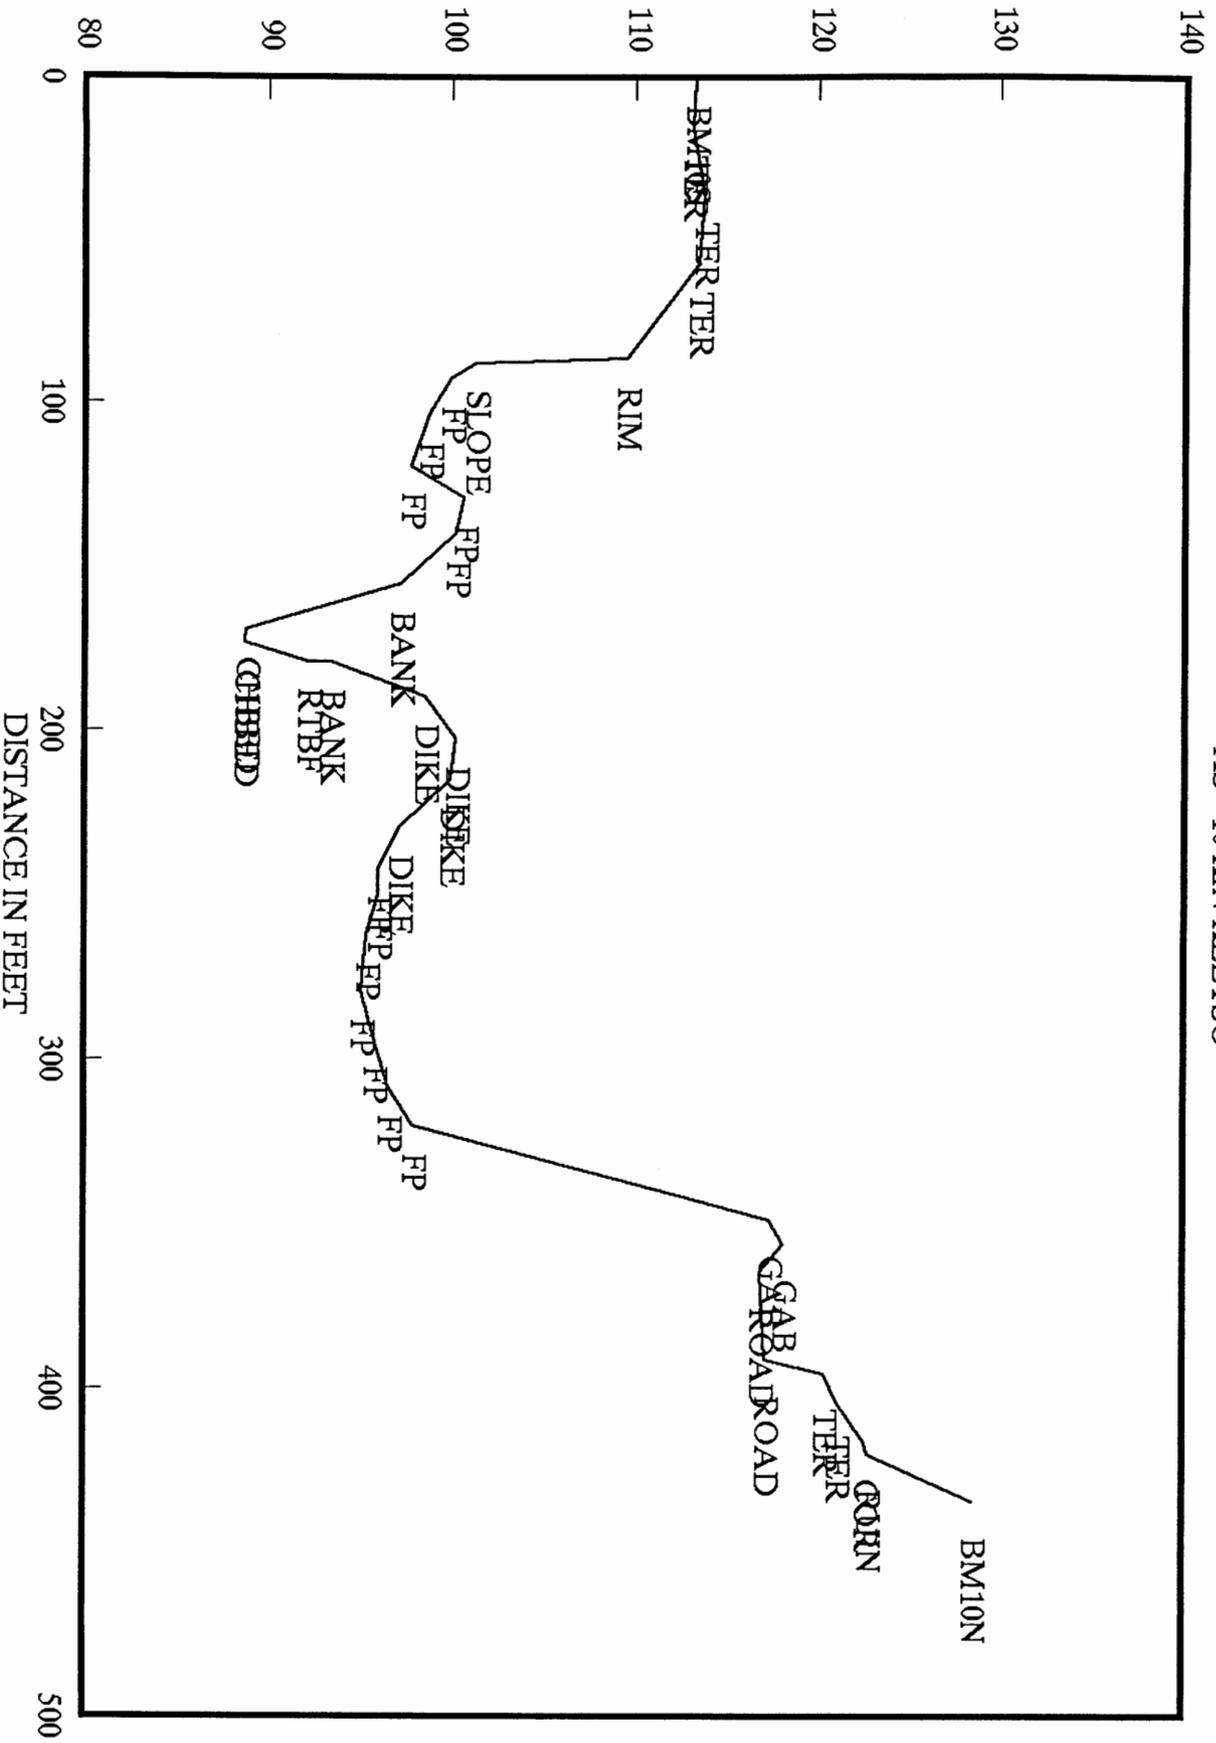
XS-10 KIN KLETSO

CHACO WASH

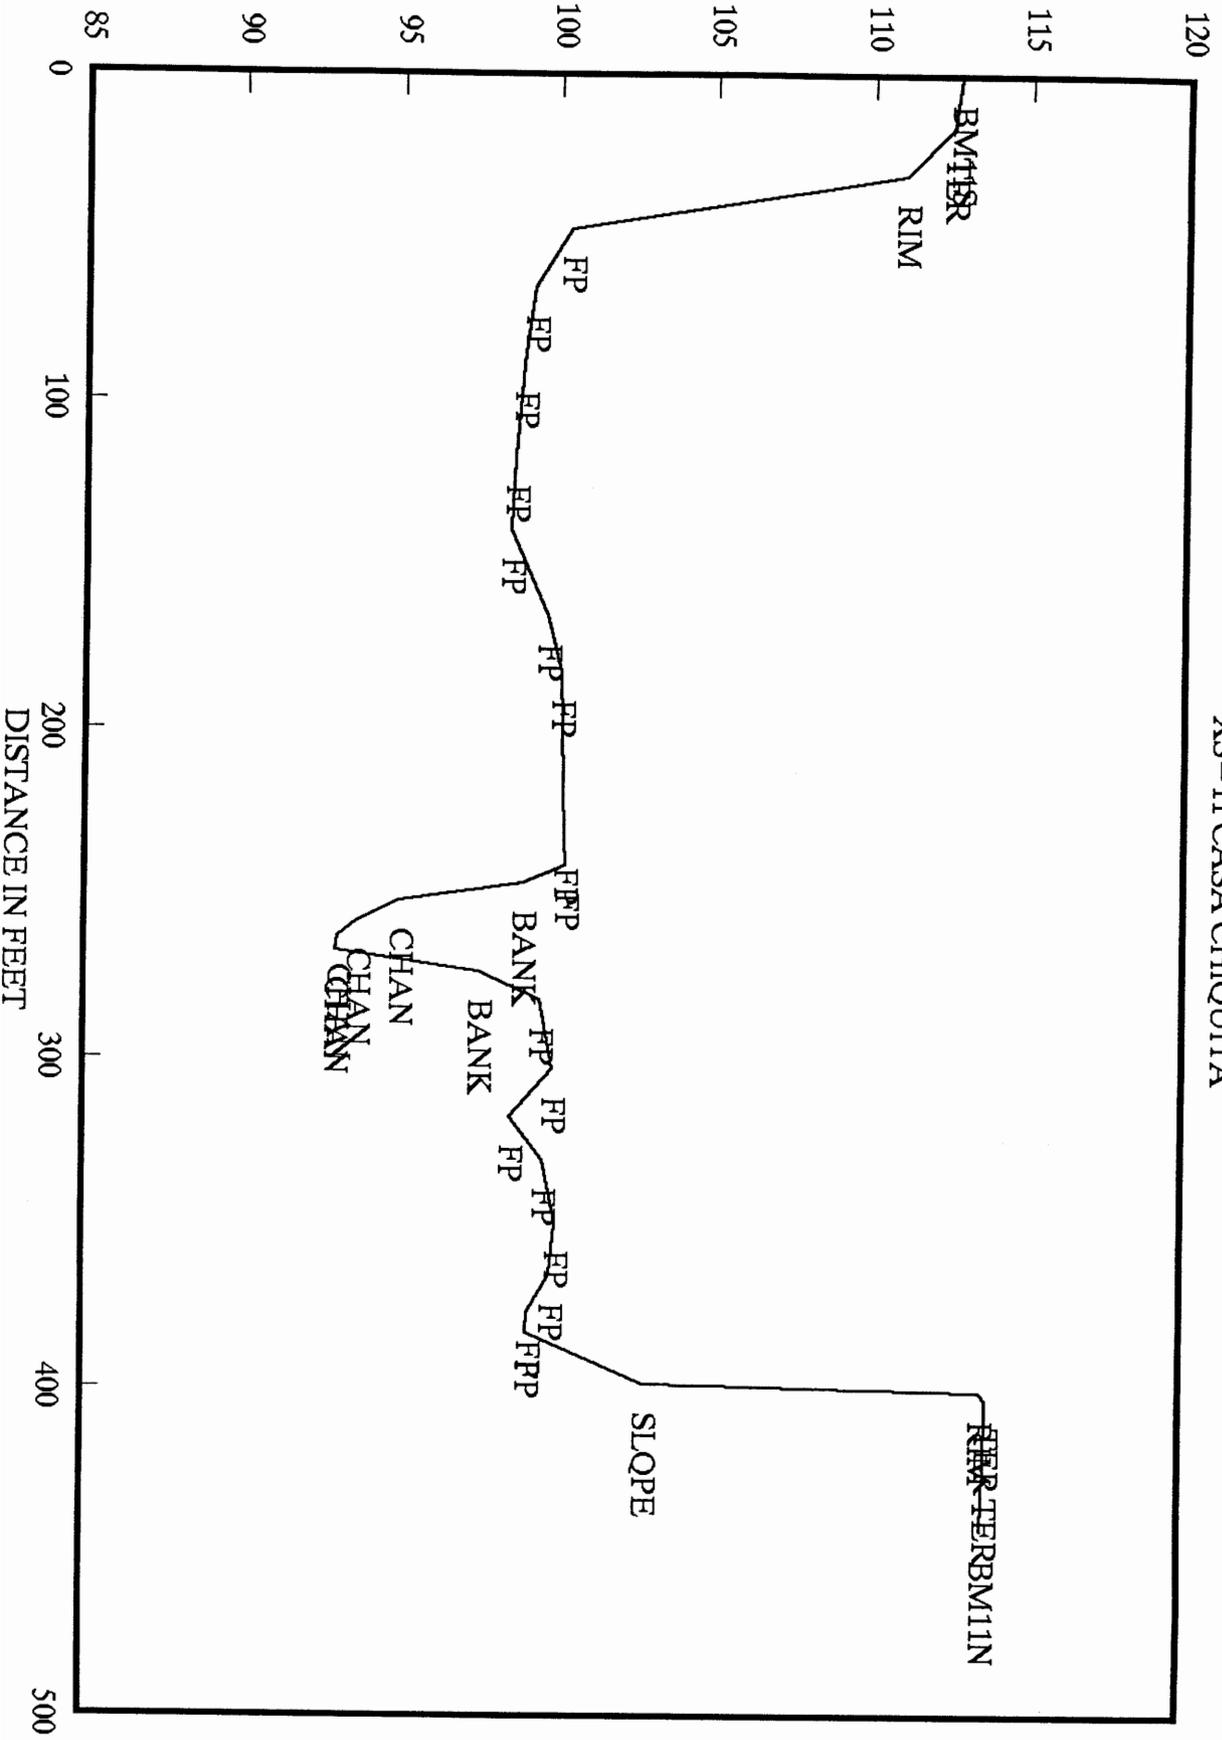
XS-11 CASA CHIOUTA

CHACO WASH

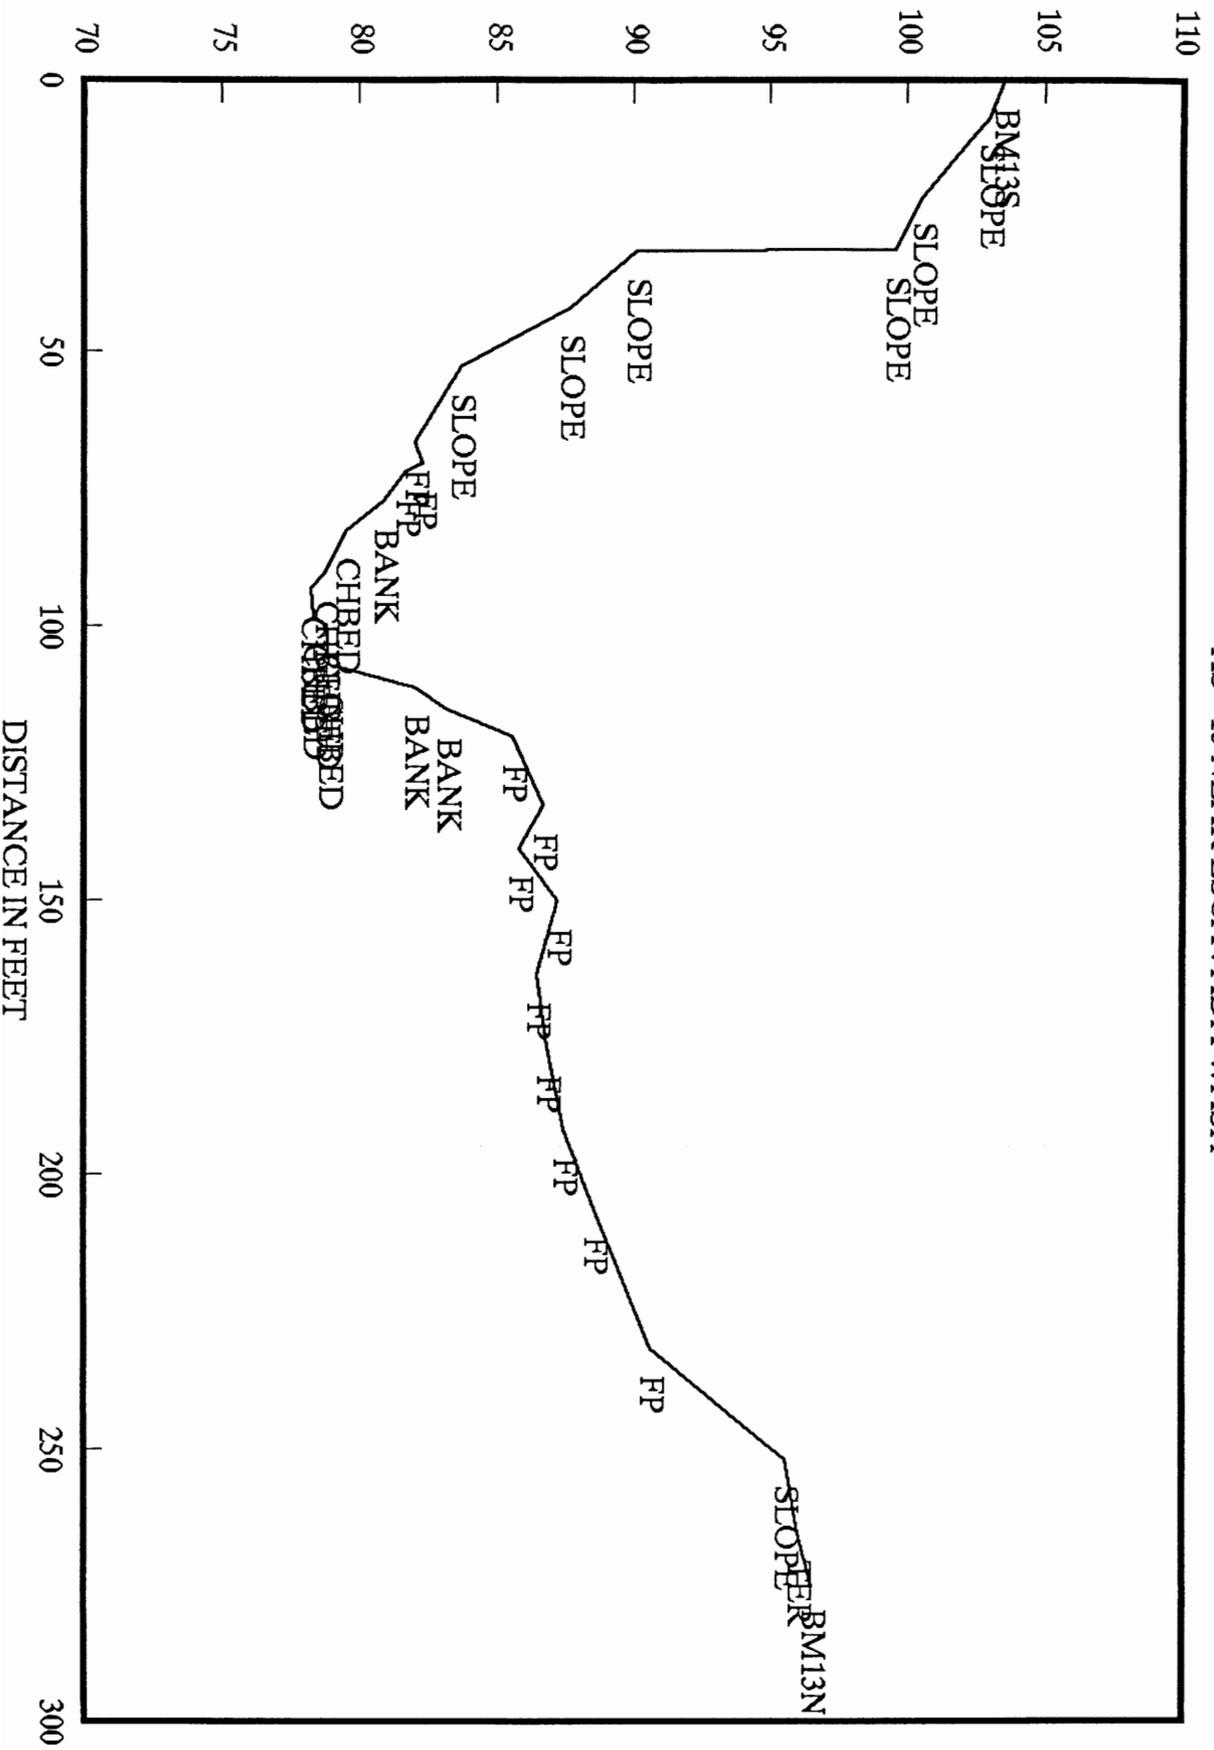
XS-13 NEAR ESCAVADA WASH

CHACO WASH
